국내·외 하천의 물리적 교란 평가 비교·분석과 개선방안

최 흥 식 |
상지대학교 건설시스템공학과 교수
hsikchoi@sangji.ac.kr

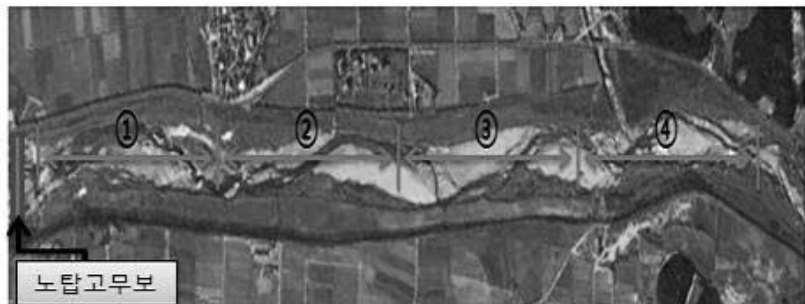
그림 1. 청미천의 하천평가 구간

299.46 km^2 (50.3%), 대지 14.49 km^2 (2.4%), 하천 및 제방 21.95 km^2 (3.7%), 기타 71.99 km^2 (12.1%)로 임야의 구성비율이 가장 크며 다음은 농경지이다. 노탑고무보의 제원 및 현황은 표 6과 같다. 본류의 하상물질은 대부분 자갈 및 모래로 구성되어 있으며, 평균 하상경사는 1/1,200 ~ 1/900의 완경사를 이루고 있다. 청미천의 하천 교란 평가 지점은 노탑고무보 설치지점에서 하류로 1,600 m이며 총 4지점에서 평가하였다(그림 1).

각 국의 평가방법을 토대로 대상지역을 400 간격으로, 4 지점으로 구분하여 조사하였다(그림 1). 실측 자료를 통해 각 국에서 사용되는 방법을 각 평가지표에 맞게 하천의 물리적 평가를 실시하였다(표 8).
