# IN-PILE PERFORMANCE OF HANA CLADDING TESTED IN HALDEN REACTOR

An in-pile performance test of HANA claddings was conducted at up to 67 GWD/MTU in the Halden research reactor in Norway over a 6.5 year period. Four types of HANA claddings (HANA-3, HANA-4, HANA-5, and HANA-6) and a reference Zircaloy-4 cladding were used for the in-pile test. The evaluation parameters of the HANA claddings were the corrosion behavior, dimensional changes, hydrogen uptake, and tensile strength after the claddings were tested under the simulated operation conditions of a Korean commercial reactor. The oxide thickness ranged from 15 to 37 mm at a high flux region in the test rods, and all HANA claddings showed corrosion resistance superior to the Zircaloy-4 cladding. The creep-down rate of all HANA claddings was lower than that of the Zircaloy-4 cladding. In addition, the hydrogen content of the HANA claddings ranged from 54 to 96 wppm at the high heat flux region of the test rods, whereas the hydrogen content of the Zircaloy-4 cladding was 119 wppm. The tensile strength of the HANA and Zircaloy-4 claddings was similarly increased when compared to the un-irradiated claddings owing to the radiation-indu

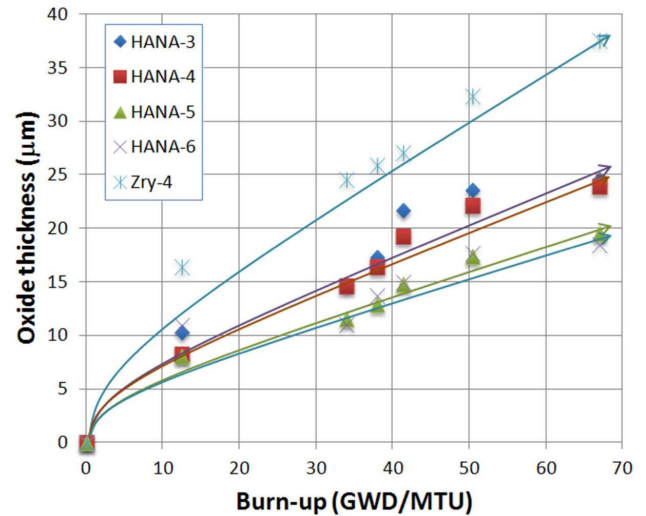
Fig. 2. Corrosion Behavior of HANA and Zircaloy-4 claddings Tested at the Halden Research Reactor Up to Burn-ups of 67 GWD/MTU [10]

Fig. 2 shows the variation in oxide thickness as a function of burn-ups up to 67 GWD/MTU [10]. The oxide thickness of all test rods increased with an increase of burn-ups, and the corrosion behavior of the test rods was followed by the parabolic rate law. This corrosion behavior of the test rods is similar to the out-of-pile test result [11]. However, the oxide thickness of the tested rods in the Halden research reactor was about two-fold higher than that of test coupons in the PWR-simulating loop autoclave test. This increase in the oxide thickness in the in-pile corrosion test compared to the out-of-pile corrosion test was caused by the irradiation damage and heat flux effect on the test cladding [12]. In addition, the transition behavior of the oxidation rate was clearly shown in the HANA test rods

at a burn-up of 40 GWD/MTU. However the transition behavior of the oxidation rate was unclear in the Zircaloy-4 cladding. It is thought that the corrosion transition of Zircaloy-4 cladding occurred at a lower burn-up than the HANA claddings, and therefore the measuring intervals used in this experimental procedure cannot be covered for the observation of the transition behavior of Zircaloy-4.

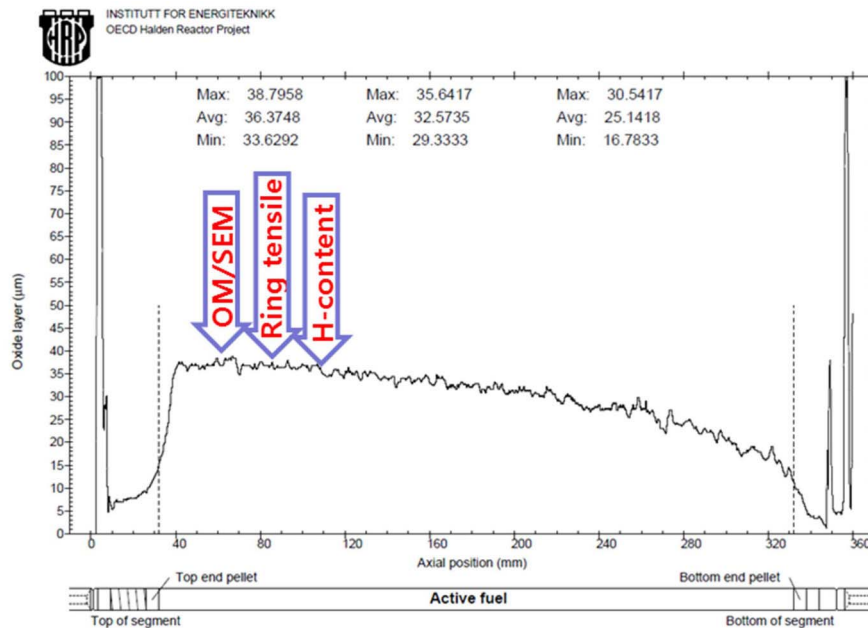
Fig. 1. Oxide Thickness Measurement Results to the Axial Direction of Zircaloy-4 Test Rod Tested at the Halden Research Reactor after Burn-ups of 67 GWD/MTU

The oxide thickness measurements of the test rods were conducted at approximately 200 day intervals using non-destructive measuring methods (ECT). Fig. 1 shows the ECT measurement result of a Zircaloy-4 test rod for the axial direction after the burn-ups of 67 GWD/MTU. The measured oxide thickness varied with the axial position of the test rod because the heat flux and coolant temperature of the test rig varied with the change in the elevated position of the test rod from the bottom to the top side. A comparison of various irradiation properties such as the oxide thickness, ring tensile result, and hydrogen content between HANA and Zircaloy-4 claddings was conducted using the high heat flux region of all test rods, as marked in Fig. 1.

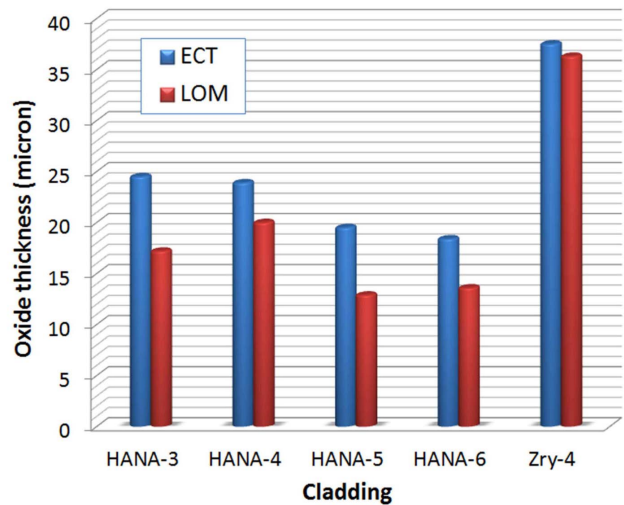
Fig. 4. Comparison of Oxide Thickness between ECT and LOM Measurement of HANA and Zircaloy-4 Claddings Tested at the Halden Research Reactor after Burn-ups of 67 GWD/MTU

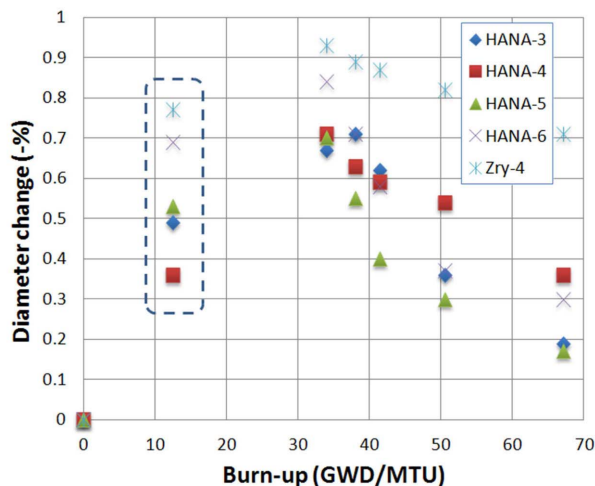
Fig. 5. Tube Diameter Variation Behavior of HANA and Zircaloy-4 Claddings Tested at the Halden Research Reactor up to Burn-ups of 67 GWD/MTU [10]

Fig. 5 shows the tube diameter measurement results as a function of irradiation burn-ups, which were corrected for the oxide thickness to evaluate the free cladding diameter variation without the oxide thickness effect. Initially, the rod diameter decreased to be up to about 34 GWD/MTU; however, the measured diameter increased with an increase in the test burn-up, which was affected by the fuel swelling behavior after the fuel-clad interaction. This inverse trace in diameter change was related to the pellet-clad mechanical interaction (PCMI), which was identified by a ridged pattern in the axial diameter measurement results. In addition, the ridges can be seen for all test rods after the burn-ups of 34 GWD/MTU. To compare the free creep behavior of the HANA and Zircaloy-4 claddings, it is necessary to use data from the period before fuel-clad interaction occurred. Because evidence of fuel-clad interaction in the majority of the fuel rods was obtained after 12 GWD/MTU, marked as the dotted line in Fig. 5, the free creep behavior of HANA and Zircaloy-4 claddings can only be evaluated from the test results after burn-ups of 12 GWD/MTU. As shown in Fig. 5, all of the HANA claddings showed superior creep resistance to that of the Zircaloy-4 cladding. In particular, the creep down of HANA-4 was less than half of that of the Zircaloy-4 cladding.

The difference in the creep deformation in the HANA claddings was caused by the optimized combination between the alloying elements and the recrystallization fractions. It is well known that the creep resistance of zirconium-based alloys is determined by the recrystallization fractions [14, 15]. Since the four types of HANA claddings have a partial recrystallized grain, the creep deformation was decreased when compared to the Zircaloy-4 cladding, which has a stress relief structure. Regarding the alloy composition, it is well known that the creep strength of zirconium alloys is affected by alloying elements such as tin, niobium, oxygen,

carbon, and sulfur in a solid solution [16]. In the HANA alloys, the alloying compositions were effectively controlled for enhancing the creep strength at concentrations in the soluble limits. However, the lower creep resistance of HANA-6 cladding than other HANA claddings was caused by the absence of Sn in HANA-6 alloy.
