## A Study on the Improvement of Philippine Maritime Traffic Environment and Safety Management System

#### Abstract

The paper presents the Philippine maritime condition, safety systems and navigational aids. It aims to uplift the maritime safety systems and infrastructures by studying the different strata of the industry, thereby emphasizing on the structures, weaknesses and opportunities. It presents the different maritime agencies involved and each responsibilities. Data from PPA demonstrate the statistics of increase in the cargo throughput, passenger, shipcalls and cargo-container handled in the year 2014. It also highlights the insufficiency of different navigational aids, VTMS, MBS and TSS placed in the whole archipelago. It gathers data of maritime accidents in 10-year period, 2006-2015, showing the most occurred accidents, casualties and areas these accidents happened. It includes the weather phenomena which contribute to the maritime movements and accidents incidence. The results show that systems and infrastructures that focus on the lack of improvement in technology and over-lapping functions of different agencies of government require development and upgrading.

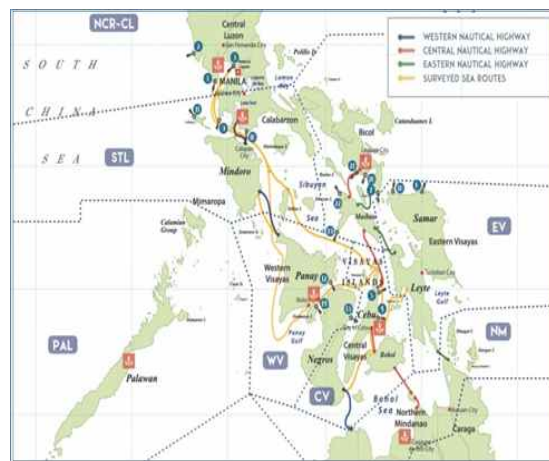
[Fig. 2] Traditional sea-routes from Manila to Central Visayas regions and Northern Mindanao.

[Fig. 2] plots the traditional routes taken by domestic and foreign vessels from the main port of Manila to the major cities and destinations in the central Visayas and northern Mindanao. These areas are also the main storm-paths during the typhoon seasons (See [Fig. 8], Sec. 2.5).

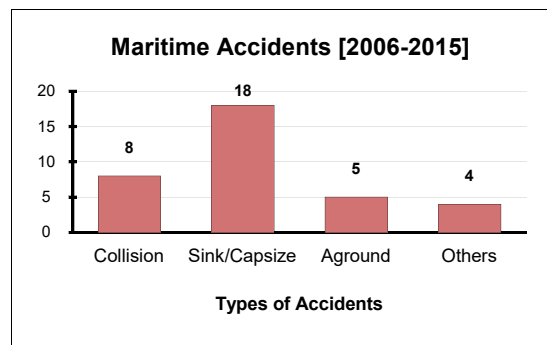
[Fig. 9] Maritime accidents promulgated by PCG-BMI from 2006-2015

[Fig. 9] graphs the number according to the nature of accidents. Sinking/capsizing has the most at 18, followed by collision, 8 and aground by 5. Other, 4, include ramming, near miss, damaged and an undeclared cause.

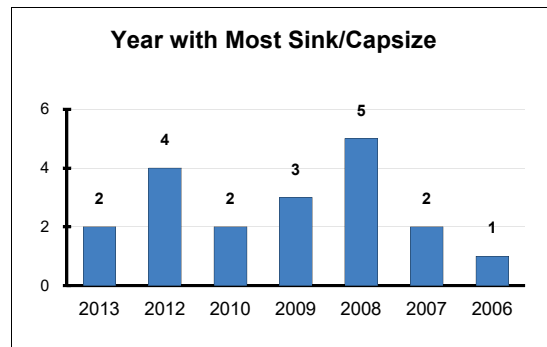
[Fig. 10] The year with the most sinkage/capsized

[Fig. 10] shows the most fatal of all accidents, sinking and capsizing. 2008 has 5 sinkage and it has also the most casualties (<Table 3> and [Fig. 11]). It was followed by 2012 with 4, and 3 in 2009.

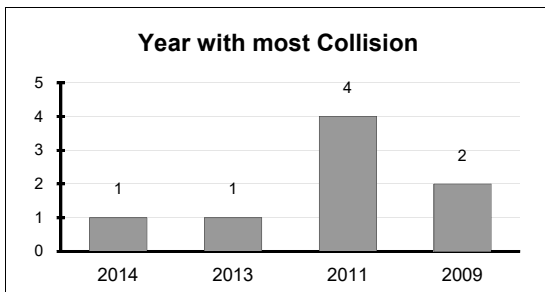
[Fig. 12] Year with the most collision accidents

Collision accidents is graphed in [Fig. 12] at year 2011 with 4, followed by 2009 at 2. Collision occurred at NCR and Eastern Visayas regions with 3 each and 2 at Southeastern Mindanao. These are the areas also where most accidents between 2006-2015 occurred shown in [Fig. 13].
