# 도심지 소단면 터널식 <del>공동구</del>의 핵심 안전 위험요소 및 위험성 평가 연구

# Study on key safety hazards and risk assessments for small section utility tunnel in urban areas

Journal of Korean Tunnelling and Underground Space Association 20(6)931-946(2018) https://doi.org/10.9711/KTAJ.2018.20.6.931

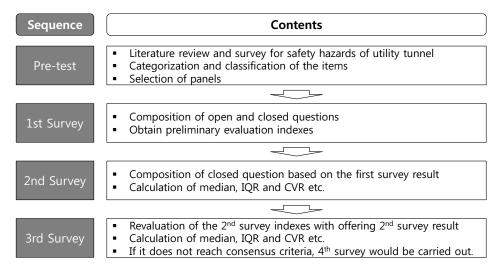
Fig. 2. Process of conventional Delphi survey

델파이 조사는 전문가 의사결정 방법 중 하나로, 선정된 주제에 대해 해당 분야 전문가들의 합의를 도출하는 기법이다. 도심지 소단면 터널식 공동구의 안전 위험요소 중 어느 위험요소를 보다 중점적으로 관리해야 하는지를 Fig. 2와 같이 반복적인 델파이 조사 절차를 통해 선정하였다. 델파이 기법은 토목분야에 다수의 활용 사례가 있다. 터널 및 지하공간 연구에 적용된 사례는 터널의 성능중심 평가기법에 대한 항목 도출에 적용되었고(An and Kim, 2016), 도심지 흙막이 굴착공사 사고 저감을 위해 관리되어야 할 우선 요소 결정에 활용되기도 하였다(Seong and Jung, 2017).
