Interaction of cracks and precipitate particles on the REBCO superconducting layers of practical CC tapes through fractographic observations

Michael de Leon, Mark A. Diaz, and Hyung-Seop Shin*

Department of Mechanical Design Engineering, Andong National University, Andong, Kyungbuk, 36729 Korea

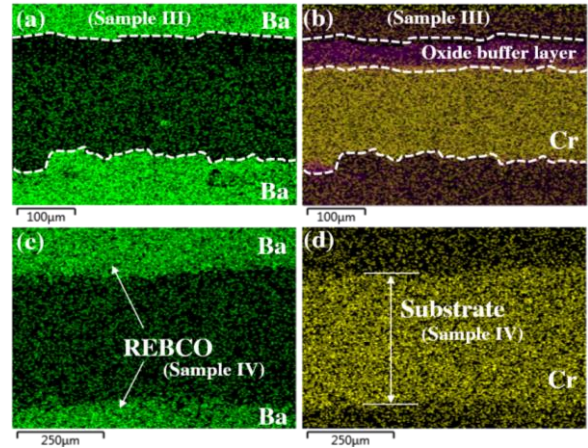
Fig. 5. Mapped elements concentration for Sample 3 (a) Ba and (b) Cr, and Sample 4 (c) Ba and (d) Cr.

Unlike Samples 1 and 2, Samples 3 and 4 have no distinct randomly oriented precipitate particles. Likewise, no cracks other than the striation cracks were observed on the surfaces of the REBCO layers, exclusively in Sample 4. Nevertheless, the length of the delaminated REBCO part in Sample 3 is doubled in Sample 4 (Fig. 5 (a) to (d)). The mapped elements of Samples 3 and 4 in Fig. 5 (a) to (d) and in the SEM images in Fig. 2 (c) to (d) show that layers of flaked elements were delaminated randomly. A layer of oxide buffer was also exposed in Fig. 5 (b). These resemble that cracks may be formed first at the substrate or buffer layers before it propagates and delaminated the REBCO layer.
