## Characteristics of Fatigue Crack Initiation and Fatigue Strength of Nitrided 1Cr-1Mo-0.25V Turbine Rotor Steels

To investigate the effect of nitriding layer on both fatigue crack initiation and fatigue life, turbine rotor steel (1Cr-1Mo-0.25V steel) specimens were nitrided by the nitemper method and then put to a rotary bending fatigue test at room and elevated temperatures. In nitriding, temperature and time were controlled to obtain a different nitrided thickness. Microstructure analysis, micro-Vickers hardness test, and scanning electron microscope observation were carried out for evaluating experiments. In results, the fatigue cracks of nitrided specimens were initiated at inclusion near the interface between nitrided layer and substrate, which showed fish-eye type appearance in fractograph. The fatigue life of nitrided specimens at every temperature was prolonged compared to that of the non-nitrided. However, there was not observable improvement in fatigue characteristics with the increase of a nitrided thickness.

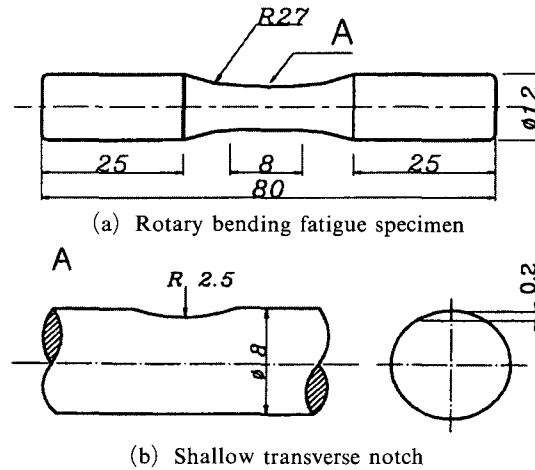
**Fig. 1** Configuration of specimen (unit : mm)

Figure 1(a) shows a rotary bending fatigue test specimen with a diameter of 8mm and gage length of 8mm. Figure 1(b) shows the surface round

notch with a radius of 2.5mm and depth of 0.2mm, which was machined using a ball-type end mill in order to observe fatigue cracks without causing in the notch sensitivity.

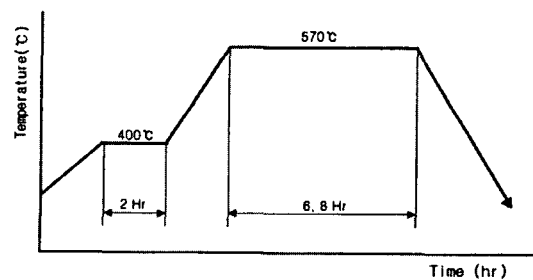
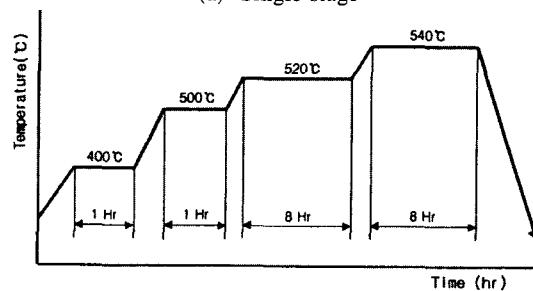
**(b)** Double stage**Fig. 2** Heat treatment cycles of nitriding

The nitemper method was used in this study for nitriding. Two kinds of heat-treatment cycles, named single and double stage nitridings, were performed to change the thickness of compound layers, formed at the surface affecting on the fatigue characteristics. Figure 2 illustrates the heat-treatment cycles of the nitriding process used in this study. Nitriding time for the single stage treatment shown in Fig. 2(a) was set to 6 and 8 hours at 570°C to make different nitrided layers. In the double stage shown in Fig. 2(b), nitriding time was set to 8 hours at 520°C and 8 hours at 540°C.

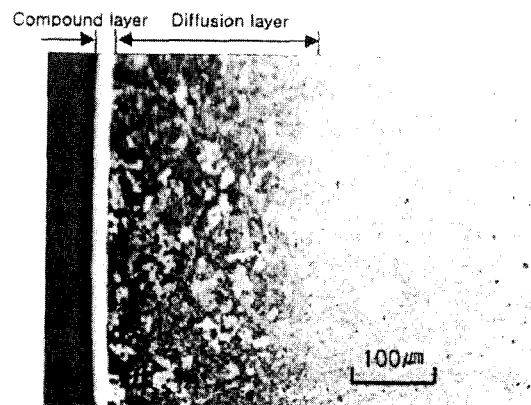
Fig. 3 Microstructure of nitrided layer formed by the single stage heating cycle for 6 hr at 570°C

Figure 3 shows the microstructure of a nitrided region that was generated by the single stage in the nitriding process for 6 hr at 570°C. As seen in Fig. 3, the nitride layer is composed of the compound layer and the diffusion layer and the layer thickness were formed differently according to the nitriding methods. The thickness of the compound layers measured 6.9µm for double stage and 19.2µm and 14.0µm for 6 hr and 8 hr single stage, respectively.

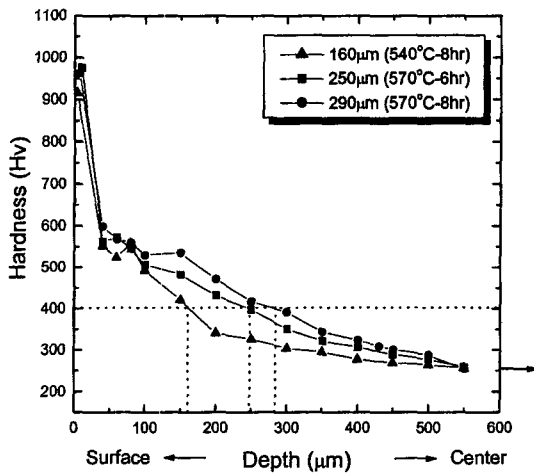
**Fig. 4** Micro-Vickers hardness profiles and nitrided depth with different nitriding process

to center direction are shown in Fig. 4 with the different nitriding processes. The hardness values apart from the surface of the nitrided specimen (260 Hv) were similar to those of the non-nitrided specimen. The hardness values of the compound layer were about 950 Hv but rapidly decreased in the diffusion layer. They fell to 260 Hv at the 500  $\mu\text{m}$  from the surface, which were similar to those of the non-nitrided specimen.

According to the references (Genel and Demirkol, 2000), the case depth, in this study, was defined as the position from the surface that had 400 Hv. By this criterion and from Fig. 4, the thickness of nitride layers were obtained as 160  $\mu\text{m}$  for double stage process and 250  $\mu\text{m}$  and 290  $\mu\text{m}$  for 6 hr and 8 hr single stage process, respectively.

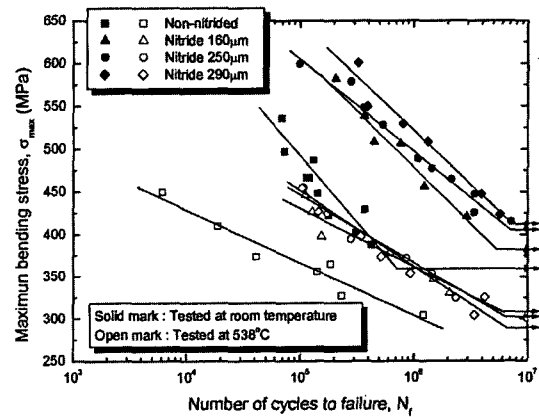
**Fig. 5** Relationship between maximum bending stress,  $\sigma_{\text{max}}$  and number of cycles to failure,  $N_f$  at room temperature and 538 °C

Figure 5 shows the S-N relationship between the maximum bending stress,  $\sigma_{\text{max}}$  and the fatigue life,  $N_f$  at room temperature and 538°C for the 160  $\mu\text{m}$ , 250  $\mu\text{m}$ , and 290  $\mu\text{m}$  nitrided and non-nitrided specimens. The fatigue life of the nitrided specimens was improved greatly compared with that of the non-nitrided specimens under all the stress levels applied in this study. The fatigue limit of the nitrided specimens at room temperature also increased with the thickness of nitrided layer. Compared with the non-nitrided specimen, the fatigue life of the 290  $\mu\text{m}$  nitrided specimen was improved as 17 times at 500MPa and 28 times at 446MPa. In addition, the fatigue limits of

nitrided specimens were also improved by 7% for 160 $\mu$ m, 14% for 270 $\mu$ m, and 17% for 290 $\mu$ m.

Similar behaviors on the high temperature fatigue life and fatigue limit can be observed in Fig. 5. However there can be seen a little difference in fatigue properties with altering the layer thickness.

At all applied stress levels, it would appear that the improvement of the fatigue life by nitriding may be attributed to the retardation of crack initiation due to the restriction of the surface plastic deformation in the substrate as a result of a hard nitrided layer (Qian and Fatemi, 1995; Magnusson, 1973; Gustavsson and Melander, 1992).

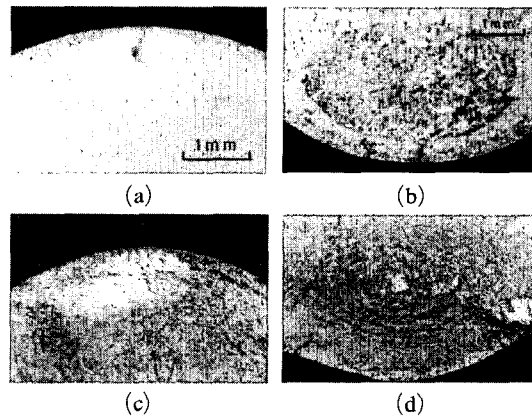
Fig. 6 Fractographs of fish-eye and final fracture pattern for 250 $\mu$ m nitrided specimen: (a) and (b) at  $\sigma_a=407$ MPa,  $N_f=1.05 \times 10^7$ , RT; (c) and (d) at  $\sigma_a=454$ MPa,  $N_f=1.04 \times 10^5$ , 538 $^{\circ}$ C

Figure 6 shows a fractograph of the fish-eye (Fig. 6(a) and 6(c)) and the final fracture pattern (Fig. 6(b) and 6(d)) at room temperature and 538 $^{\circ}$ C for the 250 $\mu$ m nitrided specimen. As shown in figures, the typical fish-eye cracking which is usually found in high-strength steels (Suh, et al., 1999; Suh and Kitagawa, 1987; Murakami, 1989) was observed and all the

nitrided specimens fractured in the fatigue test showed fish-eye cracks.

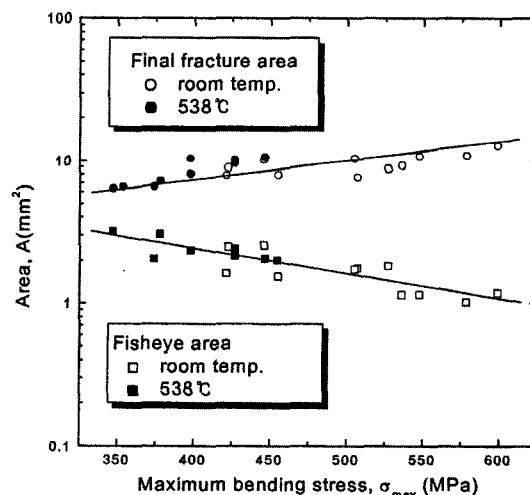
Fig. 7 Behaviors of the fish-eye and the final fractured area with the maximum applied bending stress

The area of the fish-eye crack, which is white and look like an elliptical circle, and final fracture region were quantitatively measured to clarify the initiation and growth behavior of fatigue crack in the nitrided specimens. The area of the fish-eye crack and the final fracture measured by a metallograph were then analyzed with the maximum applied bending stress. Figure 7 shows the behavior of the areas of final fracture with the applied bending stresses. As seen in Fig. 7, the areas of fish-eye crack and final fracture changed linearly with applied stress in the semi-log plot for the specimens tested at room and elevated temperature.

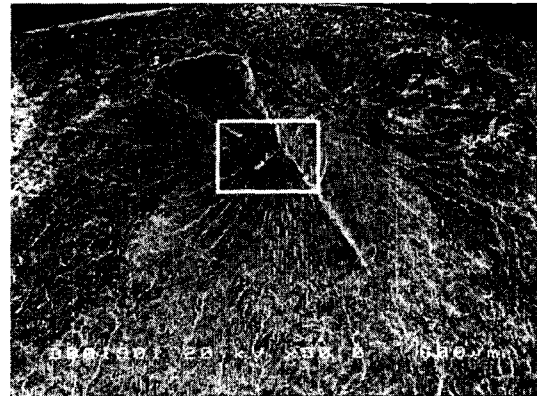
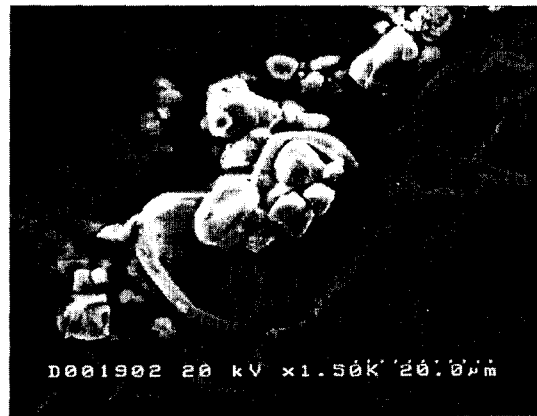
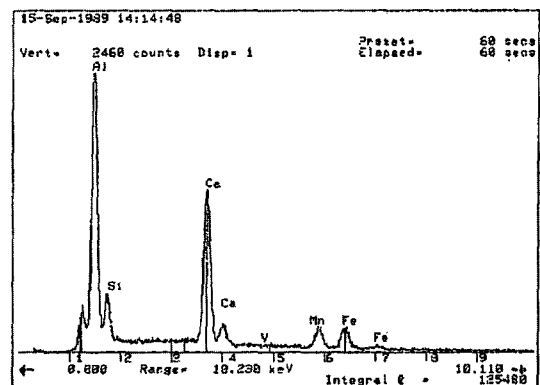
Fig. 8 SEM fractographs and EDS analysis at fish-eye crack (nitride thickness= $160\mu\text{m}$ ,  $\sigma_a=536.1\text{MPa}$ ,  $N_f=3.56 \times 10^5$  cycles, RT)

Figure 8 shows examples of low and high magnification SEM observation of the fish-eye formed in the  $160\mu\text{m}$  nitrided specimen fractured under  $536.1\text{MPa}$  at room temperature. In Fig. 8(a), the square mark indicates the center of the fish-eye crack and the fatigue crack initiated and grew from this site. Figure 8(b) shows an inclusion at the center of square mark in Fig. 8(a). As inclusions in the steel become a cause for stress concentration, it is observed that the initial fatigue crack generated in this position and then propagated. In addition, the fish-eye crack of this specimen was due to the internal cracking that frequently occurred in high-strength steel (Murakami, 1989; Gabetta and Torri, 1992; Murakami, et al., 1989).

Figure 8(c) shows the result of the EDS analysis at the inclusion; its chemical components were Al and Ca that remained in the ingot for making killed steel. Al and Ca are used for deoxidation processes such as ABS method (Alloy Bullets Shooting method) and SCAT method (Shooting Calcium Adding Technique method).

If Al and Ca were not completely removed, oxides of Al and Ca remained in the material as inclusions, which became a source of fatigue crack initiation (Suh, et al., 1999).

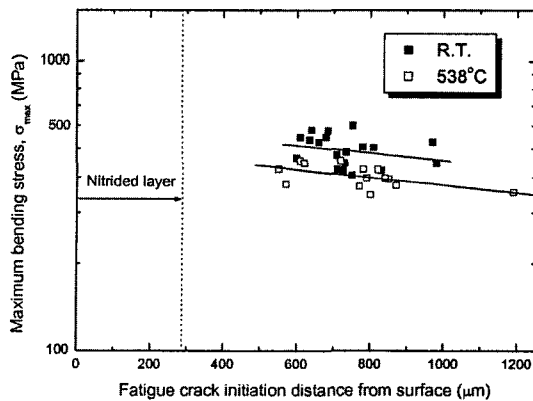
**Fig. 9** Relationship between the maximum bending stress,  $\sigma_{max}$  and the distance from surface to crack initiated position

Figure 9 shows the relationship between the maximum applied bending stress and the location of initial crack from the specimen surface. The initiation sites of fatigue cracks move toward the specimen surface as the applied bending stress increase at both room temperature and 538°C. In addition, all of the inclusion were found at a distance of over 500μm from the surface. As the positions were not hardened by nitriding, it was expected that the complex effects including the residual stress and the constraint of hardened layer have an effect on the crack initiation.

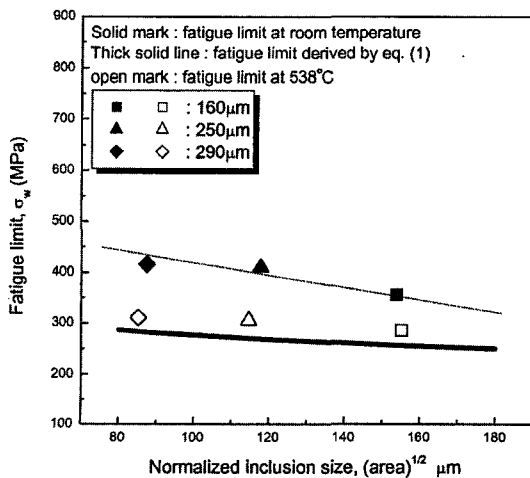
**Fig. 10** Fatigue limits,  $\sigma_w$  with the variation of inclusion size ( $\sqrt{area}$ )

Figure 10 is the fatigue limit that is obtained in the S-N curve and Eq. (1) with the area of inclusion. The fatigue limits obtained at room temperature test showed 1.5 times higher values than the calculated ones. However, at the elevated temperature test, fatigue limits fell close to the calculated line. This is considered as the effect of the residual stress relaxation and the softening of material at high temperature. Compressive residual stress is calculated as 320MPa for 400MPa of alternating stress by using Eq. (2).

to the variation of the interior defect size can be evaluated by using the formula proposed by Murakami (1989). Equation (1) and (2) are the evaluation formula proposed by Murakami for the fatigue limits ( $\sigma_w$ ) of the case hardened steels by nitriding without and with regard of residual stress, respectively.
