## Examination of Cavitation-Induced Surface Erosion Pitting of a Mechanical Heart Valve Using a Solenoid-Actuated Apparatus

**Key Words :** Mechanical Heart Valve, Cavitation, Surface Erosion Pit, Closing Velocity, Squeeze Flow

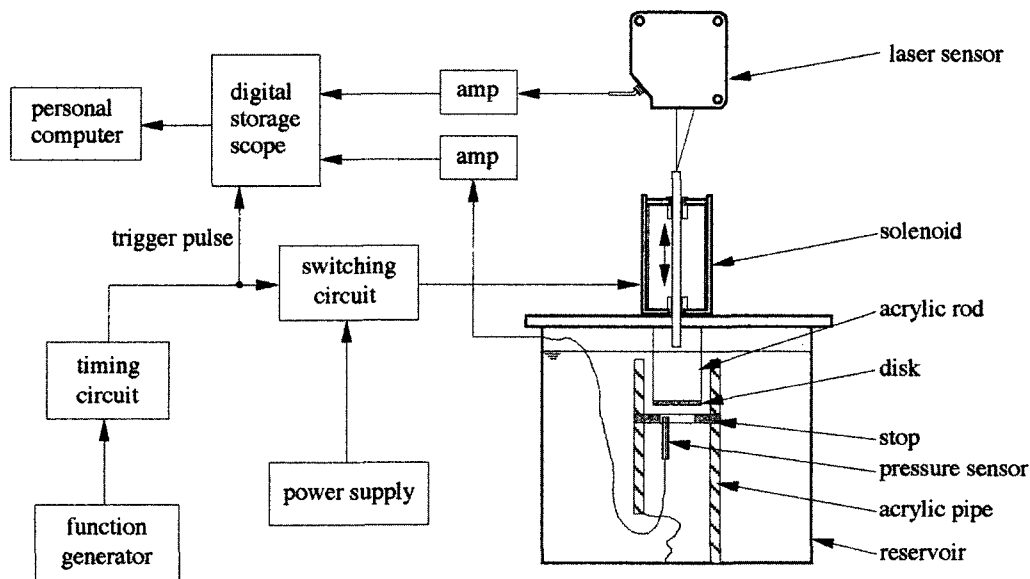
Fig. 1 Schematic diagram of the solenoid-actuated experimental system. The disk was directly actuated by the solenoid, and movement of the disk was measured using a laser displacement sensor

As shown in Fig. 1, the experimental system

was a simple in construction; there were no circulating circuits or pressurized chambers conventionally used in a valve testing system. A disk was connected to a solenoid (SS-093K-701, Shinmei Electric) through a rod and directly actuated by this solenoid. The disk and the stop were made of duralumin and stainless steel, the surface polished to observe the surface pitting, and their dimensions are shown in Fig. 2. The stop was mounted to the housing, made of acrylic pipe, and the housing was fixed to the bottom of a reservoir with dimensions of 15, 15 and 13 cm in width, length and height, respectively. The reservoir was filled with tap water, and experiments were performed at room temperature.

The opening and closing actions of the disk were controlled by the back and forth motion of the disk were controlled by the back and forth motion of the solenoid. Changing the power supply voltage to the solenoid controlled its closing velocity. To measure the closing velocity, we used a laser displacement sensor (LB-045, Keyence Ltd.; resolution, 4  $\mu\text{m}$ ), which was placed on the upper side of the solenoid and measured the movement of the disk during a closing period. Displacement signals from the sensor were stored in a digital storage scope (HP54510B, Hewlett-Packard) at a sampling frequency of 100 kHz and transferred to a personal computer via GPIB. A signal for triggering the digital storage scope was obtained from the timing circuit.

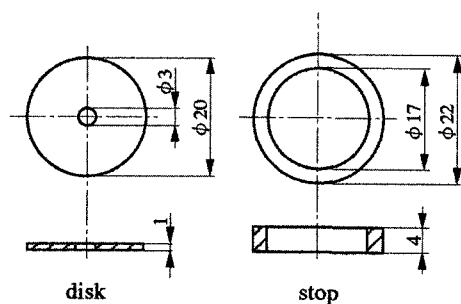
**Fig. 2** Dimensions of the disk and the stop, which were made of duralumin and stainless steel, respectively

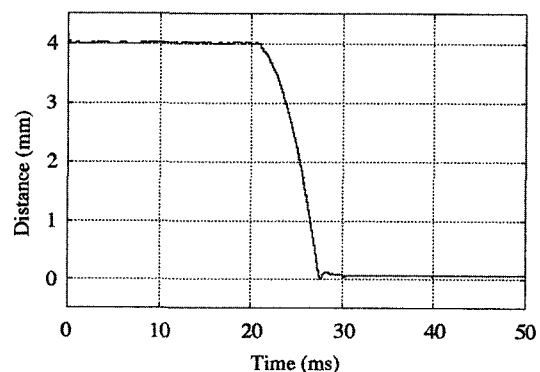
**Fig. 3** A trace of disk movement when the solenoid was driven by 20 volts. The distance between the disk and the stop was set to 4 mm. The disk was accelerated and made contact with the stop at an almost constant speed and then rebounded. The mean velocity of the disk during the last 0.3-mm interval before valve closure was defined as disk closing velocity

An example of disk movement during a closing period is shown in Fig. 3. The closing distance of

the disk was set on 4 mm. As shown by the slope of the curve, the speed of the disk increased with time after the solenoid had been actuated and that of the disk was reduced before valve closure. In this study, the mean velocity of the disk during the last 0.3-mm interval before valve closure was defined as closing velocity of the disk. The closing velocities of a disk at various driving voltages of the solenoid are shown in Fig. 4. The driving voltage of the solenoid varied from 5 to 20 volts, and the corresponding closing velocities varied from 0.37 to 0.71 m/s. The reproducibility of velocity at each driving voltage was good, as indicated by the error bars that were obtained from twenty measurements.

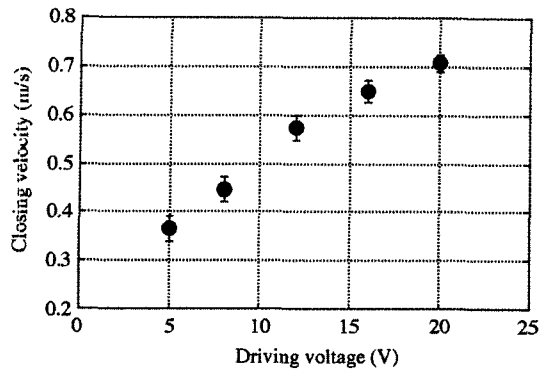
Fig. 4 Relationship between closing velocity of a disk and driving voltage of the solenoid

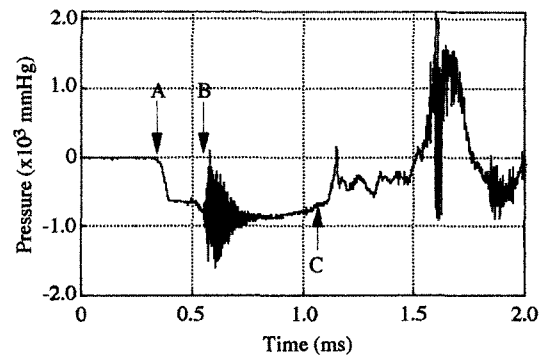
Fig. 5 A pressure waveform measured beside the stop at a closing velocity of 0.71 m/s. The section A~B indicates the pressure drop due to squeeze flow. The disk makes contact with the stop at point B, resulting in generation of impact sound. The pressure drop of section B~C is due to the water hammer phenomenon caused by the sudden stopping and rebound of the disk. Point C denotes the level of critical pressure defined by water vapor pressure

An example of the pressure waveforms measured near the disk surface during a closing period is shown in Fig. 5. Point B in Fig. 5 indicates the moment that the disk made contact with the stop, resulting in the generation of impact sound. Negative pressure due to squeeze flow was generated and was almost constant for about 0.1~0.2 ms immediately before the contact (section A~B in the Fig. 5). Then the negative pressure due to a water hammer phenomenon (flow deceleration induced by the disk suddenly stopping) gradually increased and decreased for about 0.5 ms even after the valve had closed. Thus, the pressure drops due to squeeze flow and due to the water hammer phenomenon were fairly well separated.

As shown in Fig. 5, the pressure drops due to squeeze flow and due to the water hammer phenomenon were fairly well separated. However, the pressure drop due to squeeze flow did not reach the critical pressure (Fig. 6). As described in the section on results of pressure waveform, this is because the tip of the pressure sensor was placed 1 mm from the surface of a closed disk. Jet flow squeezed from a narrow gap is restricted to

(1) When pressure drops below the critical pressure due to squeeze flow just before the closure of a disk, bubbles are formed (section A~B in Fig. 5).

(2) If negative pressure below the critical pressure is sustained by the water hammer phenomenon, the growth of bubbles occurs (section B~C in Fig. 5).

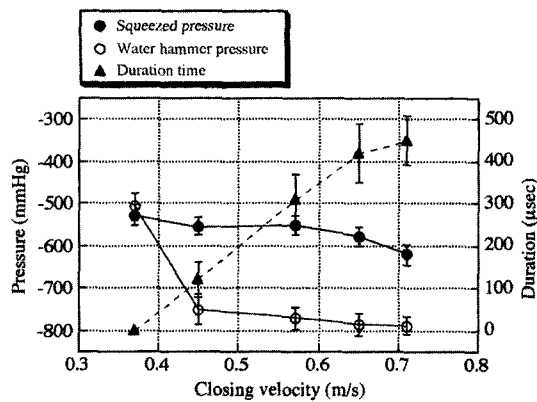
**Fig. 6** Negative pressure drops due to squeeze flow (closed circles) and water hammer phenomenon (open circles), and negative pressure duration (triangles) below the critical pressure, at various closing velocities of disks. Pressure drops due to the water hammer phenomenon were greater than the critical pressure except for at a disk closing velocity of 0.37 m/s. The duration below the critical pressure increased with increase in disk closing velocity

Pressure waveforms measured at the various closing velocities are shown in Fig. 6. The negative pressure due to squeeze flow (closed circles) gradually increased with increase in closing velocity of the disk but was not strongly dependent on the closing velocity. The measured pressure drop did not reach the critical pressure ( $-736$  mmHg at  $25^{\circ}\text{C}$ ) that is determined by saturated water vapor pressure, because the pressure drop was measured at 1 mm from the disk surface. Therefore, the actual pressure at the surface was likely have decreased more than the measured pressure as is discussed in detail in a later section. Compared to the pressure drop due to squeeze flow, pressure drop due to the water hammer effect should not be significantly dependent on the distance from the disk surface because the pressure drop is determined by mass of fluid column below the disk and deceleration of water: the 1 mm separation from the disk surface to the sensor tip was much smaller than the length of the water column. Therefore, we concluded that the changes in pressure generated by the water hammer effect were correctly measured. The pressure drops were greater than the critical

pressure except for that at the closing velocity of 0.37 m/s. In accordance with the increased closing velocity of the disk, not only the magnitude of negative pressure but also the duration of negative pressure below the critical pressure (section B~C) significantly increased.

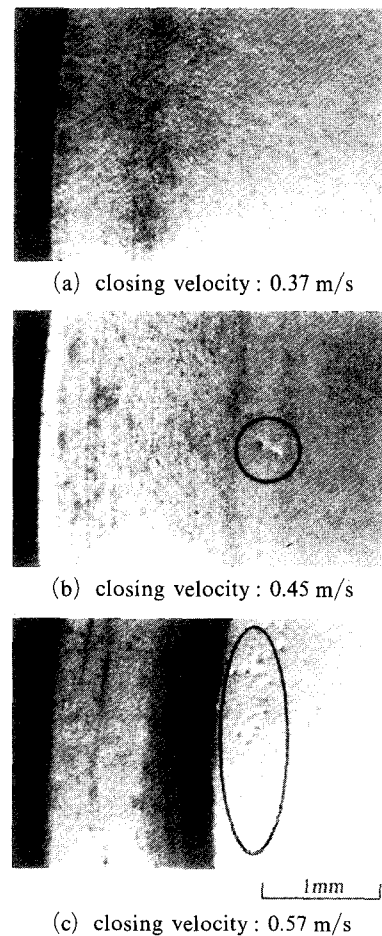
**Fig. 7** Photographs of a disk surface near the edge of contact with the stop after an opening-closing test of 3,000 cycles. No pits were observed at a closing velocity of 0.37 m/s (a). In the case of closing velocities of more than 0.45 m/s, pitting occurred as indicated by the circles. Arch-shaped black portions are areas of contact with the stop

After tests of 3,000 opening-closing cycles, erosion pits were observed on the surface of a disk when the disk had been actuated at closing velocities faster than 0.45 m/s (Figs. 7(b)~(c)). No pits were observed at 0.37 m/s. In the photographs, the dots inside the circle are erosion pits made by cavitation bubble. No pits were observed even after 40,000 cycles, when the disk had been actuated at 0.37 m/s. Thus, there was a threshold velocity inducing erosion pits around 0.4 m/s. Photographs of the surface of the disk after 40,000 opening-closing cycles with closing velocities above this threshold are shown in Fig. 8. An enlarged photograph of a pit is also given, in Fig. 9, with a cross-sectional profile that was

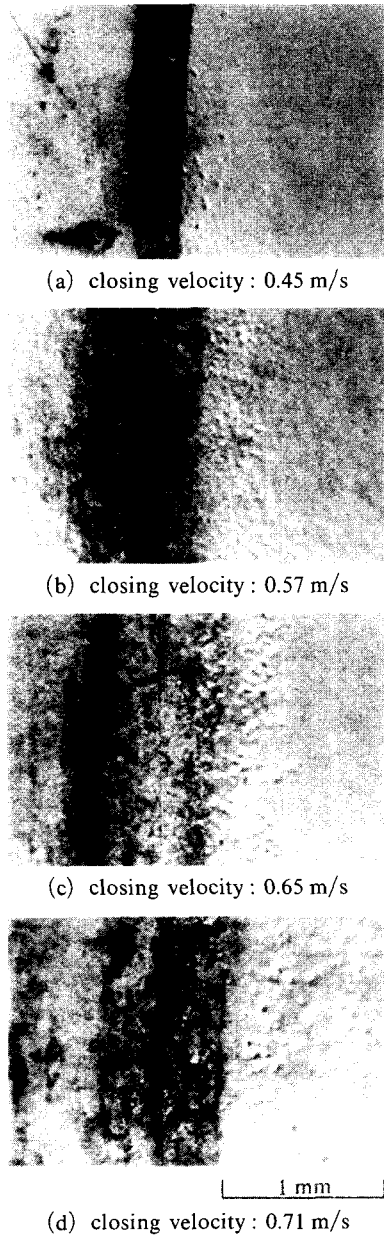
**Fig. 8** Photographs of a disk surface near the edge of contact with the stop after an opening-closing test of 40,000 cycles at disk closing velocities of more than 0.45 m/s. Arch-shaped black portions are areas of contact with the stop

measured using a microscope profilometer (VF-7510, Keyence). The black portion on the surface of the valves shown in Fig. 8 is the area of contact with the stop. The area in which erosion pits were generated was restricted to near the inside edge of contact with the stop. In the case of closing velocities of 0.45, 0.57, 0.65 and 0.71 m/s, erosion pits were found in ranges of 0.3, 0.36, 0.5 and 0.78 mm, respectively, far from the edge of the stop.

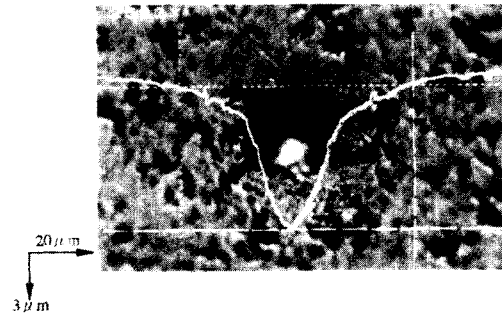
**Fig. 9** Enlarged microscopic image of a pit. The curve shows the cross-sectional profile of the pit. A scale of 3  $\mu\text{m}$  in depth is indicated by the vertical arrow. The pit diameter and depth were 62 and 8  $\mu\text{m}$ , respectively, and the area surrounding the pit was also deformed

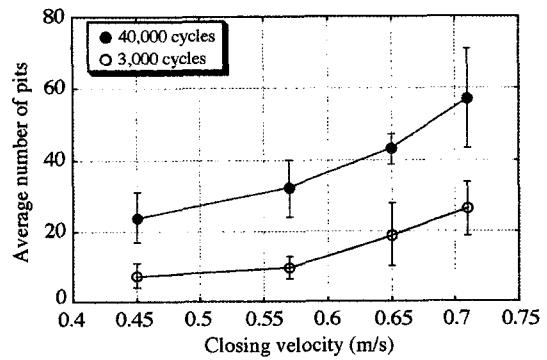
**Fig. 10** Average number of pits with a diameter of more than 30  $\mu\text{m}$  plotted against disk closing velocities after opening-closing tests of 3,000 cycles (open circles) and those of 40,000 cycles (closed circles). Pits on the disk surface were counted in an area of 1.5 mm squares. Counts at four different locations of 3~5 disks, using in each test, were averaged

30  $\mu\text{m}$  that were produced at different closing velocities is shown in Fig. 10. After both 3,000 and 40,000 opening-closing cycles, the number of pits exponentially increased with an increase in the closing velocity of the disk.

As shown in Fig. 10, the number of pits was not

proportional to the number of opening-closing cycles. Even when the difference between opening-closing cycles was more than 10 fold, the difference in the number of pits formed was only two to three fold. Furthermore, the results of additional evaluation of surface erosion showed that no pits of more than 60  $\mu\text{m}$  in diameter were formed after the 3,000 cycles test, whereas many pits larger than this size were formed after the 40,000 cycles test. These results suggest that overlapped multiple pitting occurred at the same site and that there is a possibility that deeper and wider erosion pits are formed in the case of long-term exposure to cavitation.

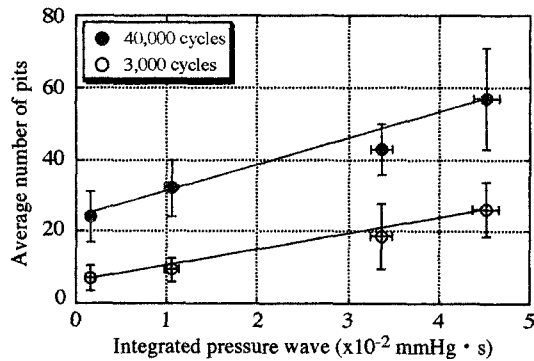
**Fig. 11** Average number of pits with a diameter of more than  $30 \mu\text{m}$  plotted against integrated pressure wave below critical pressure. The number of pits increased with increase in magnitude and duration of pressure drop and was proportional to the area of the pressure wave below critical pressure

Erosion pits formed only in a region close to the inside edge of the stop, and the area in which pits were observed increased with increase in closing velocity. These results also suggest that cavitation is induced by squeeze flow. If cavitation were induced only by the water hammer phenomenon, erosion pits would be observed over the whole surface of a disk. However, pit formation was restricted to an area beside the edge. Therefore, squeeze flow is a very important factor for initiating cavitation. On the other hand, the pressure drop caused by the water hammer phenomenon is also thought to have an important effect on cavitation because the integrated pressure was correlated well with the number of pits (Fig. 11). This speculation is also supported by the fact that no pits were observed when the pressure drop due to the water hammer phenomenon did not reach the critical pressure as shown in Figs. 6. As shown in Fig. 6, not only the magnitude of negative pressure but also the duration below the critical pressure increased with increase in closing velocity. Therefore, we hypothesize that an integrated pressure wave area below the critical pressure is significantly related to the number of pits. Figure 11 shows results plotted against the integrated pressure wave area. An approximately linear relationship was obtained.

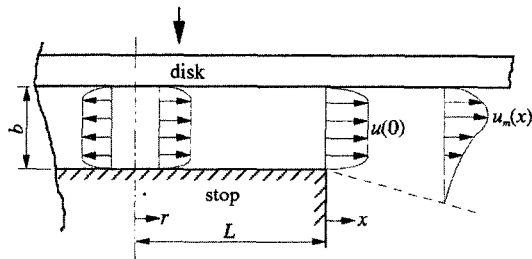
**Fig. 12** A model of jet flow squeeze from a narrow gap between a disk and a stop.  $b$ : gap;  $L$ : half the length of the stop;  $u(0)$ : uniform velocity at  $x=0$ ;  $u_m(x)$ : peak velocity at  $x$

an area near the disk surface, and flow velocity decreases rapidly with increase in the distance from the disk surface (Fig. 12). Therefore, the actual pressure drop induced by  $u_m(x)$  near the disk surface was likely to have been much greater than the pressure drop measured, as estimated below. Where  $u_m(x)$  is maximum velocity at distance  $x$ .

Assuming a uniform flow from a gap, we obtain the following simple equation with respect to squeeze flow velocity  $u$ :

$$\begin{aligned} u(r) &= \frac{r}{2b} v = \frac{r}{2b} \frac{db}{dt} \quad (0 < r < L), \\ u(0) &= \frac{L}{2b} \frac{db}{dt} \end{aligned} \quad (1)$$

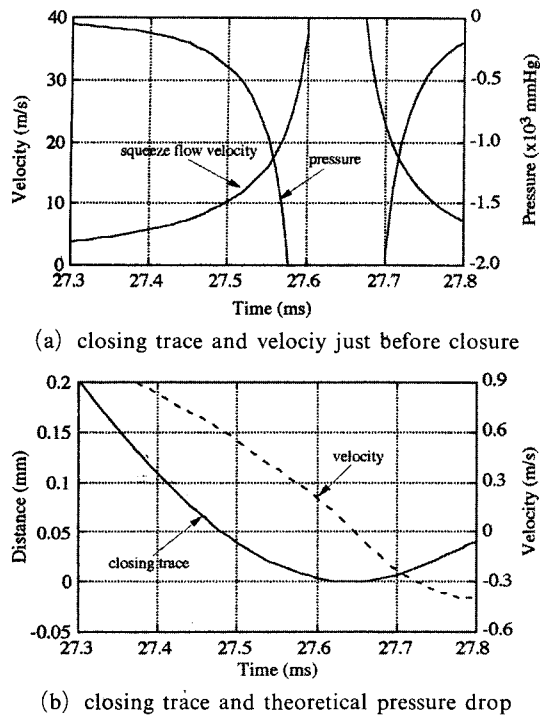
**Fig. 13** Calculated dynamic behavior around the moment of contact. Instantaneous closing velocity of a disk (a), squeeze flow velocity (b) and pressure drop (b) were calculated from the measured movement (a) of the closing disk using eqs. 1 and 2

where  $\rho$  is the density of water. When a flow velocity  $u$  is faster than  $14 \text{ m/s}$  ( $u = (2p/\rho)^{1/2} = 14 \text{ m/s}$ ), the pressure falls to the critical pressure. This flow velocity is widely used in the field of cavitation engineering as a critical fluid velocity at which cavitation bubbles may be generated. In the present study, we measured the movement of disks. This enabled us to obtain the instantaneous velocity of disks by differentiating their movement traces. An example of the instantaneous velocity around the moment of contact is shown in Fig. 13. Immediately before the contact, the disk did not approach the stop at a constant speed but at a decelerating speed, probably due to acceleration of squeeze flow and/or viscosity of water as it neared the contact, then rebounded. Substituting the instantaneous gap and velocity experimentally obtained into eq. (2), we obtained pressure drop as shown in Fig. 13(b). Curves of other closing velocities were also examined in the same manner.

The pressure rapidly fell to the critical pressure at  $0.1 \sim 0.2$  ms before contact (Fig. 13(b)). This estimated duration of pressure drop due to squeeze flow agrees well with the experimental results (section A~B in Fig. 5). The gaps in which critical squeeze flow was attained were read from the movement traces and were  $15, 16, 17, 20$  and  $22 \mu\text{m}$  in the case of mean closing velocities of  $0.37, 0.45, 0.57, 0.65$  and  $0.71 \text{ m/s}$ , respectively. In spite of the decreasing velocity of a closing disk, it was estimated that the pressure can easily drop to the critical pressure at gaps of a few tens of micrometers and that the pressure drop is accelerated as the gap approaches complete closure. However, a maximum pressure drop at the moment of contact cannot be obtained from equation 1 because the equation is divergent when  $b=0$ . As for the behavior of a valve at contact.
