## A Study on Effects of Recirculated Exhaust Gas upon Wear of Cylinder Liner and Piston in Diesel Engines

The effects of recirculated exhaust gas on the wear of cylinder liner and piston were experimentally investigated by a two-cylinder, four cycle, indirect injection diesel engine operating at 75% load and 1600 rpm. For the purpose of comparison between the wear rates of the two cylinders with and without EGR, the recirculated exhaust gas was sucked into one of two cylinders after the soot in exhaust emissions was removed by an intentionally designed cylinder-type scrubber equipped with 6 water injectors (A water injector has 144 nozzles of 1.0 mm diameter), while only the fresh air was inhaled into the other cylinder. These experiments were carried out with the fuel injection timing fixed at 15.3° BTDC. It was found that the mean wear rate of cylinder liner with EGR was greater in the measurement positions of the second half than those of the first half, that the mean wear rate without EGR was almost uniform regardless of measurement positions, and that the wear rate of piston skirt with EGR increased a little bit, but the piston head diameter increased, rather than decreased,

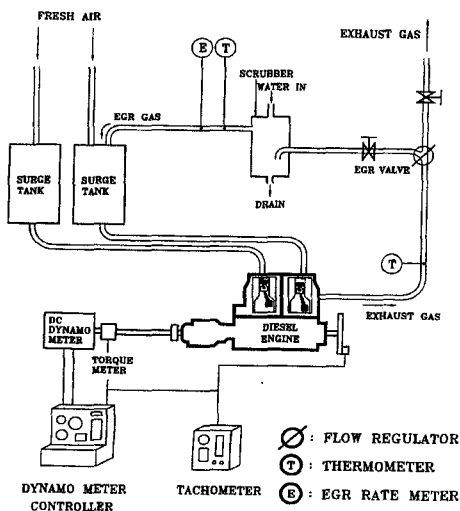
Fig. 1 Schematic diagram of experimental apparatus

The schematic diagram of experimental apparatus is shown in Fig. 1. The test engine employed in the present study was a four cycle, two-cylinder, water-cooled, indirect injection, marine diesel engine manufactured in Korea. The major specifications of the engine are presented in Table 1.

To investigate the effects of recirculated exhaust gas on the wear of cylinder liner and piston, No. 1 cylinder of the two cylinders was fed with air passed through the surge tank. While No. 2 cylinder was fed with the intake mixture of fresh air and recirculated exhaust gas of a 20% EGR rate. The exhaust gas was passed through a novel diesel soot-removal device with a cylinder-type scrubber and entered into the surge tank to minimize the surging.

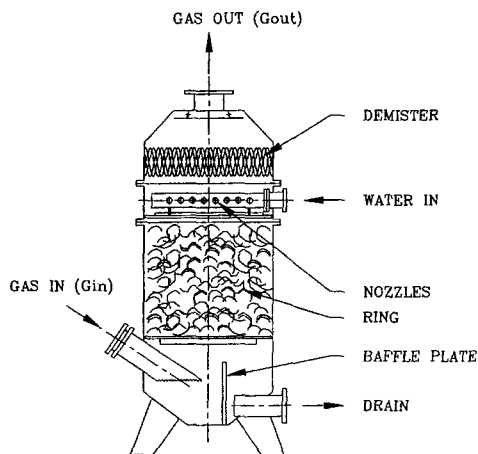
**Fig. 2** Cross-section of a novel diesel soot-removal system with a cylinder-type scrubber

The cross-section of a novel diesel soot-removal system with a cylinder-type scrubber that was designed and manufactured to eliminate soot contents from the recirculated exhaust gas is presented in Fig. 2. The exhaust gas emitted from the diesel engine is directed into the inlet port in the lower side of the scrubber and then passes through the disturbed rings before the soot is removed by water sprayed from 144 nozzle holes of 1 mm in diameter. The amount of sprayed water is automatically controlled by a flow meter with a solenoid valve according to EGR rate. In this study, however, the amount was constantly fixed since only a 20% EGR rate was applied. The resultant soot-removed exhaust gas is passed through the demister for dehydration and is flow- ed into the surge tank through outlet port, where it is mixed with the incoming fresh air.

A discharging port was installed in the lower part of the scrubber in order to prevent the sprayed water from flowing over the inlet. And a baffle plate was also installed on the floor of the scrubber to keep the incoming exhaust air from escaping directly into the discharging port.

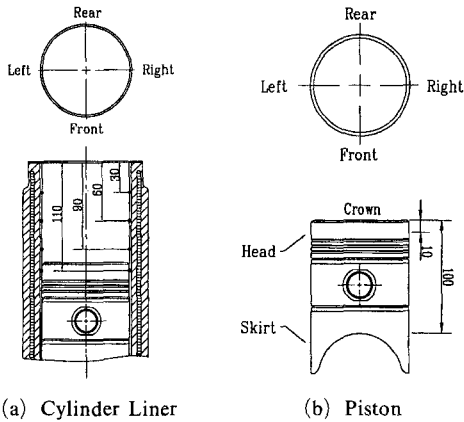
Fig. 3 Measurement spots of cylinder liner and piston

In order to measure the wear amount of cylinder liner inner diameter after the experiment, the engine was disassembled prior to it. The inner diameter of cylinder liner was measured at intervals of 90° rotated positions with distances of 30, 60, 90 and 110 mm from the top; A bore gauge was used for these measurements. The measurement positions are shown in Fig. 3(a). This gauge has a measurement range of 50~100 mm and a minimum scale of 1  $\mu\text{m}$ . For the outer diameter of piston, a digital micrometer was used to take measurements of the head part 10 mm away from the piston crown and the skirt part 100 mm away from the piston crown, as shown in Fig. 3(b). The micrometer has a measurement range of

75~100 mm, with a minimum scale of 1  $\mu$ m. To distinguish the right-left and front-rear of measurement spots, the position located in piston pin hole was defined as a front spot for the measurements. The right spot was decided as the point 90° rotated counterclockwise from the front.

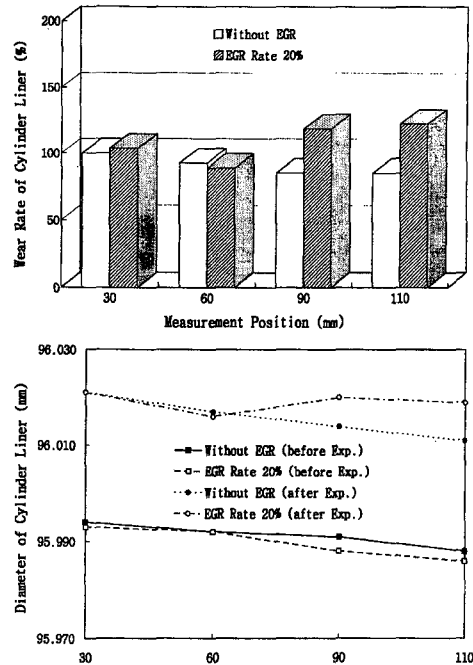
Fig. 4 Wear rate and inner diameter of cylinder liner for a right-left spot at the respective positions measured from the top

The inner diameters of the cylinder liners were measured on No. 1 (with fresh air only) and No. 2 (with an EGR rate of 20%) cylinders as mentioned above. Figure 4 shows the measured values of the inner diameters obtained at a right-left spot with and without EGR before and after experiments, and a comparison between the wear rates of measured spots. As compared with measurements before experiments, the cylinder liners were found to have increased wear amounts regardless of EGR application; with higher wear amounts in case of EGR. In particular, the wear amounts with EGR were considerably higher than those without EGR at 90 and 110 mm from the top. Based on the above data, all the measured wear amounts were converted by defining the spot without EGR 30 mm away from the top as a wear rate of 100%. The relative percentage of the measurement is presented in Fig. 4, where it is shown that in no EGR condition, spots closer to the top produced higher wear rate, and that in

case of EGR, distances greater than the spot 60 mm away from the top had higher wear rate, with the highest wear rate at 110 mm from the top in this study.

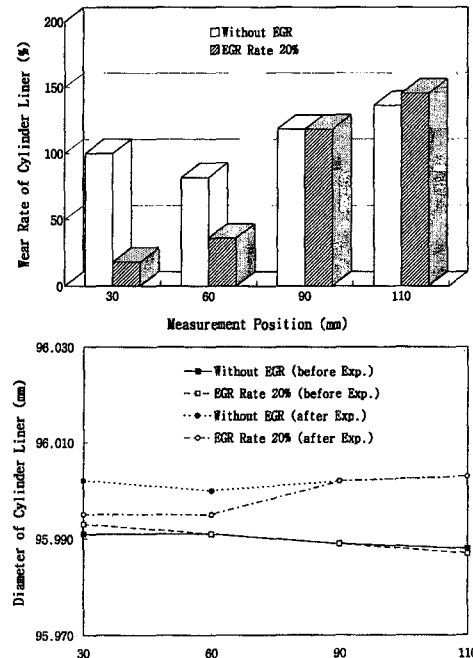
Fig. 5 Wear rate and inner diameter of cylinder liner for a front-rear spot at the respective positions measured from the top

Figure 5 shows the measured values at a front-rear spot and the wear rate of a relative percentage in the same way mentioned above. This figure indicates that the wear rate with EGR was lower than that without EGR up to the spot 90 mm away from the top, and that the wear rate due to EGR application grew higher at closer distances to the second half part.

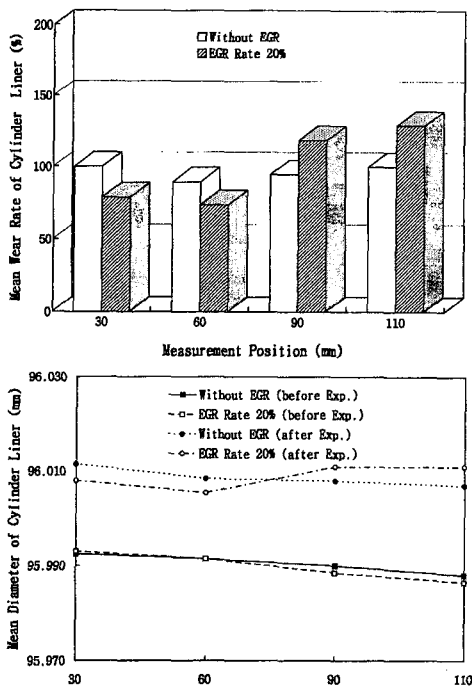
Fig. 6 Mean wear rate and inner diameter of cylinder liner for two spots of right-left and front-rear at the respective positions measured from the top

Figure 6 shows the mean wear rate for right-left and front-rear spots. As can be seen from the figure, the wear amount without EGR was greater than that with EGR up to the spot 60 mm away from the top. Longer distanced spots than 60 mm, however, produced higher wear amount for applying EGR. The relative wear rate for the spot measurement is also shown in Fig. 6, where the first half beginning from the cylinder top showed

higher wear rate in no EGR than that with EGR application, and the wear rate with EGR was greater in the second half. In particular, No. 1 cylinder without EGR showed a similar wear rate regardless of the measuring positions, though showing slight variations. No. 2 cylinder with EGR showed a significantly higher wear rate in the second half than in the first half.

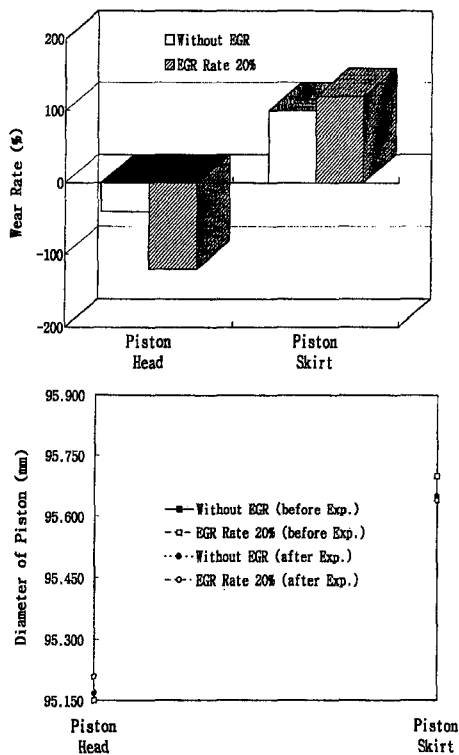
Fig. 7 Wear rates and outer diameters of piston head and skirt for a right-left spot at the respective measured positions away from the crown

Figure 7 shows the measured values of piston outer diameter and the wear rate. As can be seen from the figure, the skirt part at a right-left spot produced somewhat higher wear rate in case of EGR application, but the head part showed

increase in piston diameter regardless of EGR application, especially higher in case of EGR application. This peculiar result suggests the possibility that though the piston head suffered from significant wear, the roughened piston due to soot and other matters adhered to a piston surface or erosion by  $H_2SO_4$  may have contributed to apparent piston diameter increase. In this experiment, a part of the roughened piston surface was wiped off by a scraper, but complete wiping could have caused a severe damage to the piston, making exact measurements impossible. As a solution to this problem, the increased and decreased amounts of the measured values were marked with - and + respectively to represent them in percentage.

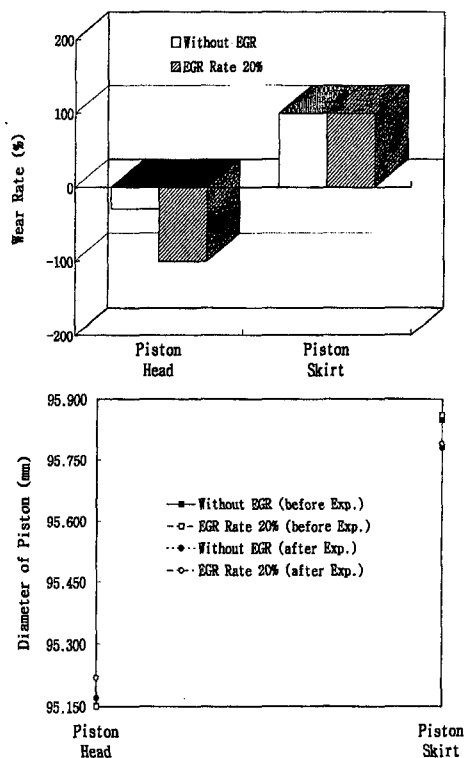
Fig. 8 Wear rates and outer diameters of piston head and skirt for a front-rear spot at the respective measured positions away from the crown

Table 3 indicates the outer diameters of piston head and skirt measured before and after the experiment to calculate the wear amounts of two cylinders at a front-rear spot. Figure 8 shows

relative percentages of piston wear amounts at a front-rear spot, where the wear amount of the piston skirt part without EGR was defined as 100%. It can be seen that the skirt part showed nearly identical wear rates regardless of EGR application, but the head parts did show increase in piston diameter after the experiment, in particular in case of EGR application. It should be also considered that the reason that the wear rate of skirt part at a front-rear spot was identical re-

ardless of EGR may have been due to the adhesion of soot and the erosion by  $H_2SO_4$  on a piston surface as discussed previously even though the skirt part may be worn away by applying EGR.

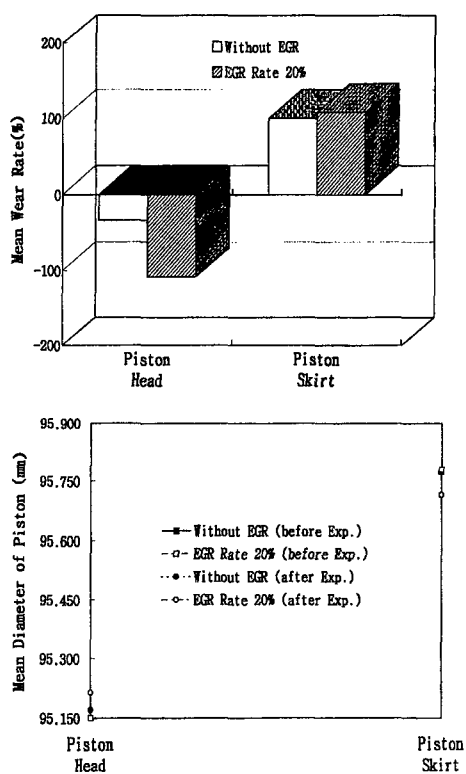
**Fig. 9** Mean wear rates and outer diameters of piston head and skirt for two spots of right-left and front-rear at the respective measured positions away from the crown

The mean outer diameters of piston head and skirt measured before and after the experiment to calculate the wear amounts of two cylinders at two spots of front-rear and right-left are shown in Table 4. Figure 9 presents the mean wear rates and piston outer diameters of Fig. 7 and 8. The skirt parts showed a slightly higher wear rate in case of EGR application, while the head parts showed a remarkably higher piston diameter increase with EGR application. Urabe *et al.* (1998) have measured the piston frictional force to investigate the influence of soot contents in recirculated exhaust gas with EGR application on the piston lubricating condition in diesel engines, and have showed that the reduction of sulfur contents in fuel was very effective to decrease the wear, but the wear increased with the soot or water contents in recirculated exhaust gas even though sulfur contents were not included in fuel. They have also demonstrated that the piston frictional force increased sharply by the soot contents in recirculated exhaust gas at the latter half of compression stroke, which may form the abnormal wear.
