VISUALIZATION OF THE INTERNAL WATER DISTRIBUTION AT PEMFC USING NEUTRON IMAGING TECHNOLOGY: FEASIBILITY TEST AT HANARO

Neutron imaging technique was used to investigate the water distribution and movement in Polymer Electrolyte Membrane Fuel Cell (PEMFC) at HANARO, KAERI. The Feasibility tests were performed in the first and second exposure rooms at the neutron radiography facility (NRF) at HANARO in order to check the ability of each exposure room, respectively. The feasibility test apparatus was composed of water and pressurized air before making up the actual test apparatus. Due to the low neutron intensity in the second exposure room, the exposure time was too long to investigate the transient phenomena of PEMFC. Although the exposure time was improved to 0.1 sec in the first exposure room, it was difficult to discriminate detail water movement at the channel due to the high noise level. Therefore, the experimental setup must be optimized according to the test conditions. Water discharge characteristics were investigated under different flow field geometries by using feasibility test apparatus and the neutron imaging technique. The water discharge characteristics of a 3-parall

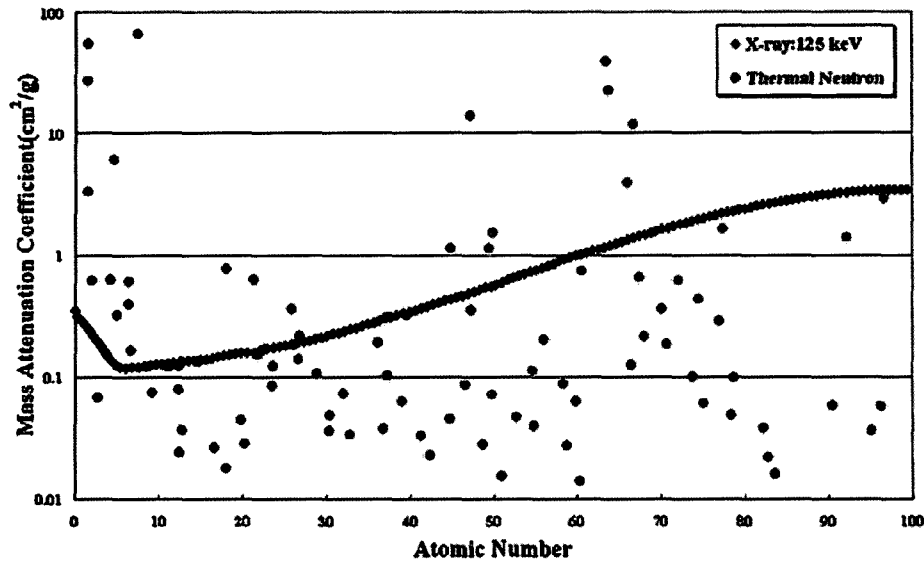
Fig. 1. Mass Attenuation Coefficient Among a Thermal Neutron and X-ray

On the other hand, the mass attenuation coefficient of thermal neutrons depends much on the nucleus. Thermal neutrons penetrate most of metals with particular ease, while they are strongly attenuated by such materials as hydrogen and water [5,6]. Most PEMFCs has a metallic coverage, made of aluminum, for example, and the water is generated during operation. Therefore, a thermal neutron is a powerful tool to visualize the water movement and distribution in PEMFC.

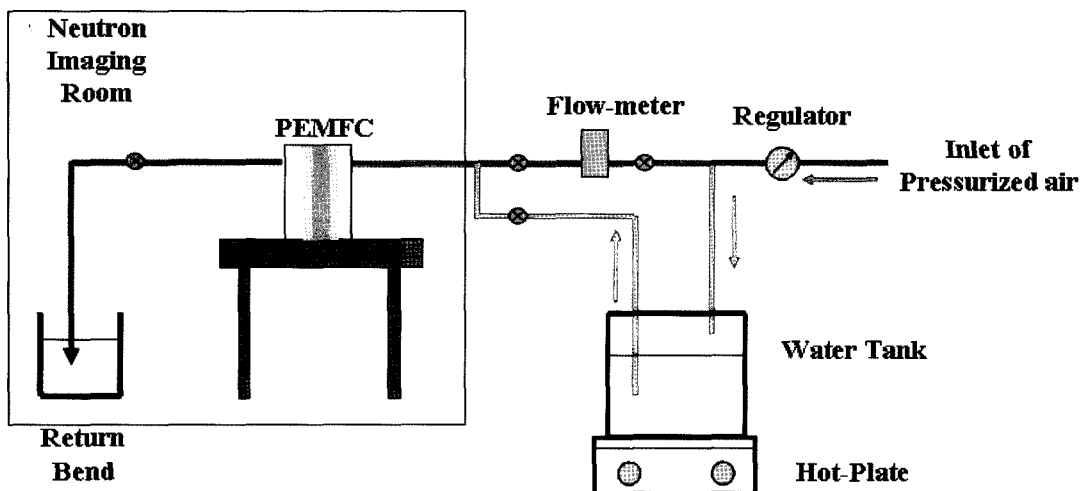
Fig. 2. Schematic Diagram of Test Apparatus

In order to check the ability of the neutron radiography facility (NRF) at HANARO, the feasibility test apparatus was set up. The feasibility test apparatus consists of two parts: a water supply loop and pressurized air loop. Fig. 2 shows a schematic diagram of the feasibility test apparatus. Since the objective of this feasibility test was to identify the ability of the neutron imaging facility at HANARO, KAERI for the PEMFC research field, a real fuel cell test station was not needed. The distilled water and pressurized air was used in order to simulate an actual operating PEMFC. Because the water temperature during operation ranges

The water of the PEMFC is usually formed at the cathode. The water for the feasibility test is only supplied to the cathode by using a pressurized air and water tank. Since the PEMFC is opaque, it is difficult to know how much water exists at the cathode channel. The water is supplied about ten minutes into the cathode channel. The valve located at the outlet of the PEMFC is closed in order to entrap water in the cathode channel. The pressurized air is supplied for about 2 minutes, and then is stopped. Afterwards, the valve at the outlet of the PEMFC is opened. Finally the neutron images were taken supplying the pressurized air into cathode channel.

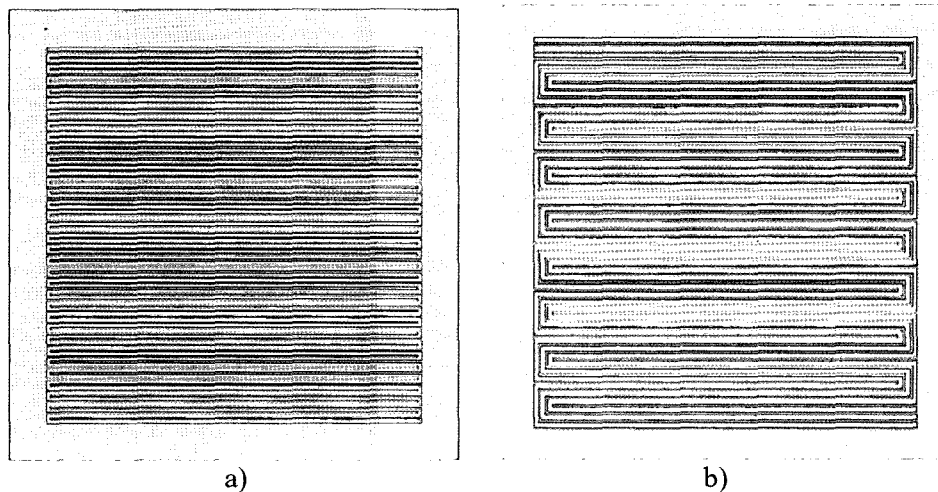
Fig. 3. Schematic Diagram of the Investigated Flow Field Geometries: a) Shows a Continuous Flow Field with a 1-Parallel Serpentine; b) Shows a Continuous Flow Field with a 3-Parallel Serpentine

The two geometries sketched in Fig. 3 have been chosen to investigate the water discharge characteristics with an active area of 100 cm² single-cells. One illustration is a 1-parallel serpentine, and the other is a 3-parallel serpentine. In all experiments, the flow field used for anode and cathode are symmetric, disregarding their different demands for the sake of simplicity. The flow fields were directly machined into a carbon-graphite block. Both have a channel width and depth of 1[^]10⁻³ m, and the rib-to-channel ratio is 0.5. The GDL used at this study is Nafion-112.

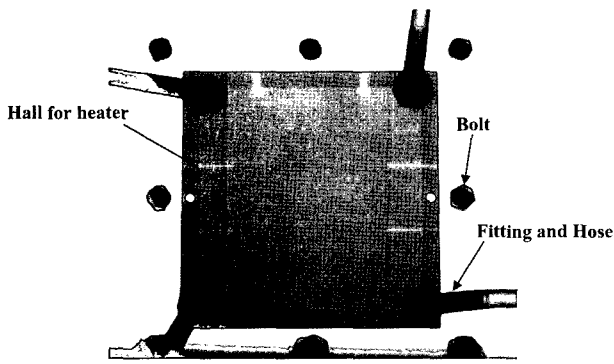
Fig. 4. Test Result at Second Exposure Room with 20 sec Exposure Time at 3-Parallel Serpentine

Fig. 4 is a dry neutron image of PEMFC developed at the second exposure room. The image is an averaged result of 100 images with exposure times of 20 sec. It is possible to see the components of PEMFC and part of the feasibility test apparatus, as shown in Fig.4. Since the exposure time is 20 sec, it is difficult to discriminate and determine the instant phenomena and the transition process of water distribution and movement at the PEMFC. From these results, the second exposure room of the NRF is not suitable for the instant phenomena of the PEMFC.

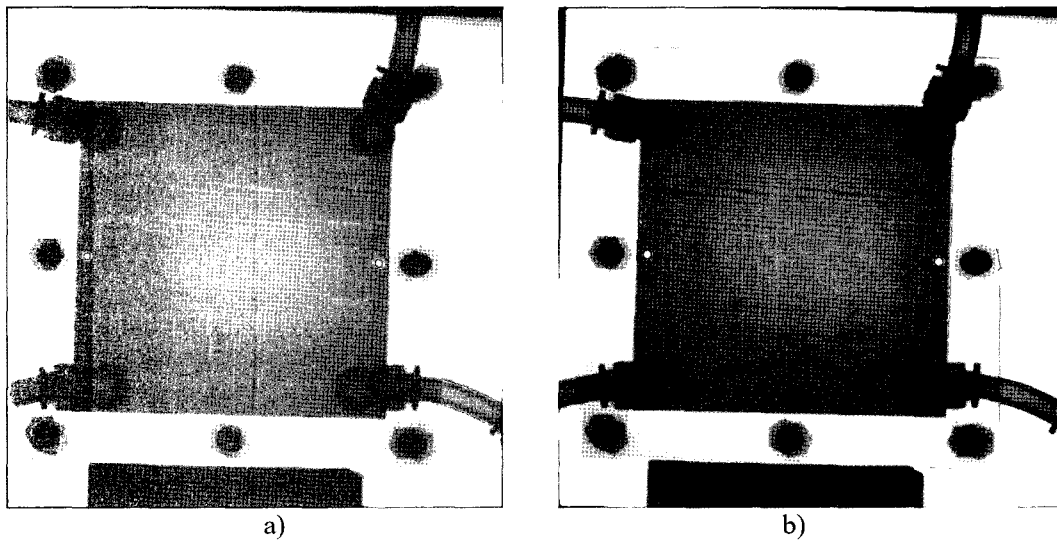
Fig. 5. Test Result at the First Exposure Room at the 3-Parallel Serpentine: a) 0.1 sec and b) 4 sec

Fig. 5 is dry neutron images of the PEMFC taken at the first exposure room under various exposure times. Each image is an averaged result of 100 images with exposure

times of 0.1 sec and 4 sec. The first exposure room has higher neutron intensity compared with the second exposure room, and the exposure time is improved from 20 sec to 0.1 sec. However, the neutron image taken at 0.1 sec uses very little of the dynamic range of the CCD camera. After normalizing the dry and wet images, too much noise remains. Due to the high noise level, the spatial resolution was lost, as shown in Fig. 6. The red color at Fig.6 means a high water fraction, and the black color stands for a low water fraction. Since the exposure time is short, it is possible to visualize the transient water movement and distribution in the channels of PEMFC. However, it is difficult to discriminate the detailed water behavior due to poor spatial resolution. Fig. 7 is a neutron image with an exposure time of 4 sec. The image quality of Fig. 7 is higher than that of Fig. 6, but since the exposure time is increased from 0.1 sec to 4 sec, the instant phenomena of the PEMFC were lost. Therefore, the temporal and spatial resolutions were optimized in order to investigate the PEMFC at the NRF, HANARO. Anyway, the NRF of HANARO is acceptable for the investigation of water movement and distribution at PEMFC.

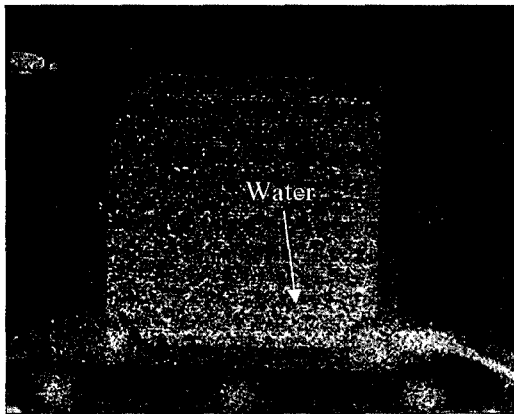
Fig. 6. Test Results at the First Exposure Room with 0.1 sec Exposure Time at the 3-Parallel Serpentine

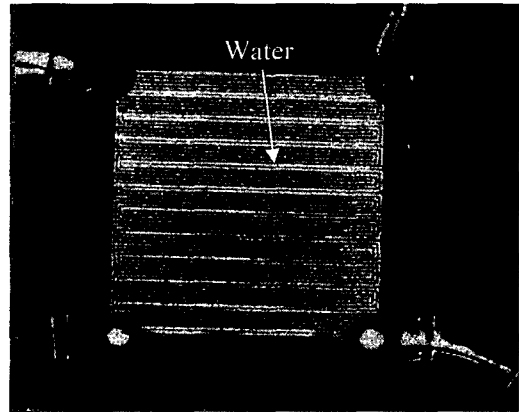
Fig. 7. Test Results at the First Exposure Room with 4 sec Exposure Time at the 3-Parallel Serpentine

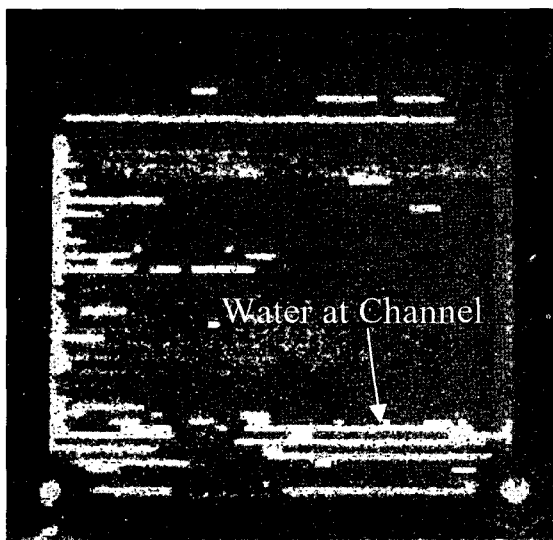
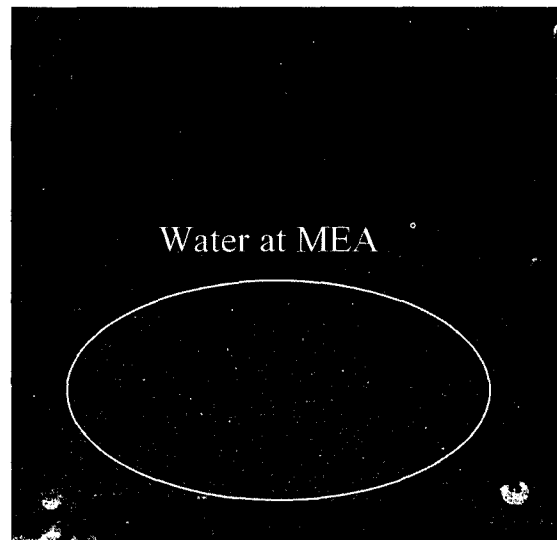
Fig. 8. Test Results at the 1-Parallel Serpentine Flow Field at 200 cc/min: a) Start and b) After 300 sec

After checking the ability of the NRF, the water removal characteristics at PEMFC were investigated under a different flow field design at same flow-rate (200cc/min) by using the neutron imaging technique at the NRF, HANARO. The feasibility test was performed at first exposure room with a 4 sec exposure time. Figs. 8 and 9 are test results of different flow field geometries. Although the flow-rate is the same, the water discharge characteristics are different according to the flow field design. At the start position, each PEMFC has water in the channel, as shown

at Figs. 8 and 9, but the discharge time is different: a) the 1-parallel serpentine is about 300 sec and b) the 3-parallel serpentine is about 160 sec. This result comes from the differential pressure between the inlet and outlet of each PEMFC. The total flow pass-length of the 1-parallel serpentine is 3 times that of the 3-parallel serpentine. The longer flow pass produces higher fractional loss and it is difficult to discharge the water at channel. Moreover, though the water at each channel was removed, the water at membrane electrode assembly (MEA) is not removed. This result shows the merit of the neutron imaging technique compared with other methods. Though the visualization method with a transparent window can discriminate the water movement

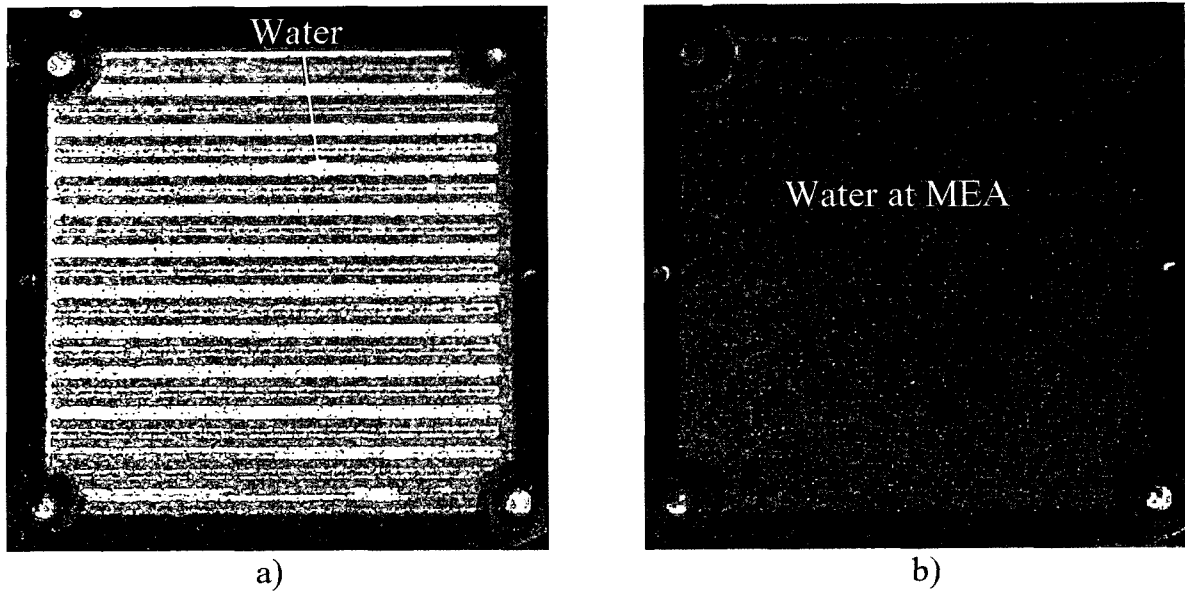
Fig. 9. Test Results at the 3-Parallel Serpentine Flow Field at 200 cc/min: a) Start and b) After 160 sec
