# Comparion of stability in titanium implants with different surface topographies in dogs

STATEMENT OF PROBLEM. A few of studies which compared and continuously measured the stability of various surface treated implants in the same individual had been performed. PURPOSE. We aim to find the clinical significance of surface treatments by observing the differences in the stabilization stages of implant stability. MATERIAL AND METHODS. Eight different surface topographies of dental implants were especially designed for the present study. Machined surface implants were used as a control group. 4 nano-treated surface implants (20 nm TiO<sub>2</sub> coating surface, heat-treated 80 nm TiO<sub>2</sub> coating surface, CaP coating surface, heat treated CaP coating surface) and 3 micro-treated surface implants [resorbable blast media (RBM) surface, sandblast and acid-etched (SAE) surface, anodized RBM surface] were used as experiment groups. All 24 implants were placed in 3 adult dogs. Periotest® & ISQ values measured for 8 weeks and all animals were sacrificed at 8 weeks after surgery. Then the histological analyses were done. RESULTS. In PTV, all implants were stabilized except 1 failed i

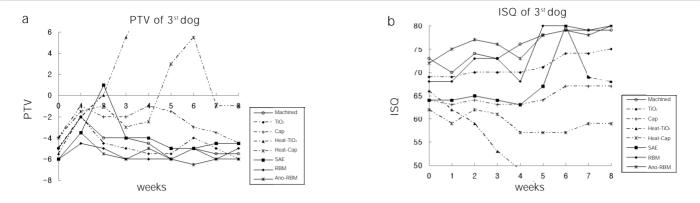
Fig. 6. PTV & ISQ values in diagram (dog 3). (a) Generally the PTV were increased at the starting and then decreased. (b) The ISQ values showed the increasing tendency after 4 weeks. Refer to Fig. 4. for abbreviations

The PTV increased till 4 weeks and then had the decreasing tendency. The values were decreased till 4 weeks and then had the increasing tendency (Table VI and VII, Fig. 6).
