AE 기법을 이용한 외부수압을 받는 복합재 원통의 균열 검출

Crack Detection of Composite Cylinders under external pressure using the Acoustic Emission

ABSTRACT

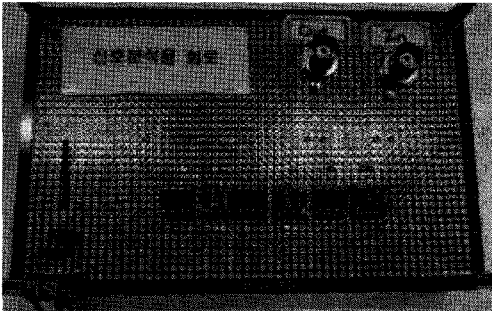
Fig. 1 Photograph of the OP amp.

The two step OP amp which could amplify the 200 times from the original PVDF sensor signals was fabricated. Fig. 1 shows the OP amp and Fig. 2 shows the PVDF sensor. The amplified signals were input to the computer using the A/D converter (NI USB 6251) and LABVIEW software. The FFT (Fast Fourier Transform) of the signal was done by AGU-Vallen Wavelet software.

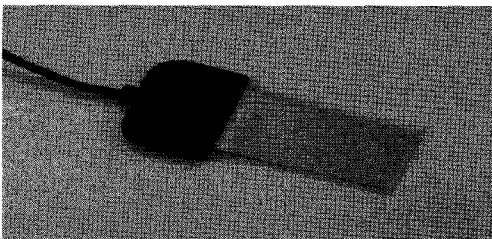
Fig. 2 Photograph of the PVDF sensor.

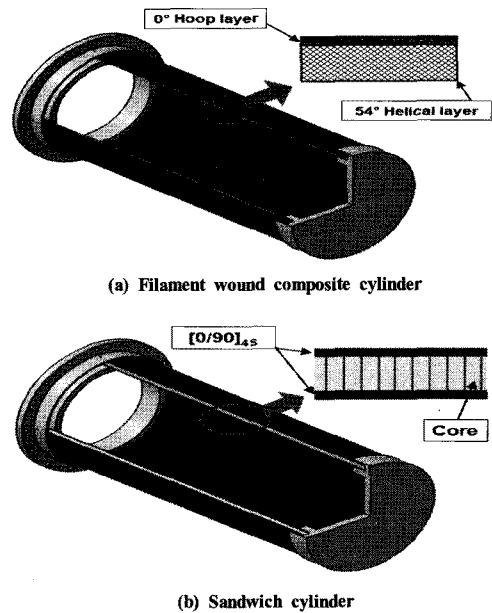
Fig. 3 Shapes of composite cylinder.

For the analyses of the composite fracture tests of the composite fracture signals, the external pressure tests of the composite cylinders were performed by the water pressure tester. Fig. 3 shows the schematic diagrams of the composite cylinders. The filament wound composite cylinder of Fig. 3 (a) was composed of the ± 54 layer and hoop layer, and the sandwich cylinder of Fig. 3 (b) was composed of two $[0/90]_{4s}$ laminates and honeycomb core. The prepreg for the composite laminate was USN-125B of the SK Chemical Co. Figure 4 shows the photograph of the fractured composite cylinder after the pressure test. Fig. 5 shows the FFT analyses of the AE signals around the fracture of the composite cylinder during the pressure test. As shown in Figure 5, the 240 - 330kHz frequencies were detected during the fracture. To measure the AE signals during the impact which do not occur the fracture, the impacts by a hammer were applied to the composite cylinder. Figure 6 shows the FFT signals during the impact. As shown in Figure 6, 0.1~ 1 kHz frequencies were detected during the impact test.

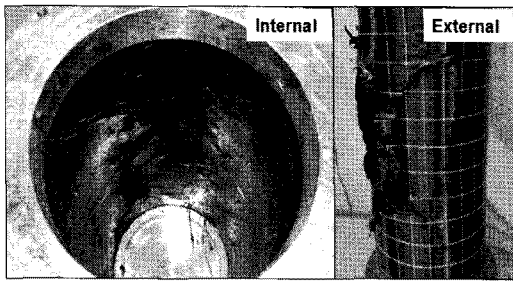
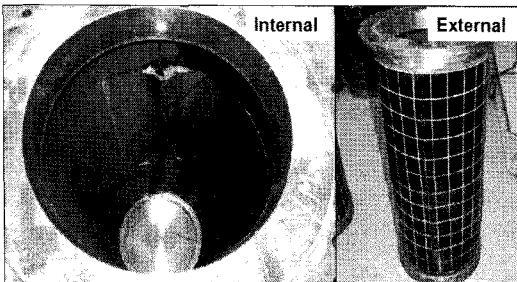
(a) Filament wound composite cylinder

(b) Sandwich cylinder

Fig. 4 Photograph of the fractured composite cylinder after pressure test.

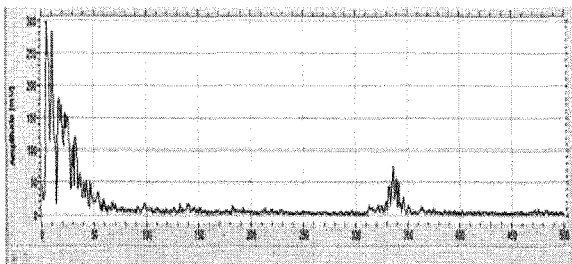
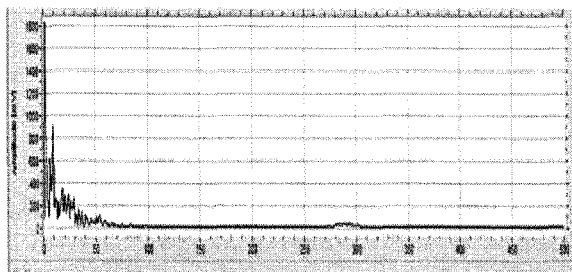
Fig. 5 FFT analyses of the AE signals under the pressure test.

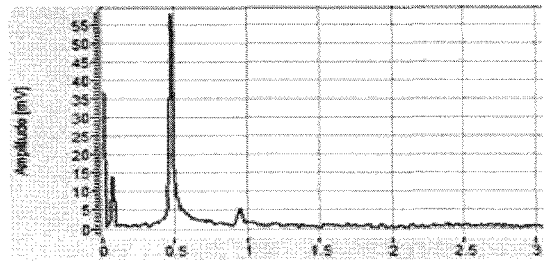
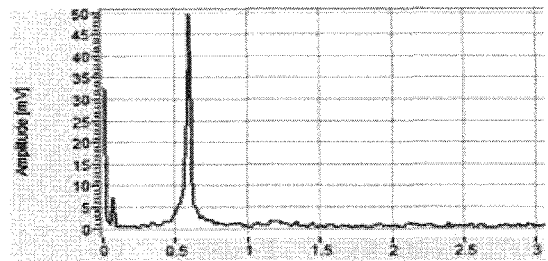
Fig. 6 FFT analyses of the AE signals under the impact test.

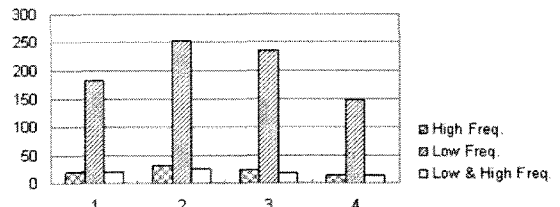
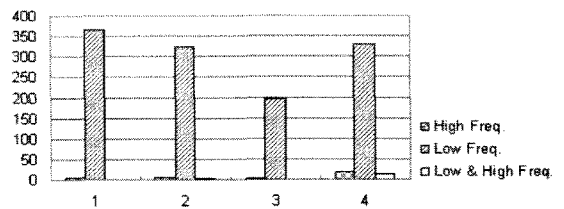
Fig. 7 Event counts after the impact test.

The impact tests of the composite cylinders were performed by an impact hammer. Figure 7 shows the event counts after the impact test. As shown in Figure 8, the low frequency event counts had a large value and they were about ten times of the high frequency (L-C resonator) event counts. For the generation of the composite fracture signals, the external pressure tests of the composite cylinders were performed by the water pressure tester. The water pressure was increased step by step with measuring the deformation shape of the composite cylinder. The buckling of the cylinder occurred

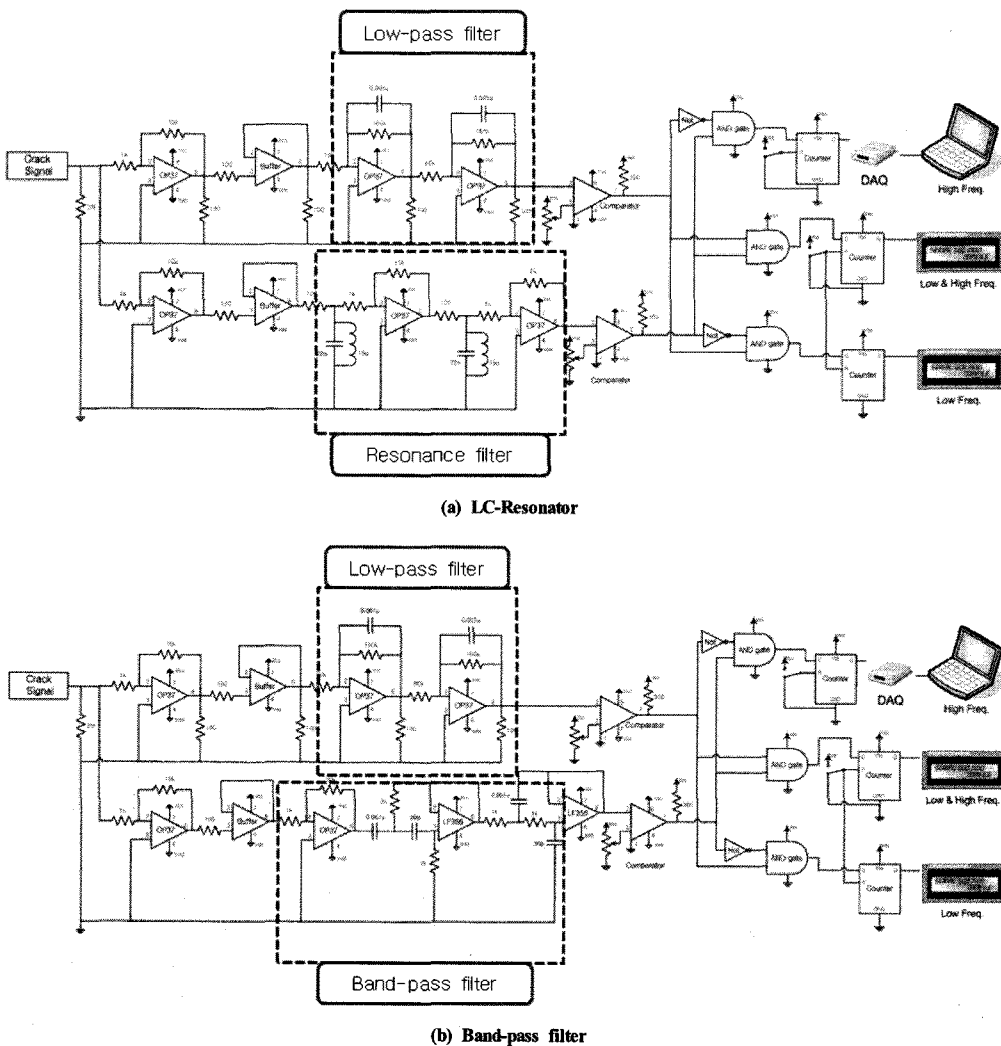
Fig. 8 AE signal analyzer.

The AE signal analyzer which can detect the fracture of the composite cylinder was designed and manufactured. Figure 8 shows the electric circuit of the AE signal analyzer. As shown in Figure 8, the amplified signal was input into the

low-pass filter and L-C resonator. The low-pass filter is for the impact detection and the L-C resonator is for the fracture detection. The cut-off frequency of the low-pass filter and the resonance frequency of the L-C resonator were

set to 700Hz and 240 Hz, respectively. Since the fracture frequencies of the composite cylinder can be changed slightly in each test and have a narrow band as shown in Figure 8, the band pass filter can be used. The filtered signals are input to the comparator. The digital signals of 5 volts are produced by the comparator when the filtered signals are larger than the threshold voltage level. the threshold level can be adjusted by the three counters. The each event count of low (impact) or high (fracture) frequency can be measured.

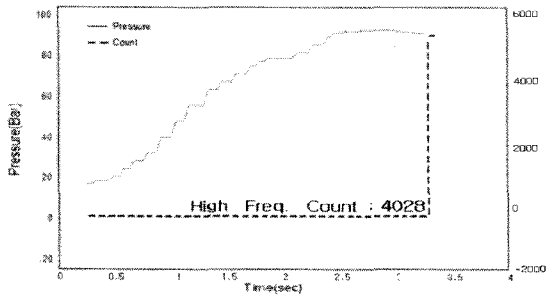
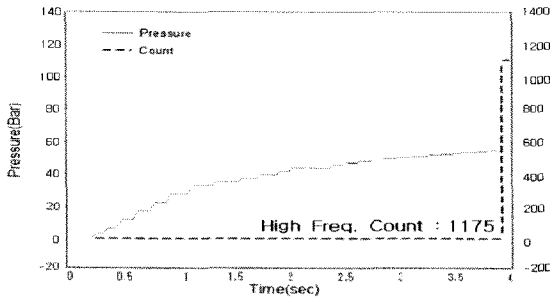
(a) Filament wound composite cylinder

(b) sandwich cylinder

Fig. 9 Fracture detection of the composite cylinder using the fabricated AE signal analyzer (L-C resonator).

abruptly at the same time. Figure 9 shows the fracture detection of the composite cylinder using the L-C resonator. As shown in Figure 9, the high frequency event count had a larger value when the abrupt fracture of the composite cylinder occurred. The low frequency event count during the fracture had a small value relatively to the high frequency event count. Figure 10 shows the fracture detection of the composite cylinder using the band-pass filter. As shown in Figure 10, the high frequency event count had a larger value relatively to the low frequency event count during the fracture.

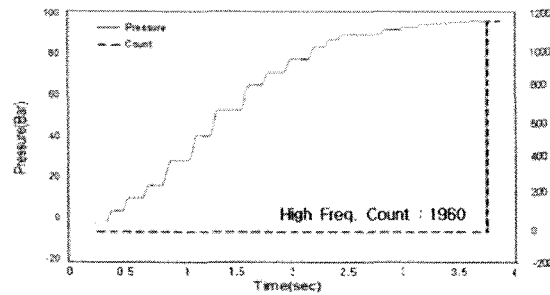
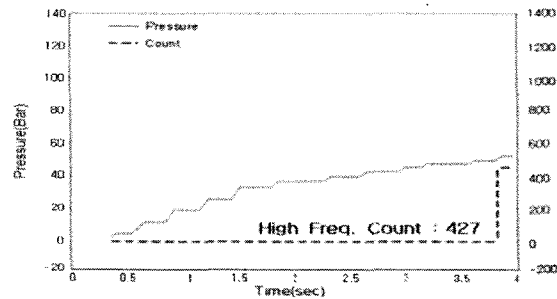
(a) Filament wound composite cylinder

(b) sandwich cylinder

Fig. 10 Fracture detection of the composite cylinder using the fabricated AE signal analyzer (Band-pass filter).

From the impact and pressure tests, it could be proved the fabricated AE analyzer could distinguish and measure the mechanical impact and fracture of the composite cylinder under the pressure test.
