Effect of erbium-doped: yttrium, aluminium and garnet laser irradiation on the surface microstructure and roughness of sand-blasted, large grit, acid-etched implants

Purpose: The present study was performed to evaluate the effect of erbium-doped: yttrium, aluminium and garnet (Er:YAG) laser irradiation on sand-blasted, large grit, acid-etched (SLA) implant surface microstructure according to varying energy levels and application times of the laser.

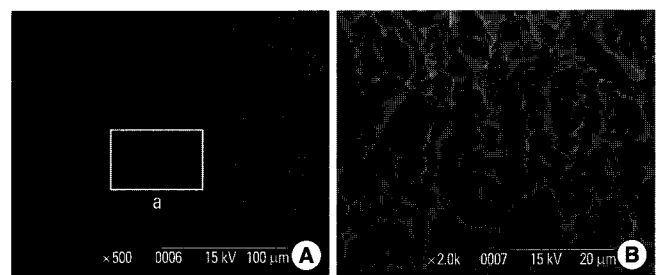
Figure 6. (A) Sand-blasted, large grit, acid-etched implant surface irradiated at 140 mJ/pulse for 1.5 minutes ($\times 500$). (B) Inset of Figure 6A. Flattened surface is observed ($\times 2,000$).

The implants in group 1 (irradiated at 100 mJ/pulse) showed no changes in the structure of their surfaces after 1 minute and 1.5 minutes of irradiation (Figs. 2, 3). However, as the irradiation time increased to 2 minutes under the same energy intensity, a heat-induced meltdown was observed in the implant surface under microscopic observation at 2,000× (Fig. 4). In group 2 and 3, for which the laser irradiation power increased to 140 mJ/pulse and 180 mJ/pulse, respectively, surface changes were observed in all the implants regardless of the application time. Meltdown and subsequent flattening of the surfaces were observed (Figs. 5B-10B). These changes became more evident with increasing intensity of pulse energy and application time (Figs. 5A-10A).

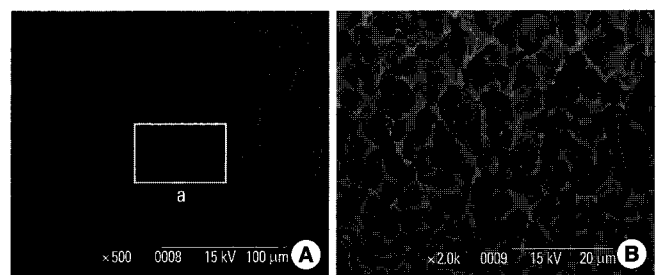
Figure 7. (A) Sand-blasted, large grit, acid-etched implant surface irradiated at 140 mJ/pulse for 2 minutes ($\times 500$). (B) Inset of Figure 7A. Flattened surface is observed ($\times 2,000$).

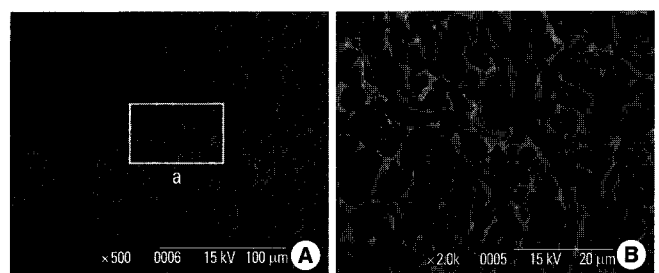
Figure 8. (A) Sand-blasted, large grit, acid-etched implant surface irradiated at 180 mJ/pulse for 1 minute ($\times 500$). (B) Inset of Figure 8A. Melted surface is observed ($\times 2,000$).

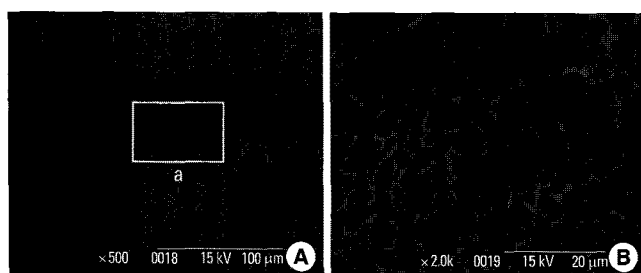
Figure 9. (A) Sand-blasted, large grit, acid-etched implant surface irradiated at 180 mJ/pulse for 1.5 minutes ($\times 500$). (B) Inset of Figure 9A. Flattened surface is observed ($\times 2,000$).

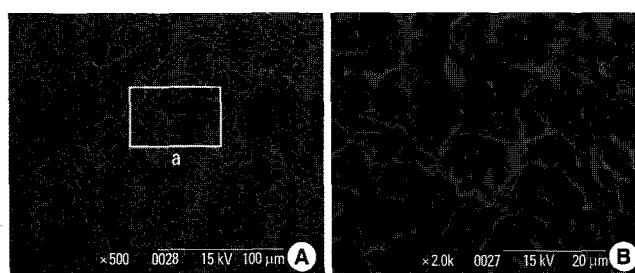
Figure 10. (A) Sand-blasted, large grit, acid-etched implant surface irradiated at 180 mJ/pulse for 2 minutes ($\times 500$). (B) Inset of Figure 10A. Flattened surface is observed ($\times 2,000$).
