Minimally invasive treatment for esthetic enhancement of white spot lesion in adjacent tooth

This article describes the treatment provided to a patient with the maxillary anterior teeth exhibiting severe secondary caries beneath the previous restoration and a white spot lesion on the adjacent incisor. Two implants were placed after extraction of hopeless teeth with the guided bone regeneration technique. A white spot lesion of the adjacent incisor was treated with minimally invasive treatment. This clinical report describes the multidisciplinary treatment for the white spot lesion and esthetic restoration of missing anterior teeth. [*J Adv Prosthodont* 2013;5:359-63]

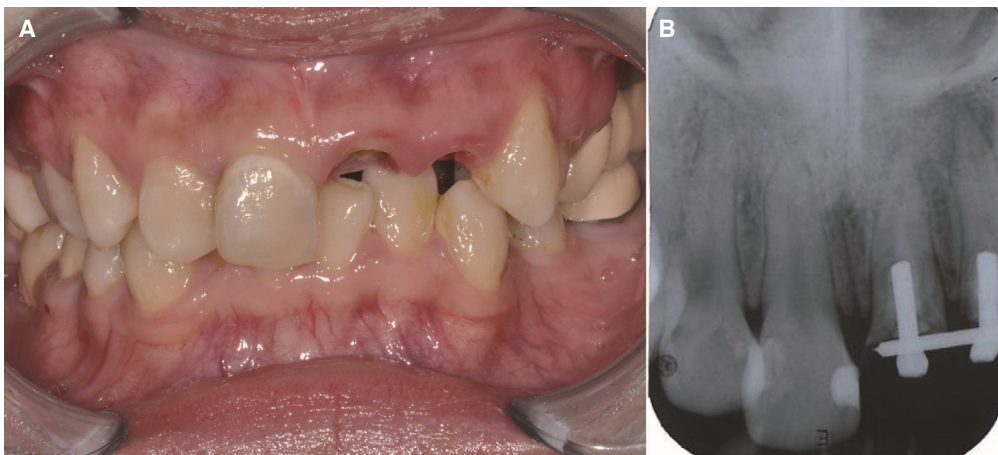
Fig. 1. (A) Pre-treatment clinical view, (B) Pre-treatment radiograph. Note the cervical white spot lesion with poor oral hygiene.

A 22-year-old woman who lost her maxillary right central and lateral incisor prosthesis presented to the Gangneung-Wonju National University Dental Hospital for treatment (Fig. 1A). The prosthesis was lost with severe secondary caries around the metal post. Each root canal was incom-

pletely filled with a radiopaque resinous hard material, and the right lateral incisor root had apical rarefying osteitis (Fig. 1B). Extraction was necessary due to the large extent of secondary caries and the nonremovable canal filling material. A white spot was found in the maxillary left central incisor with poor oral hygienic control.

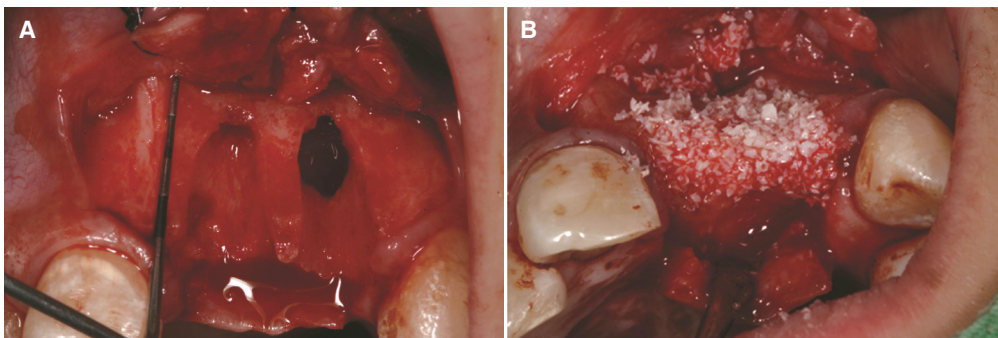
Fig. 2. (A) Extraction socket after 6-week-healing, (B) Defects covered with resorbable bilayer collagen membrane.

Because the patient refused tooth preparation, restoring the teeth with an implant prosthesis was planned. A diagnostic waxing of the teeth determined the installing site of implants to meet the esthetic needs and to fabricate a radiographic stent and a surgical stent. Six weeks after extraction, severe bone loss of the buccal plate was confirmed (Fig. 2A). In view of the insufficient implant primary stability, guided bone regeneration was performed as defects were filled with a xenograft material (Bioss; Geistlich Pharma AG, Wolhusen, Switzerland) and covered with a resorbable bilayer collagen membrane (Bio-gide; Geistlich Pharma AG) (Fig. 2B). Four months after guided bone regeneration, sufficient hard and soft tissue volume was acquired. A tapered internal hex titanium implants (Implantium; Dentium, Seoul, Korea) were installed, oriented by a surgical guide. An acrylic resin RPD was fabricated to

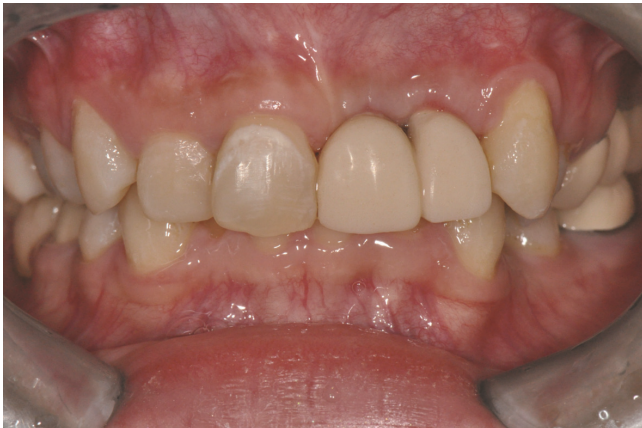
Fig. 3. Placement of provisional restoration.

Six months after implant placement, a tissue-punch technique was used to place a screw-retained provisional restoration with a provisional plastic abutment (Plastic temporary abutment, Dentium). The treatment for the white spot of the left maxillary central incisor was also needed. Diagnosis for the white spot was performed with visual-tactile inspection evaluating change of the surface gloss and color after desiccation. The lesion surface was hard and shiny, it was diagnosed as an inactive ICDAS (International Caries Detection and Assessment System) code 2 which requires esthetic improvement only. Regenerating the white spot on the prosthesis was not esthetic and removal of the white spot lesion was thus required. Gingival recession after a surgical procedure highlights the white spot in the cervical area (Fig. 3). Furthermore, bandlike whitish discoloration along the perikymata in the middle third coronal area also needed esthetic enhancement. The proposed minimally invasive technique is based on a combined approach of bleaching, resin infiltration and composite resin bonding. In-office bleaching treatment was applied according to the manufacturer's (Lumawhite; Luma Lite, Spring Valley, CA,

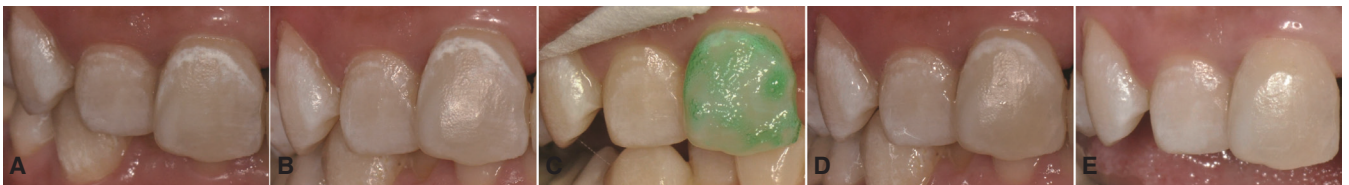
Fig. 4. (A) Left central incisor after bleaching, (B) 2 weeks after bleaching, (C) Hydrochloric acid etching for resin infiltration technique, (D) After resin infiltration technique, (E) Composite resin restoration. Note the disappearance of general white bandlike area in the middle portion and distal part of white spot lesion after resin infiltration.

USA) recommendations. After gingival tissues were isolated using a light-polymerized resin dam (Opal Dam; Ultradent Products Inc., South Jordan, UT, USA), 35% hydrogen peroxide (Lumawhite) was applied onto the left maxillary incisor with consistent coverage of 2 to 3 mm thickness for 8 minutes, for a total of 3 times (Fig. 4A). Two weeks after treatment, the white spot lesion was still apparent though bleaching became effective on the normal tooth structure, requiring more effective treatment (Fig. 4B).

Consequently, the decision was made to conduct the resin infiltration technique as it was more preservative than microabrasion or macroabrasion. On the enamel surface, careful application of 15% hydrochloric acid gel (ICON-Etch; DMG, Hamburg, Germany) was performed for 120 seconds to remove the surface layer less than 30 to 40 μm (Fig. 4C). The acid gel was suctioned and washed away thoroughly. The lesions were desiccated using ethanol (ICON-Dry; DMG) for 30 seconds. At the moment of applying ethanol, the color change in the white spot lesion was confirmed with ethanol penetration. After thorough desiccation with ethanol, an infiltrant resin (ICON-Infiltrant; DMG) was placed on the tooth surface for 3 minutes for inside penetration. Excessive resin was wiped away from the surface and the proximal spaces. Light polymerizing was performed for 40 seconds. Applying the infiltrant resin was repeated to compensate for the shrinkage after polymerization. The tooth surface was polished with polishing discs (Sof-lex disk; 3M ESPE, Saint Paul, MN, USA). After resin infiltration, some of the cervical white spot and bandlike whitish discoloration along the perikymata in the middle third coronal area disappeared (Fig. 4D). However, resin infiltration in some parts of the cervical white spot lesion was ineffective, requiring an advanced approach.

The limited, unchanged white spot lesion was removed with a carbide bur (Carbide Burs Round; Mani Inc., Tochigi, Japan). The tooth structure was etched with 38% phosphoric acid (Scotchbond Etchant; 3M ESPE) for 15 seconds. The etching gel was washed away and dried. A bonding agent (Adper Single Bond Plus adhesive, 3M ESPE) was applied to the preparation area and light polymerized for 10

seconds. Composite resin (Filtek Supreme XT; 3M ESPE) was placed and polymerized for 40 seconds. Finally, polishing the restoration surface was performed with polishing discs (Sof-lex disk; 3M ESPE) (Fig. 4E).

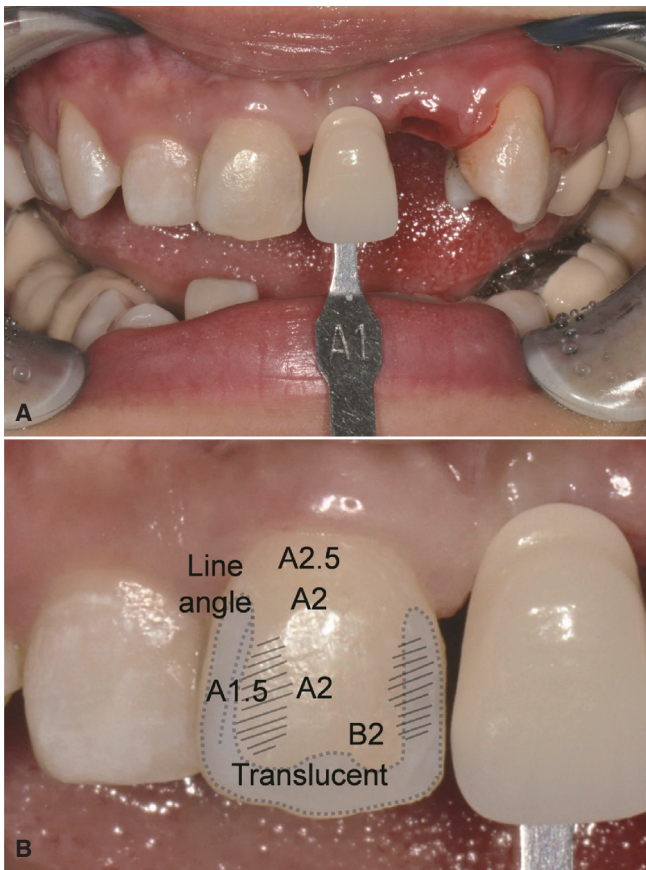
Fig. 5. (A) Clinical photograph with shade guide, (B) Shade mapping on clinical photograph.

A complete maxillary arch impression was made with a silicone impression material (Exafine, GC, Tokyo, Japan). A customized abutment (Direct Casting Abutment; Dentium) was fabricated. Shade information was transferred to the dental laboratory after taking clinical photos with a shade guide (VitaLumin shade guide; VidentInc, Brea, CA, USA) and a detailed shade map (Fig. 5A and Fig. 5B). A metal ceramic fixed dental prosthesis was cemented with implant cement (Premier Implant Cement; Premier Products Co., Plymouth Meeting, PA, USA) (Fig. 6A).

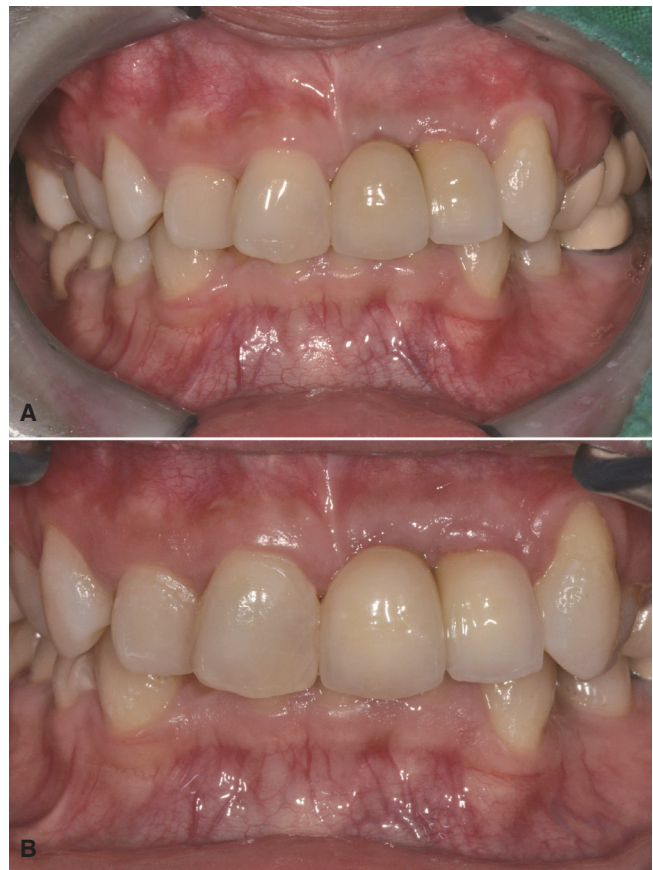
Fig. 6. (A) Post-treatment clinical view after 1 month, (B) Post-treatment clinical view after 6 months.

The patient was followed for oral hygiene instruction and no complications were found after 6 months (Fig. 6B). However, due to insufficient long term clinical research on color stability for resin infiltration treatment, continuous post-treatment monitoring should be followed. It is also important to monitor the maintenance of proper surface gloss, oral hygiene and health of peri-implant soft and hard tissue.
