## Comparison of high-resolution and standard zoom imaging modes in cone beam computed tomography for detection of longitudinal root fracture: An in vitro study

**Purpose:** The purpose of this study was to compare the efficacy of two imaging modes in a cone beam computed tomography (CBCT) system in detecting root fracture in endodontically-treated teeth with fiber posts or screw posts by selecting two fields of view.

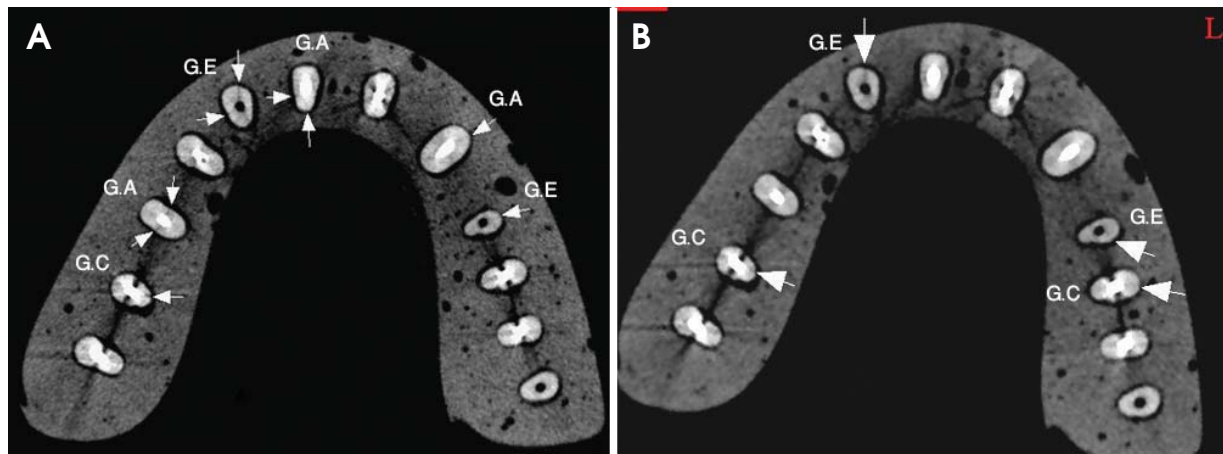
**Fig. 1.** The axial images of high resolution (A) and standard (B) zoom modes of CBCT images show several root fractures (arrows). The teeth with a fiber post and root fracture (Group A; G.A), with a screw post and root fracture (Group C; G.C), and with a post space and root fracture (Group E; G.E) are seen in each arch set.

Then, to reconstruct the study images taken from the volumetric ones, the plane was selected in such a way as to ensure that it was parallel to the occlusal plane. Axial images with a thickness and an interval of 0.4 mm (Fig. 1) and cross-sectional images with a thickness of 0.5 mm and an interval of 0.5 mm perpendicular to the mesio-distal and/or bucco-lingual axes of each root (Fig. 2) were prepared by a maxillofacial radiologist and an endodontist. They were familiar with CBCT and had more than 15 years of professional work experience; they served as observers. These individuals then determined the absence or presence of root fracture and their locations concomitantly and in agreement with each other (i.e., on the root surface and/or in which). The process of observation was repeated on 50 out of the 78 samples after one week for both imaging modes. SPSS 16.0 (SPSS Inc., Chicago, IL, USA) was used for data gathering and analysis. The sensitivity,

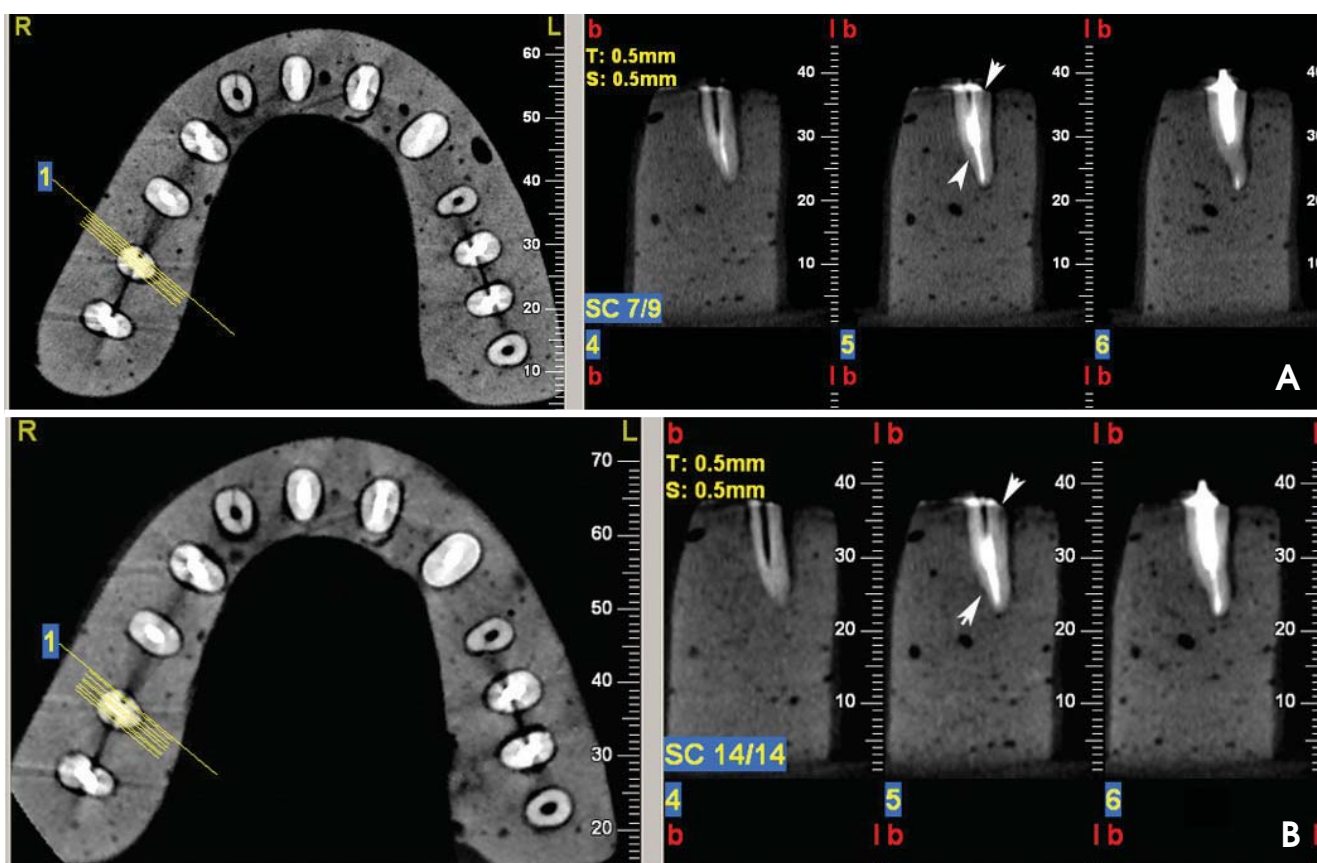
**Fig. 2.** The axial and cross-sectional images of high resolution (A) and standard (B) zoom modes show the direction of root fracture in a tooth with a screw post and root fracture (arrows).
