Use of ultrasound Doppler to determine tooth vitality in a discolored tooth after traumatic injury: its prospects and limitations

When a tooth shows discoloration and does not respond to the cold test or electric pulp test (EPT) after a traumatic injury, its diagnosis can be even more difficult due to the lack of proper diagnostic methods to evaluate its vitality. In these case reports, we hope to demonstrate that ultrasound Doppler might be successfully used to evaluate the vitality of the tooth after trauma, and help reduce unnecessary endodontic treatments. In all three of the present cases, the teeth were discolored after traumatic injuries and showed negative responses to the cold test and EPT. However, they showed distinctive vital reactions in the ultrasound Doppler test during the whole observation period. In the first case, the tooth color returned to normal, and the tooth showed a positive response to the cold test and EPT at 10 wk after the injury. In the second case, the tooth color had returned to its normal shade at 10 wk after the traumatic injury but remained insensitive to the cold test and EPT. In the third case, the discoloration was successfully treated with vi

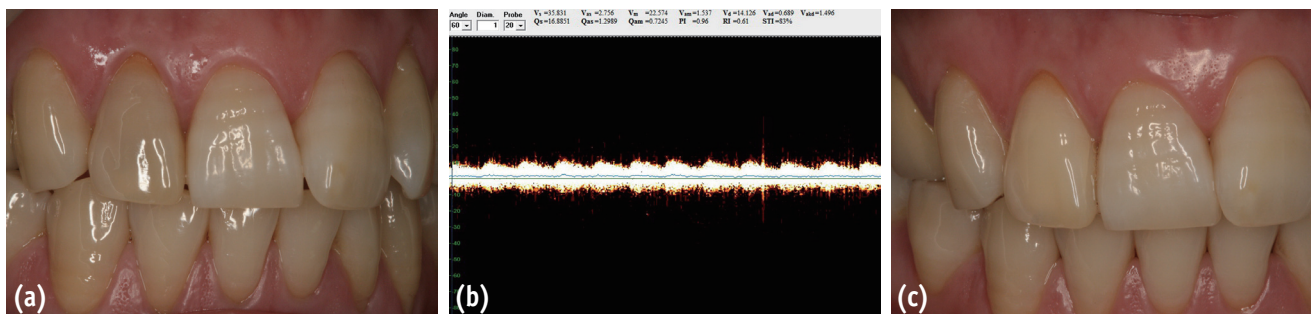
Figure 1. (a) In case 1, discoloration of tooth #12 was observed at 2 weeks after the injury; (b) The result of an ultrasound Doppler test at 6 weeks after the injury. It shows a typical pulsated image, which represents normal vital pulp; (c) At 10 weeks after the injury, the tooth had returned to a normal shade.

A 47-year-old female patient visited our department due to traumatic injury to her upper right lateral incisor (tooth #12). She sustained the injury 3 days before she visited our clinic by a fist blow injury to her face. Tooth #12 was subluxated, and showed a positive response to a percussion test. It did not show any response to a cold test or EPT. The tooth was diagnosed with subluxation, and we decided to wait and observe its course. There was no discomfort during the 2 weeks after the injury, but there was no response to the thermal test or EPT, and a reddish discoloration was observed (Figure 1a).

At 6 weeks after the injury, the patient did not show any discomfort, but the discoloration lasted, and the tooth did not respond to cold or EPT. We decided to use the ultrasound Doppler unit to evaluate the vitality of the pulp, and the result was shown in Figure 1b. Tooth #12 produced a typical pulsated image, which represents normal vital pulp (Figure 1b). We explained the results and implications of the test to the patient. We decided to continue to wait and observe the tooth because the patient had no discomfort, did not mind the discoloration at that time, and was willing to wait to determine whether the tooth could recover to normal without any treatment. At 10 weeks after the injury, the tooth had returned to a normal shade and regained its normal responses to the cold test and EPT (Figure 1c).

In the first case, the ultrasound Doppler showed a typical pulsated image when the tooth did not respond to the cold test and EPT in the early phase after a traumatic injury. Then, in ongoing follow-up, the Doppler test continued to show vital image, but the tooth still did not respond to the other two tests. The tooth regained its shade by 10 weeks after the traumatic injury, and its response to the cold test and EPT returned to normal. This finding is consistent with previous reports that indicated that the discoloration returned to normal when the teeth regained their vitality and demonstrating that ultrasound Doppler can be successfully used to determine the vitality of teeth during the period when they do not respond to the cold test and EPT after a traumatic injury.⁴⁻⁸ Ultrasound Doppler may help decrease unnecessary endodontic treatments, which could be performed due to a lack of the proper diagnostic methods after a traumatic injury.

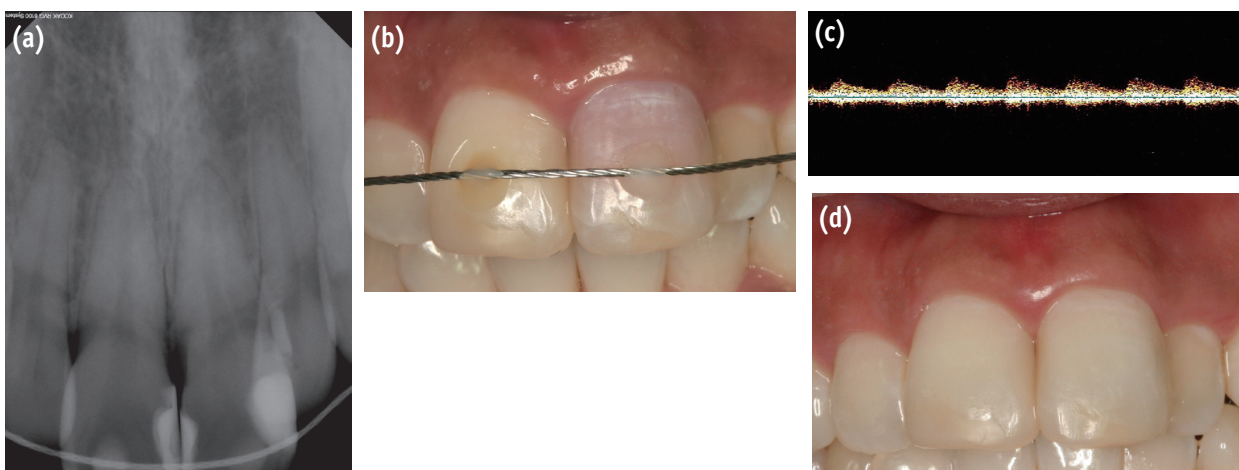
Figure 2. (a) In case 2, tooth #21 was splinted at a local clinic after a subluxation injury that had occurred 2 weeks before the patient visited our clinic. It showed a negative response to the thermal test and EPT, and a positive response to the percussion test; (b) Tooth #21 showed pinkish discoloration; (c) In the ultrasound Doppler test, tooth #21 showed a normal pulsated response like that of the other teeth; (d) At 10 weeks after the injury, the shade of tooth #21 had returned to normal.

A 30-year-old female patient visited our clinic for further treatment of traumatized anterior teeth. She had sustained an injury from a fall 2 weeks ago, and had visited a local clinic immediately after the trauma. The subluxated tooth #21 was splinted with composite resin and wire from tooth #13 to tooth #23, and then the local dentist referred her to our clinic. In the periapical radiographic view, the root and periapical area were normal (Figure 2a). Tooth #21 showed negative responses to the thermal test and EPT, a positive response to the percussion test, and pinkish discoloration (Figure 2b). The other teeth showed normal responses to all of the tests. In the ultrasound Doppler test, tooth #21 produced a normal pulsated response like those of the other teeth, and we were also able to hear the beat of the pulsation from the speaker (Figure 2c). At 4 weeks after the injury, tooth #21 showed normal response to percussion, again. In the other tests, the results were also the same as in the previous visit. At 6 weeks after the injury, tooth #21 still showed pinkish discoloration and negative responses to the thermal test and EPT. At 10 weeks after the injury, the shade of tooth #21 returned to normal (Figure 2d). At 12, 16, 20, and 24 weeks after the injury, the patient did not feel any discomfort at all. In the ultrasound Doppler test, tooth #21 showed a vital response, but it did not respond to the cold test or EPT. In the periapical view, the root and periapical area were within the normal range. The negative response continued throughout the follow-up period for 9 months. At that time, she was pregnant and wanted to delay her next visit until after her delivery.

months after root fracture resulting in tooth discoloration after trauma.⁶ The second case was interesting in that the discoloration returned to normal by 10 weeks after injury, but the tooth did not respond to the cold test and EPT even at 9 months after the traumatic injury, although it showed a consistent vital image in the Doppler test from the beginning. False positive responses in the ultrasound Doppler test have not yet been studied. In the present study, a 20-MHz ultrasound Doppler probe was used. The frequency of ultrasound is very important because it determines the penetration depth of the ultrasound wave. Although a 20-MHz frequency was reported to efficiently penetrate the enamel and dentin, and detect the blood flow in the pulp spaces, it might be possible to detect the blood flow outside of the pulp spaces if the thickness of the hard tissue is very thin.^{1,12} The potential for false positive responses with the ultrasound Doppler probe requires further investigation. In the second case, long-term follow-up is necessary to verify whether the vitality was actually maintained, which could be confirmed by a positive response to the cold test and EPT. However, in this case, the tooth returned to its normal shade by 10 weeks after the traumatic injury, which suggests that the blood supply to the pulp was maintained and the pulp survived.⁶ More time might be needed for the nerve fiber to heal. Further follow-up is required to determine whether the test results are true or false positive.

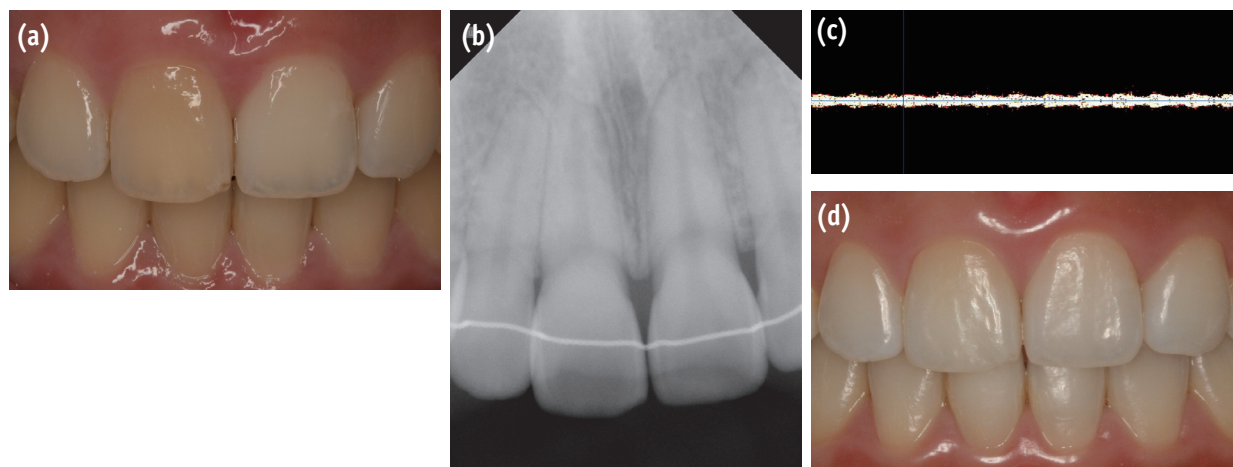
Figure 3. (a) In case 3, tooth #11 showed yellowish brown discoloration; (b) The coronal pulp space was obliterated, whereas the pulp space was present in the root area. There was no radiolucency in the periapical area, but the root apex was slightly shortened; (c) In the ultrasound Doppler test, tooth #11 showed an image typical of a vital tooth; (d) The patient was satisfied with the shade of tooth #11 after vital bleaching treatment.

A 22-year-old female patient visited our department to have her teeth bleached. She thought her teeth were generally yellowish, and she was especially unsatisfied with the shade of tooth #11, which showed yellowish brown discoloration (Figure 3a). She reported experiencing trauma to her anterior teeth when she was in primary school, and she had finished orthodontic treatment approximately 7 years before presentation. However, she did not know exactly when tooth #11 started to become discolored. In the radiograph, the coronal pulp space was obliterated, whereas the pulp space was present in the root area. There was no radiolucency in the periapical region, but the root apex was slightly shortened (Figure 3b). In the cold test, tooth #11 did not show any response, although she occasionally displayed a delayed response. The tooth did not respond to the EPT. In the ultrasound Doppler test, tooth #11 showed an image and sound typical of a vital tooth (Figure 3c). We decided to perform vital tooth bleaching first and then re-evaluate the color to decide whether restorative treatment was needed. Home bleaching was started using 15% carbamide peroxide gel (Opalescence, Ultradent, South Jordan, UT, USA). Additional home bleaching was continued only for tooth #11 after she was satisfied with the shade of her other teeth. After approximately 2 months of bleaching, she was satisfied with the shade of tooth #11 and did not want any further treatment (Figure 3d).

In the third case, the patient did not respond to the cold test and EPT, although she occasionally showed an obscure positive delayed response to the cold test. The cold test depends on the hydrodynamic movement of fluid within

the dentinal tubules, which excites the A-fibers.¹³ Teeth with calcified pulp spaces might have normal and healthy pulps, but cold stimuli might not be able to excite the nerve endings due to the insulating effect of the thicker layer of dentin, which is the result of secondary and reactionary dentin formation.¹⁴ Ehrmann reported that EPT is particularly effective in older patients and in teeth that have limited fluid movement through the dentinal tubules as a result of dentine sclerosis and calcification of the pulp space because thermal pulp tests are usually inadequate in these situations.¹⁴ Klein reported that a patient was unlikely to respond to a cold test but may respond to an EPT if the pulp space had been significantly calcified.¹⁵ In their case, more electric pulp current was often needed to elicit a response because there was an increased dentin layer and a diminished pulp cavity or a fibrotic pulp. In the third case, tooth #11 was diagnosed as a vital tooth based on the results of the ultrasound Doppler test because it displayed a consistent positive sign throughout the observation period. In this case, the coronal pulp space was obliterated, whereas the pulp space was present in the root area. Because the ultrasound Doppler probe tip was positioned apically, there was a possibility of detecting the blood flow of the root canal. Furthermore, the patient showed a response to the cold test, although the response was delayed and inconsistent. For further research, we need more cases and studies related to ultrasound Doppler.
