Microbiologically Induced Corrosion of Three Tubular Materials

S. Mukadam[†] and A. Al-Hashem

Petroleum Research Center, Kuwait Institute for Scientific Research, P.O. Box 24885, Safat 13109, Kuwait

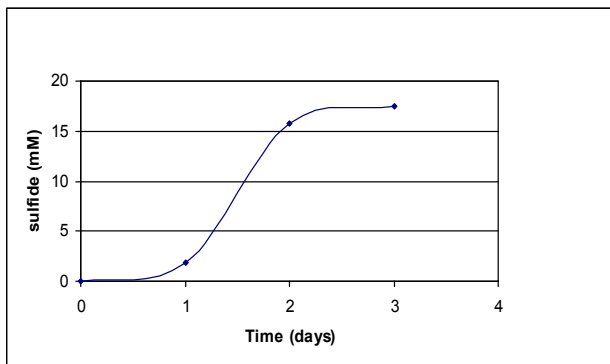
Fig. 1. The concentration of sulfide with exposure time in the media with SRB.

Bacteria growth in the anaerobic chamber was measured by measuring the amount of sulfide produced in the media. Fig. 1 illustrates the growth of SRB followed the typical "S" curve.

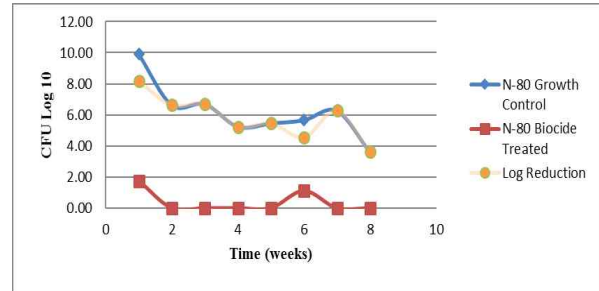
Fig. 2. Effect of biocide on SRB growth with time for N-80 alloy.

The log reduction of the planktonic cells showed that the biocide treated media water had almost no bacterial activity. This was the case for the every time point and every metal coupon type. This showed large inhibition of SRB activity when the biocide was present (Fig. 2-4).

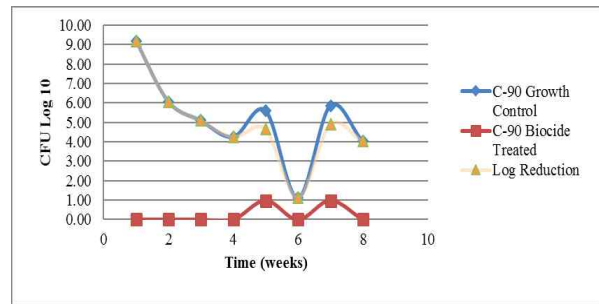
Fig. 3. Effect of biocide on SRB growth with time for C-90 alloy.

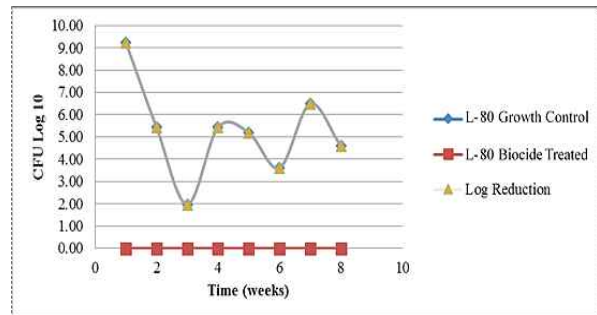
Fig. 4. Effect of biocide on SRB growth with time for L-80 alloy.

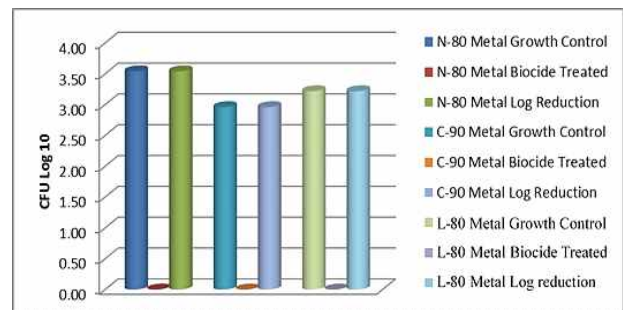
Fig. 5. Effect of biocide on SRB growth with time for C-90 alloy.

cells recovered from sonicating was lower than the planktonic amounts. Fig. 5 illustrates a typical biofilm recoveries for the three alloys.

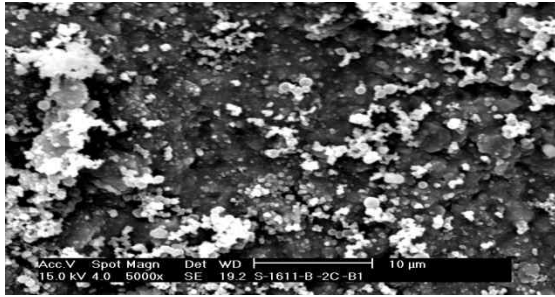
a. Biocide Treated. Some pitting is present.

Fig. 6. SEM micrograph of alloy C-90 after exposure to SRB media.

and untreated samples. Alloy C-90 had no visible cells on the biocide treated coupon. The metal looked cleaner and smoother than the growth control. The growth control on the other hand had large amounts of visible bacteria and the metal surface looked rougher. Slime can be seen in some of the photos (Fig. 6d). Alloy N-80 growth control

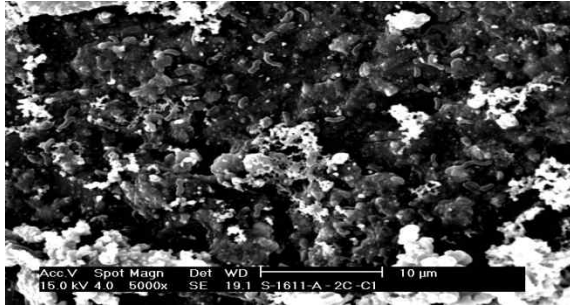
b. Growth Control. Bacteria cells present.

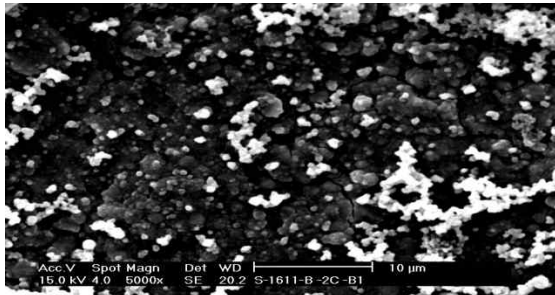
c. Biocide Treated. No cells present.

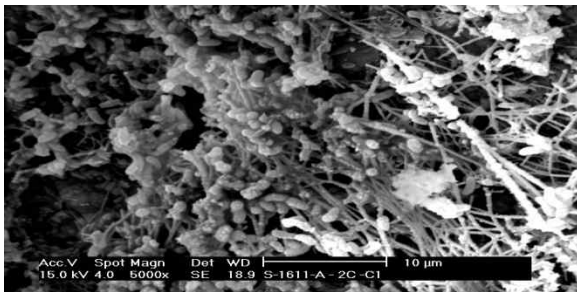
d. Growth Control. Some biofilm / slime found.

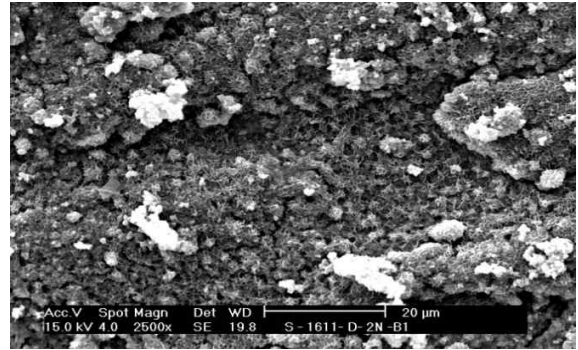
a. Biocide Treated. No cells are visible.

Fig. 7. SEM micrograph of alloy N-80 after exposure to SRB media.

had large amounts of bacteria on its surface along with large bacterial colonies scattered on its surface (Fig. 7). The metal seemed to be rough and the valleys seemed to be bigger indicating that there was perhaps higher corrosion on this sample. The biocide treated coupon had no visible colonies and the metal seemed to be smoother and cleaner. Alloy L-80 growth control had no visible cells on the surface (Fig. 8). This may be because the cells were beneath a slime layer or the fixing process may have removed them. The surface did look different than the biocide treated compound with large amounts of small cube-like formations and high amounts of pitting when compared to the biocide treated samples. The biocide treated had almost no cube like formations and the surface was smoother, with less pits and valleys. This may indicate that there was less corrosion happening on the biocide treated sample.

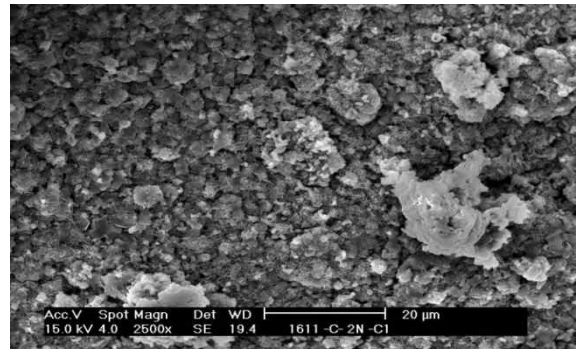
b. Growth Control. Cells visible.

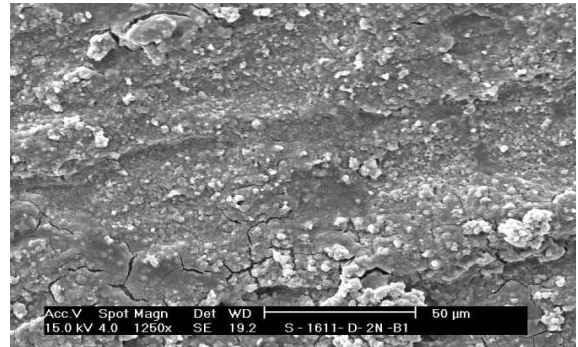
c. Biocide Treated. Metal surface looks clean.

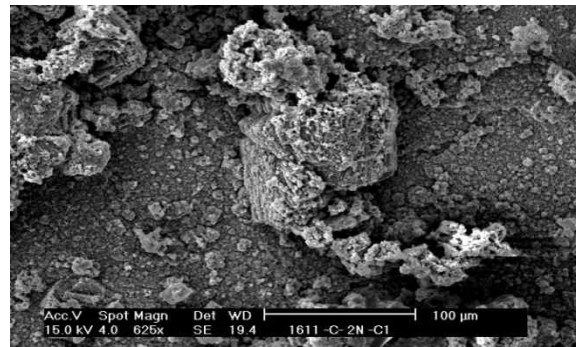
d. Growth Control. Metal surface is covered in large colonies of bacteria.

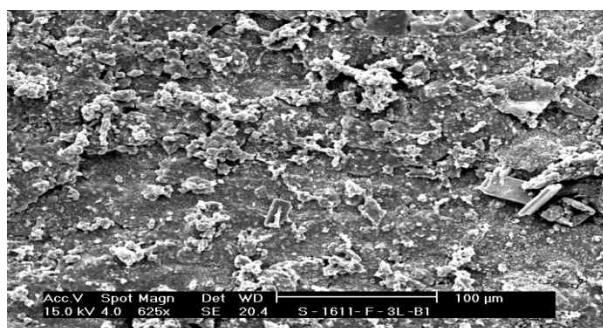
a. Biocide Treated. Some salt deposits are visible.

Fig. 8. SEM micrograph of alloy L-80 after exposure to SRB media.

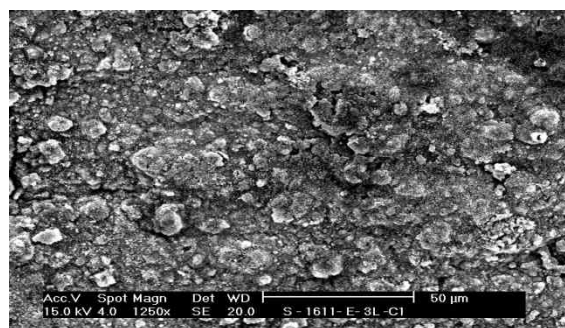
b. Growth Control. Surface looks rough.

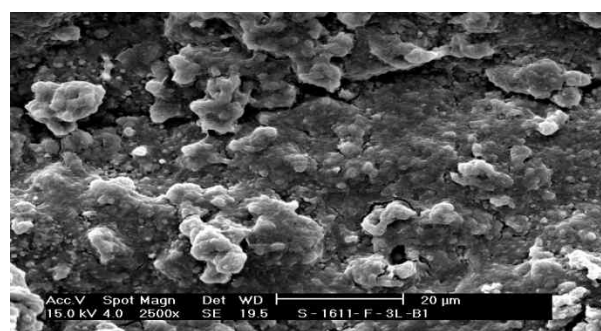
c. Biocide Treated. Metal surface looks clean.

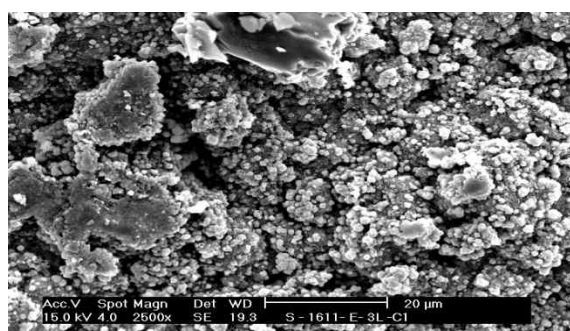
d. Growth Control. Large amounts of pitting and debris can be seen.
