Condensation Prevention Performance Assessment Taking Into Account Thermal Insulation Performance Degradation Due to Aging for Apartment Housing

ABSTRACT

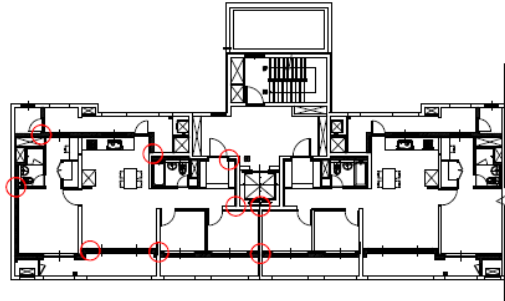
As seen in Table 5, surface temperature was measured on the sections or parts as suggested in Apartment Housing Condensation Prevention Design Guideline. Figure 1 shows the areas where condensation occurs on the plane .

Fig 1. Possible Condensation Area

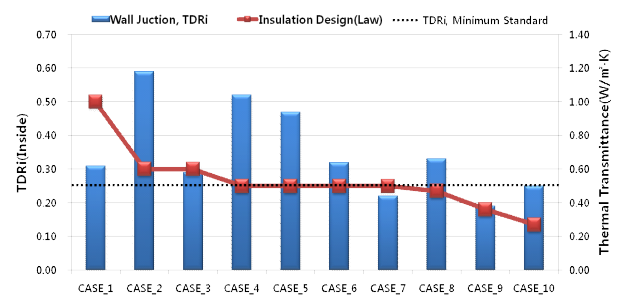
Figure 2 shows legal thermal insulation design guideline (heat transfer coefficient) of walls (contacting directly open space) by the year of completion and the results of TDRi calculation (Table 8). This study chose non-expansion unit households to evaluate the thermal insulation performance of wall junctions and condensation performance. The results are shown in Figure 2.

Fig 2. The Average TDRi Results of The Measurement Target-wall junctions

7 subjects out of the total 10 showed higher TDRi for condensation performance than minimum performance standard (0.25), which evidences they (7 subjects) are subject to the conditions for the risk of having condensation.

As seen in Figure 2, the legal thermal insulation design guideline for walls contacting open space has been reinforced. In case of 2010 as the year of completion, wall heat transfer coefficient (based on design) of Case 10 is $0.27\text{W}/\text{m}^2\cdot\text{K}$, which is 2.7 times stricter than Case 1 (as of 1975, $1.0\text{W}/\text{m}^2\cdot\text{K}$).

According to the results of TDRi in Figure 2, however, TDRi does not proportionately and uniformly lower to the reinforced thermal insulation design guideline. It has an irregular trend.

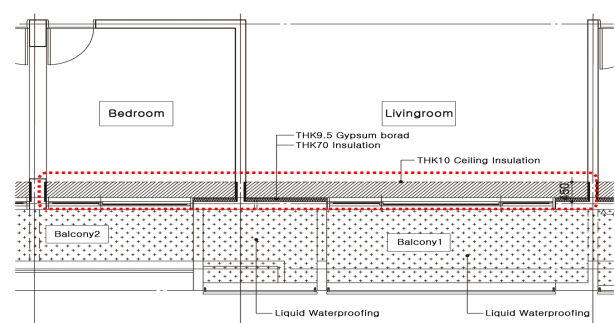
Fig 3. Wall Junction Reinforced Insulation Construction Case

When each of drawings and specifications are compared with TDRi results by subject to measure, as seen in Figure 3, the reason is found in the impact of the applicability of reinforced thermal insulation material and the types of applied thermal insulation material. To evaluate thermal

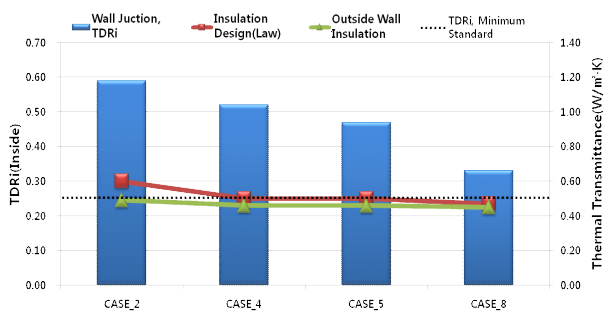
Figure 4 shows TDRi of the subjects that did not apply reinforced thermal insulation material to wall junctions for the purpose of condensation prevention and the heat transfer coefficients of outer walls calculated from the legal thermal insulation design guideline (heat transfer coefficient) for out wall and drawing analysis.

Fig 4. Wall Junction TDRi Results (Non-Reinforced Insulation Construction)

As seen in the results, all of Case 2, 4, 5, and 8, which are the subjects that did not apply reinforced thermal insulation material to wall junctions for the purpose of condensation prevention, show satisfactory level of outer wall heat transfer coefficients with legal thermal insulation design guideline. In Case 8 whose the year of completion is 2001, wall heat transfer coefficient (based on design) was $0.45\text{W}/\text{m}^2\cdot\text{K}$ and turned out more reinforced by 8.2%, 2.2%, and 2.2% than the heat transfer coefficients of Case 2, 4, and 5, respectively.

According to TDRi results, TDRi of Case 2, 4, and 5 were 0.59, 0.52, and 0.47, respectively and when compared with Case 8 (0.33), they were higher by 44.1%, 36.5%, and 29.8%, respectively. In addition, all of them met the minimum performance standard (0.25), which means they have condition for the occurrence of condensation.

Like this, TDRi of the subjects that did not apply reinforced thermal insulation material to wall junctions shows change more than simple difference of wall thermal insulation value (heat transfer coefficient) and the difference between TDRi applied with the heat transfer coefficient of wall junctions in design and the measured TDRi turned out to be 0.54, 0.47, 0.42, and 0.28 in Case 2, 4, 5, and 8, respectively. It clearly demonstrated that the thermal insulation performance of

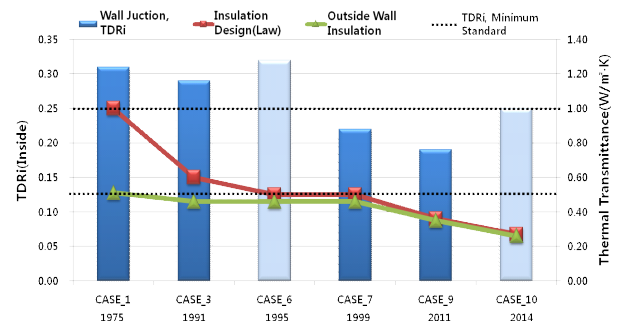
Figure 4 shows TDRi of the subjects that applied reinforced thermal insulation material to wall junctions for the purpose of condensation prevention and the heat transfer coefficients of outer walls calculated from the legal thermal insulation design guideline (heat transfer coefficient) for out wall and drawing analysis.

Fig 5. Wall Junction TDRi Results (Reinforced Insulation Construction)

This study examined the design method of reinforced thermal insulation material through the drawings and found that most of the subjects were installed with reinforced thermal insulation material in wall junctions to prevent condensation from mid and late 1990s. However, there is no standard for reinforced thermal insulation for wall junctions before the current Condensation Prevention Design Guideline was enacted. Therefore, the thermal insulation material varies in type, thickness, and length by subject building and thus construction methods are also different.

For example, Case 1, 3, 7, and 9 used THK 10 expanded polystyrene (EPS) while Case 6 and 10 used THK 5 extruded polystyrene (XPS). As a result, they showed difference in thermal insulation performance as seen in Figure 5, which eventually led to the difference in condensation prevention performance (TDRi).

Of the subjects that used expanded polystyrene (EPS), Case 9 whose the year of completion was 2011 has wall heat transfer coefficient (based on design) of $0.35\text{W}/\text{m}^2\cdot\text{K}$, which is more reinforced by 45.7%, 31.4%, and 31.4% than the heat transfer coefficients of Case 1, 3, and 7, respectively. According to TDRi results, TDRi of Case 1, 3, and 7 was higher by 38.7%, 34.5%, 13.6% than Case 9 (0.19), respectively. Both Case 1 and 3 met the minimum performance standard (0.25), which means they have conditions for the occurrence of condensation.

Case 6 and 10 which used extruded polystyrene (XPS) have wall heat transfer coefficient (based on design) of $0.46\text{W}/\text{m}^2\cdot\text{K}$, and $0.26\text{W}/\text{m}^2\cdot\text{K}$, respectively, and the thermal insulation design guideline was more reinforced by 46.0%

(Case 10) compared with Case 6. According to TDRi results, TDRi of Case 6 is 0.32, meeting the minimum performance standard (0.25), which means they have conditions for the occurrence of condensation. It is 21.9% higher than TDRi of Case 10 (0.25).

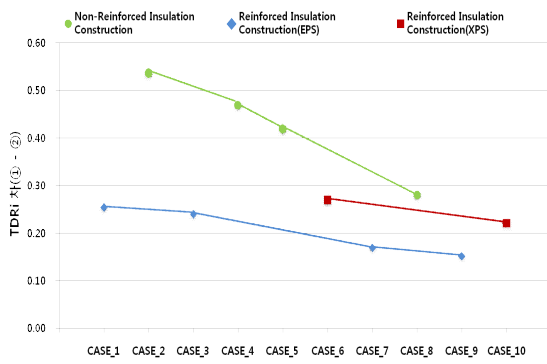
Next, Figure 5 shows the difference between TDRi(①) that is calculated based on heat transfer coefficients designed at the point of the completion and TDRi(②) calculated with surface temperature measured at wall junctions, which is eventually thermal insulation performance degradation by building year.

Fig. 6. Measurement Target-Wall Junction TDRi Rate of Decrease Results

As seen in the difference in TDRi(①-②) of Figure 6, all the subjects show degrading thermal insulation performance regardless of the application of reinforced thermal insulation material in proportion to aging of apartment housing and consequently high risk of condensation occurrence. In addition, the subjects without reinforced thermal insulation material at wall junctions have slower rate of thermal insulation performance degradation aging of apartment housing than those with lower reinforced thermal insulation material at wall junctions. Finally, all the subjects older than 20 years of building life showed high risk of thermal insulation performance degradation.
