Resin bonding of metal brackets to glazed zirconia with a porcelain primer

[Korean J Orthod 2015;45(6):299-307]

Key words: Bracket bonding, Adhesive, Glazed zirconia, Porcelain primer

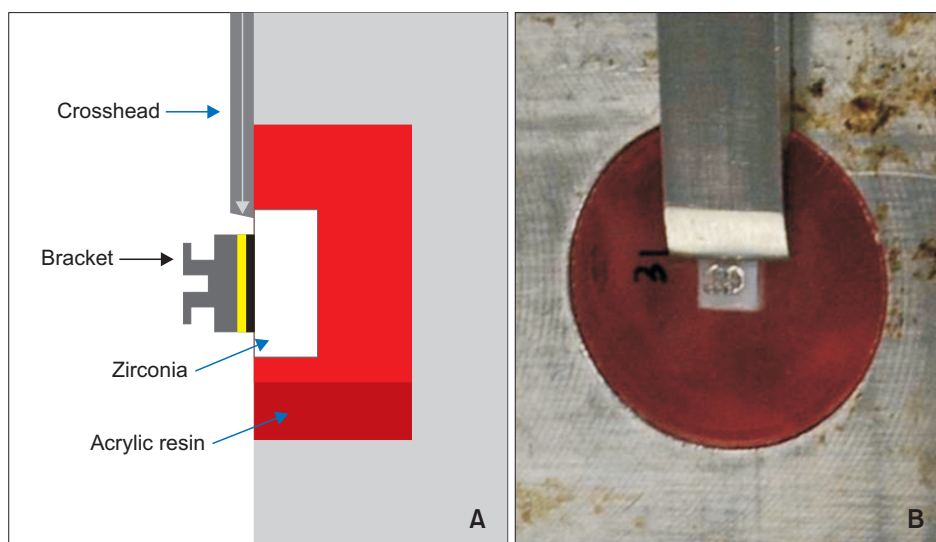
Figure 1. A, Schematic illustration of the shear-bond-strength test. B, Equipment for measuring shear bond strength.

The shear bond strength of the specimens was measured by a universal testing machine (Model 3366; Instron® Co., Norwood, MA, USA) at a cross-head speed of 1 mm/min. The measured values were then divided by the area of the bracket base (9.81 mm²) and converted to units of MPa (Figure 1).

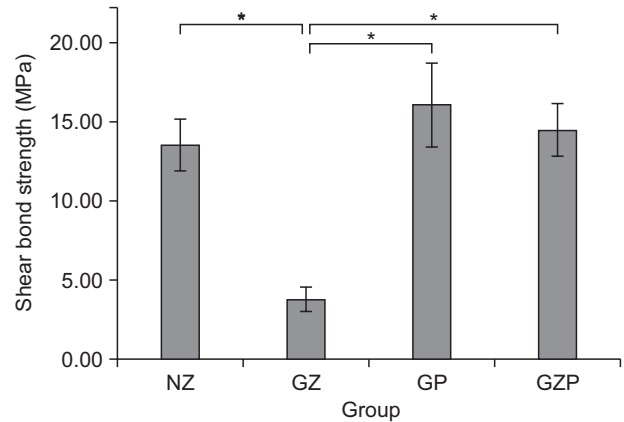
Figure 2. Comparison of the values of shear bond strength. *Statistically significant ($p < 0.05$).

NZ, Nonglazed zirconia with sandblasting and zirconia primer; GZ, glazed zirconia with sandblasting, etching, and zirconia primer; GP, glazed zirconia with sandblasting, etching, and porcelain primer; GZP, glazed zirconia with sandblasting, etching, and both zirconia and porcelain primers.

The mean shear bond strength (MPa) and standard deviations for each specimen group are presented in Figure 2. Group GZ, with zirconia primer on a glazed surface, showed significantly lower shear bond strength than the other groups (NZ, GP, and GZP; $p < 0.05$). There were no statistically significant differences among the NZ, GP, and GZP groups ($p > 0.05$).

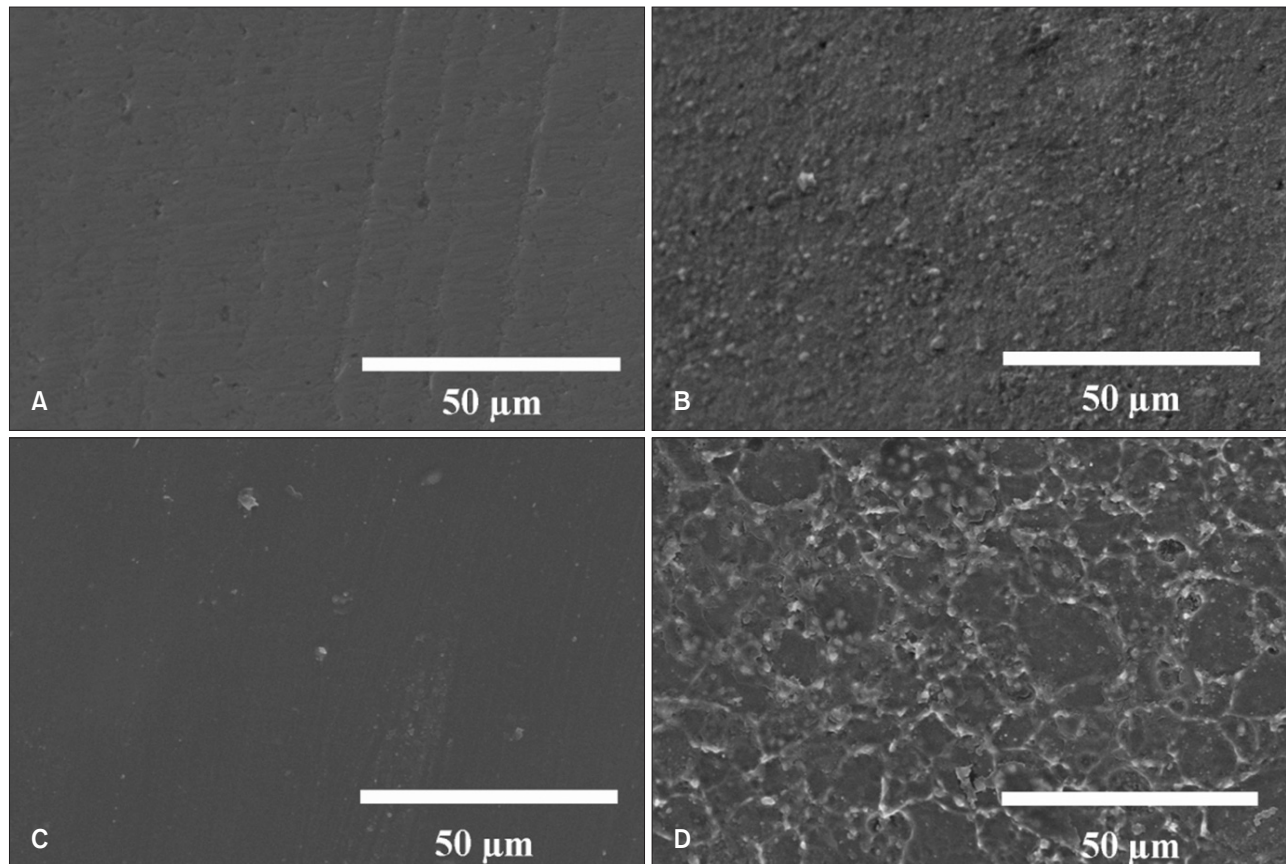
Figure 3. Scanning electron microscopy images of zirconia surface (magnification $\times 1,000$). A, Nonglazed zirconia; B, nonglazed zirconia + sandblasting; C, glazed zirconia; and D, glazed zirconia + sandblasting and acid etching.

SEM images of the zirconia surfaces before and after roughening are presented in Figure 3. Figure 3A shows the slightly cut surface of zirconia (group NZ) that resulted from the cutting operation. In Figure 3C, the glazed zirconia (groups GZ, GP, and GZP) exhibited a plane surface with a few pits.

Sandblasting (and acid etching for glazed specimens) resulted in increased surface roughness (Figure 3). The surface of sandblasted and acid-etched glazed zirconia (Figure 3D) which had small or large pores (1–50 μm) was more roughened than that of sandblasted nonglazed zirconia (Figure 3B).

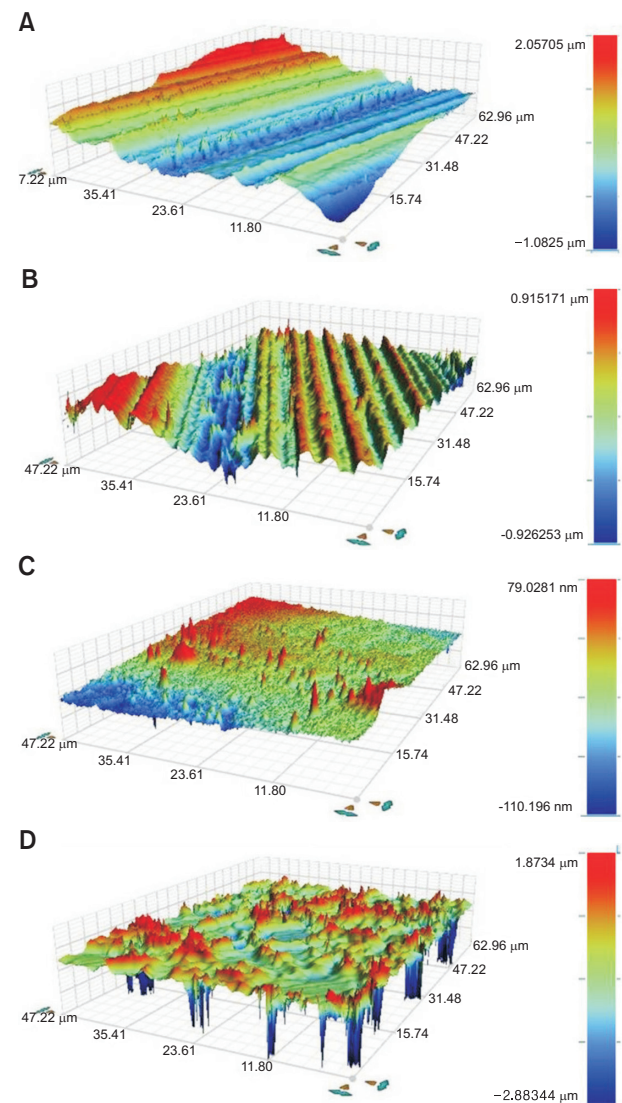
Figure 4. Three-dimensional optical profiler images of zirconia surface (magnification $\times 100$). A, Nonglazed zirconia; B, nonglazed zirconia + sandblasting; C, glazed zirconia; and D, glazed zirconia + sandblasting and acid etching. The right side of each figure includes a colorimeter band representing the height of each spot as different color.

Figure 4 shows three-dimensional optical profiler images corresponding to the SEM images. Each color represents the height of each spot. Compared with the glazed specimens (Figure 4C), the sandblasted and etched surfaces had pits of various depths (Figure 4D). The roughness average (R_a) of nonglazed zirconia was significantly increased after sandblasting treatment (from 0.104 ± 0.03 to 0.165 ± 0.02 , $p < 0.05$). The R_a of glazed zirconia was also significantly increased after sandblasting and etching (from 0.01 ± 0.01 to 0.209 ± 0.03 , $p < 0.05$).

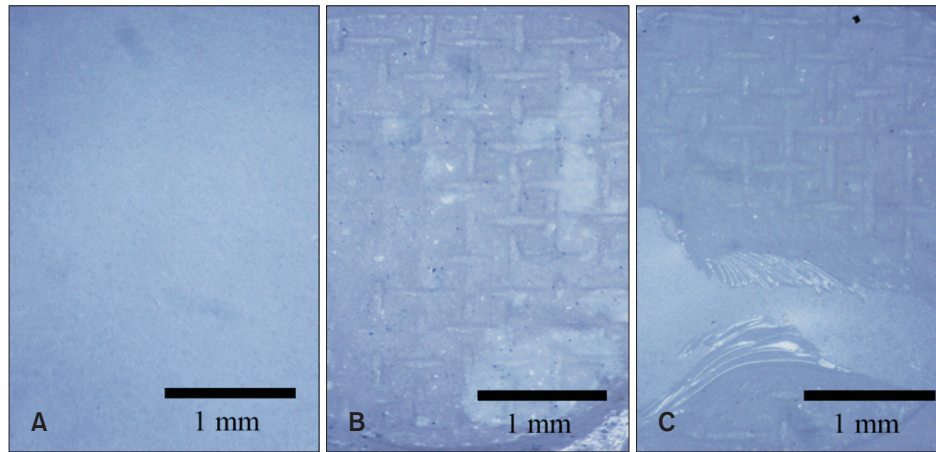
Figure 5. Stereoscopic micrographs of debonded surfaces (magnification $\times 16$). A, Adhesive failure between zirconia and resin cement; B, adhesive failure between resin cement and bracket base; C, complex adhesive and cohesive failure.

Failure-mode analysis was performed with a stereoscopic microscope. Images representing each failure mode are shown in Figure 5, and the results ($n = 40$) are shown in Table 2.

All specimens ($n = 10$) in group GZ showed adhesive failure between the zirconia and resin cement. In groups NZ and GP, bonding failed at the interface between the resin cement and the bracket base or showed complex

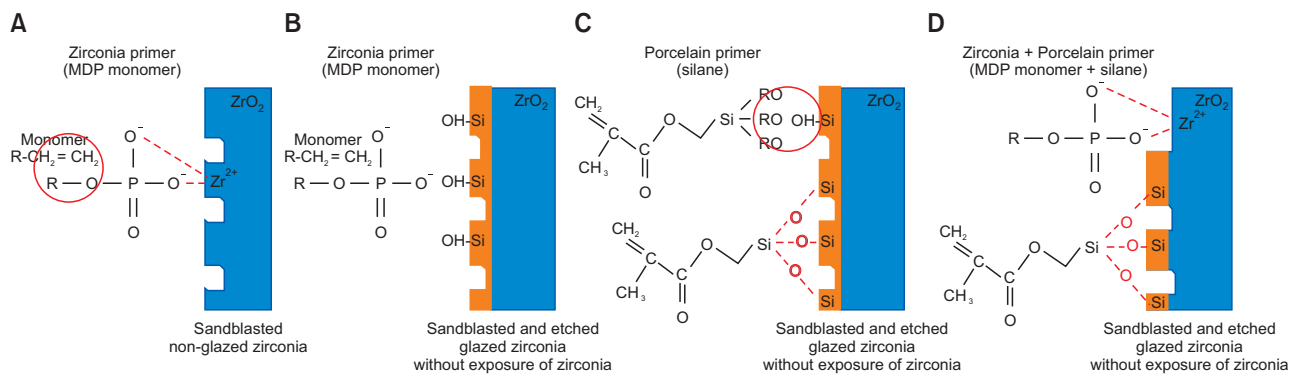
Figure 6. Chemical interaction models between primer and various zirconia surfaces. A, Nonglazed zirconia with zirconia primer; B, glazed and roughened zirconia with zirconia primer, showing mismatched interaction between zirconia primer (MDP) and the glazed surface; C, glazed and roughened zirconia with porcelain primer; and D, glazed and roughened zirconia with both primers.

Chemical interaction models of each experimental group are shown in Figure 6. Zirconia Liner Premium, the zirconia primer used in this study, is composed mainly of methyl methacrylate (97%); the balance comprises 3% MDP and 0.01% 4-methoxyphenol. The MDP monomer effectively forms a bond between resin cement and zirconia, enabling the phosphate ester group ($R-PO_4^{2-}$) of the MDP to directly bond to positively charged metal ions (such as Zr^{4+} , Al^{3+} , and Ti^{4+}) in metal oxides including those of zirconium, chromium, nickel, aluminum, tin, and titanium (Figure 6A).²⁹

The porcelain primer, a silane coupling agent, effectively creates a strong bond between resin cement and silica-based ceramics by increasing the wettability of the ceramic surface for the resin cement.²¹ Silane monomer commonly has one backbone end containing a vinylic carbon-carbon double bond ($-CH=CH_2$), while the other end has relatively rapidly hydrolyzable alkoxy groups ($-O-CH_3$). Once activated by hydrolyzation with water, the alkoxy groups form hydrophilic labile silanol groups ($-Si-OH$), which combine $-Si-OH$ in a silica surface (SiO_2). Glazing surfaces generally include silica with minor amounts of various metal oxides. Therefore, it is reasonable that silane agents may attach to glazed surfaces with hydrophobic siloxane bonds ($-Si-O-Si-$, Figure 6C).

Because the aesthetic appearance of a prosthesis is less important on the lingual side than on the buccal side, the glazing layer on the lingual side may be thin or absent, and the zirconia surface can be exposed during conventional roughening. In such a situation, an operator must either choose a single surface type in order to obtain acceptable bonding with a single primer or know whether two different primers can be used at the same time on two surface types without lowering their adhesion ability (Figure 6D).
