# Effect of zirconia surface treatment using nitric acid-hydrofluoric acid on the shear bond strengths of resin cements

Jin Hyung Cho, Sun Jai Kim, June Sung Shim, Keun-Woo Lee\*

**PURPOSE.** The aim of this study was to compare the surface roughness of zirconia when using Zircos E etching system (ZSAT), applying a nitric acid-hydrofluoric acid compound as a pretreatment agent, and also to compare the shear bonding strength according to different resin cements. **MATERIALS AND METHODS.** ZSAT, air abrasion, and tribochemical silicacoating were applied on prepared 120 zirconia specimens (10 mm in diameter, 7 mm in height) using CAD/CAM. Each 12 specimens with 4 different resin cements (Panavia F 2.0, Rely X Unicem, Superbond C&B, and Hot bond) were applied to test interfacial bond strength. The statistical analysis was performed using SAS 9.1 (SAS Institute Inc., Cary, NC, USA). The results are as follows: after application of the ZSAT on the zirconia specimens, surface roughness value after 2-hour etching was higher than those after 1- and 3-hour etching on SEM images. **RESULTS.** For Superbond C&B and Rely X Unicem, the specimens treated with ZSAT showed higher shear bond stren

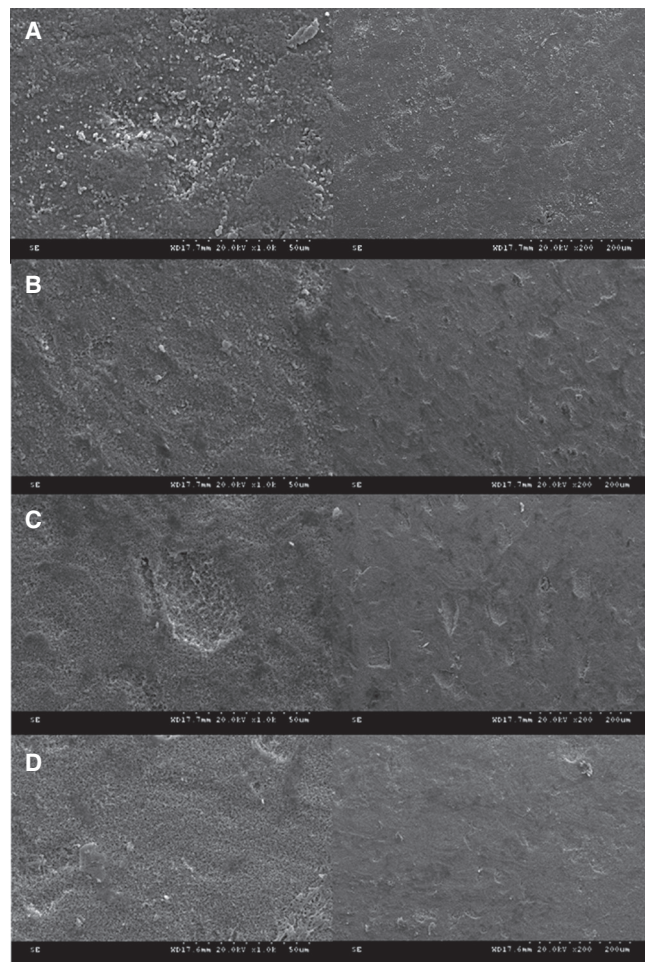
**Fig. 2.** (A) SEM image of zirconia surface after HF etching ( $\times 1000$ ,  $\times 200$ ), (B) Zircos E 1-hour etching ( $\times 1000$ ,  $\times 200$ ), (C) 2-hour etching ( $\times 1000$ ,  $\times 200$ ), (D) 3-hour etching ( $\times 1000$ ,  $\times 200$ ). Zirconia specimens with 2-hour application of zircos E etching system showed most rough surface.

The following SEM images are specimen surfaces after conditioning with 9.5% hydrofluoric acid in 925°C and Zircos E etching system for 1, 2, and 3 hours, respectively (Fig. 2).

Surface roughness observed by 3D optical analyzer showed the average of 0.562, 0.683, and 0.532 when conditioned with Zircos E etching system for 1, 2, and 3 hours group, respectively. With these results combined with SEM images, the test group that used Zircos E etching system for 2 hours appeared to be most effective for resin tag infiltration, and thus was used in zirconia-resin cement bond strength evaluation. Considering the clinical conditions, an annealing process was added to remove residual surface remnants and relieve remaining stress produced during sintering. EMAX (HORIBA, Tokyo, Japan) images of the surface remnants were taken after acid etching. The results are seen as follows (Fig. 3).

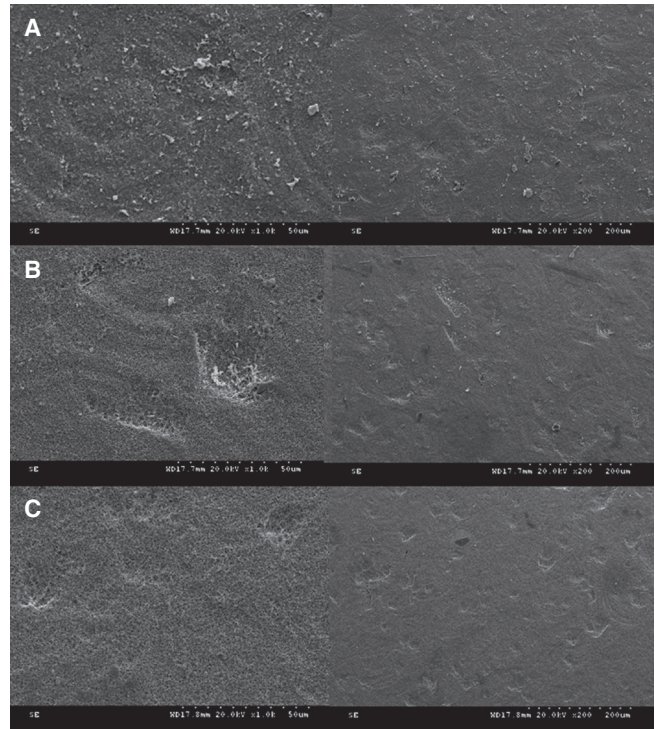
**Fig. 4.** SEM image of zirconia surface after annealing process. (A) 1-hour etching (×1000, ×200), (B) 2-hour etching (×1000, ×200), (C) 3-hour etching (×1000, ×200).

The specimens underwent thermal cycling in the furnace under 1150°C to observe the changes of surface roughness using SEM and 3D optical analyzer before and after annealing. Surface roughnesses after annealing were 0.539, 0.638, and 0.539 in the groups that used Zircos E etching system for 1, 2, and 3 hours, respectively (Fig. 4).

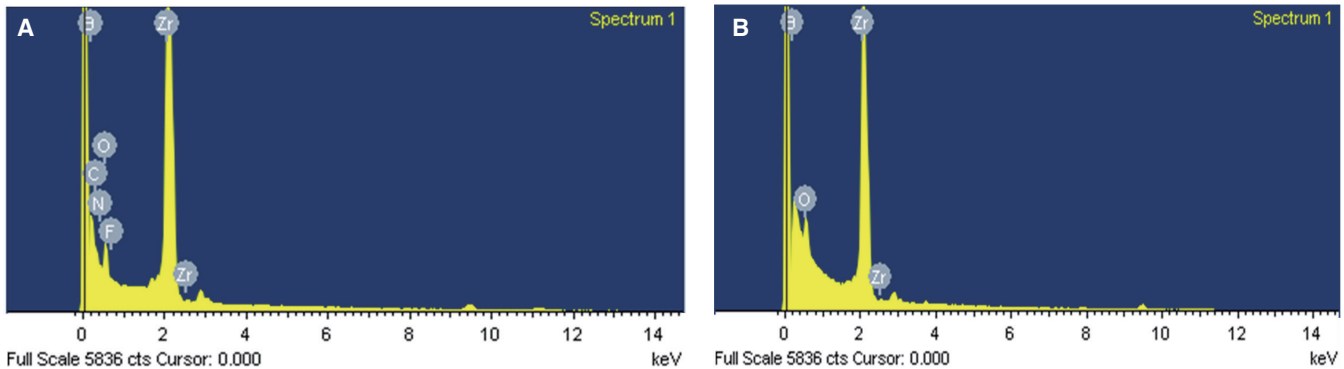
**Fig. 3.** EMAX spectrum before annealing (A) and after annealing (B). Flourine, Nitrogen, and Carbon removed by heating process.

Percentage differences in elements were observed among the groups with different conditioning times. Elements such as fluorine, carbon, nitrogen, and oxygen were observed in the test groups that used distilled water as a rinsing agent after surface conditioning. Carbon, fluorine, and nitrogen were not observed in the test groups that underwent an annealing process in 1150°C. According to Kosmac *et al.*, the annealing process is known to relieve compressive stress and reduce average flexural strength. However, in clinical usage, thermal cycling is used to eliminate surface impurities and possible factors that can reduce bond strength.

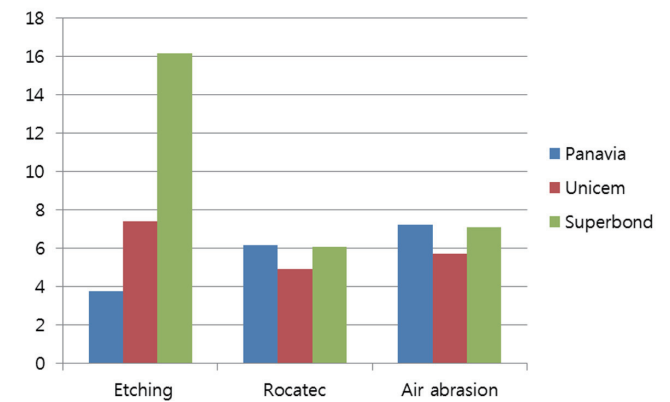
Fig. 8. Comparison of mean force value in MPa.

Significantly higher shear bond strengths were observed in the groups that used Rely X Unicem and Superbond after Zircos E etching system. On the other hand, in the groups that used Panavia F 2.0, air abrasion group showed the highest shear bond strength (Fig. 8).

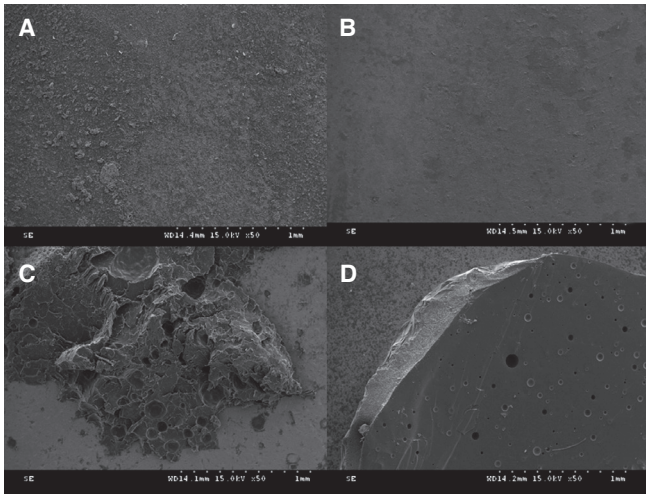
**Fig. 9.** SEM image failure mode of zirconia surface at ×50 magnification. (A) Panavia F 2.0, (B) Unicem, (C) Superbond, (D) Hot bond.

SEM images of failure modes following shear bond strength evaluation are shown as follows (Fig. 9). In Panavia F 2.0 and Superbond groups, adhesive failure and cohesive failure behaviors were both observed. In the Rely X Unicem group, adhesive failure was predominant. In the Hot bond group, cohesive failure within the resin cement was observed (Table 3).
