Assessing Compliance with the Wildlife Crossing Guideline in South Korea

Donggul Woo, Heebok Park, Hyeong-Soo Seo, Ho-Gyeong Moon, Euigun Song, Anya Lim* and Tae-Young Choi*
National Institute of Ecology, Seochon 33657, Republic of Korea

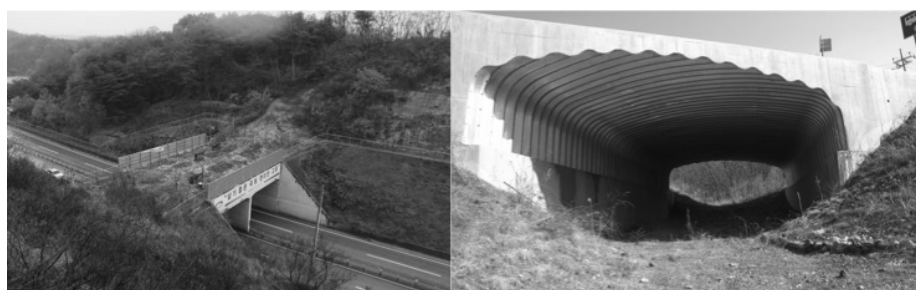
Fig. 1. Example of overpass (left) and underpass (right) wildlife crossing.

We surveyed 83 randomly chosen wildlife crossings, composed of 56 overpass wildlife crossings (hereafter overpass) and 27 underpass wildlife crossings (hereafter underpass), among 415 in South Korea between August and December 2014 (Fig. 1). We examined whether wildlife crossings appropriately followed the guideline for wildlife crossing construction and management, provided by the Ministry of Environment Korea (Ministry of Environment 2010). For the survey, we prepared a checklist based on the guideline. The survey list included 14 items for overpass and 11 items for underpass that critically influence the effectiveness of wildlife crossings, such as installation of drainage at the entrance, prevention of pedestrian and vehicle access, installation of wildlife fence around wildlife crossings, and use of similar materials with adjacent vegeta-
