Review Article

Unwanted effects due to interactions between dental materials and magnetic resonance imaging: a review of the literature

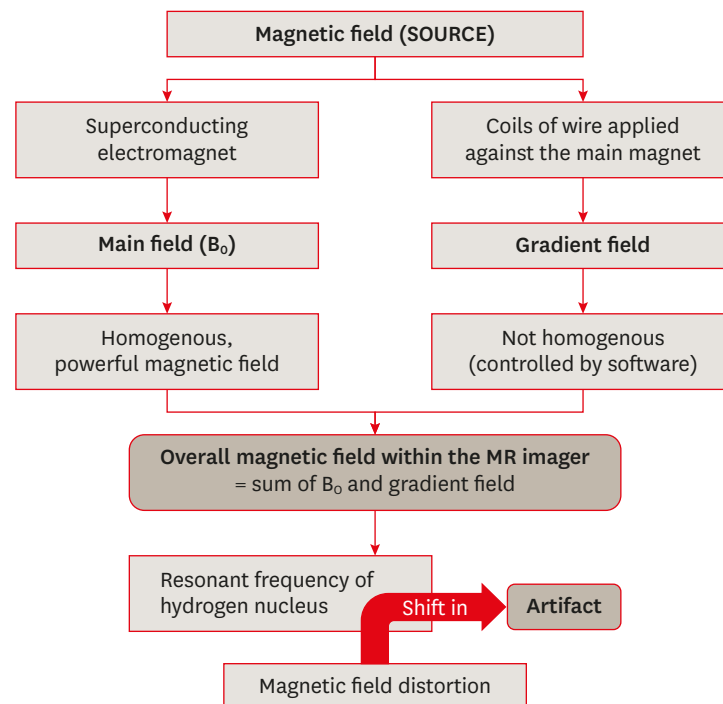
Figure 1. Mechanism of artifact formation. MR, magnetic resonance.

The mechanisms of artifact formation and other interactions can be understood by reviewing the principles of MRI (**Figure 1**). MR is based on the dependence of the resonant frequency of a hydrogen (H) nucleus on the strength of the magnetic field to which the nucleus is exposed. Any distortion of the magnetic field, either by intrinsic or extrinsic effects, will therefore result in spatial distortion of the image; that is, the distortion of the magnetic field at a certain point shifts the resonant frequency of the H nuclei at that point [6]. **Figure 1** summarizes the mechanism of MRI and artifact formation. In the case of dental materials, there are 2 potential sources of artifacts in MRI.

1) Distortion of the static magnetic field (B_0) due to differences in the magnetic susceptibility of materials and body tissues

A susceptibility artifact (SA) is defined as signal incoherence generated by the intermingling of substances with discrepant capacities to be magnetized (measured by χ , susceptibility). Because most body tissues are diamagnetic (not very magnetizable), proximity to substances with highly magnetic properties (*i.e.*, ferromagnetic materials) induces SAs.

2) Eddy currents

These are induced by alternating gradients and radiofrequency magnetic fields. The induced eddy currents distort the applied magnetic field, leading to image distortion [8]. Eddy current artifacts due to metallic objects within the MRI field are referred to as non-SAs [35].

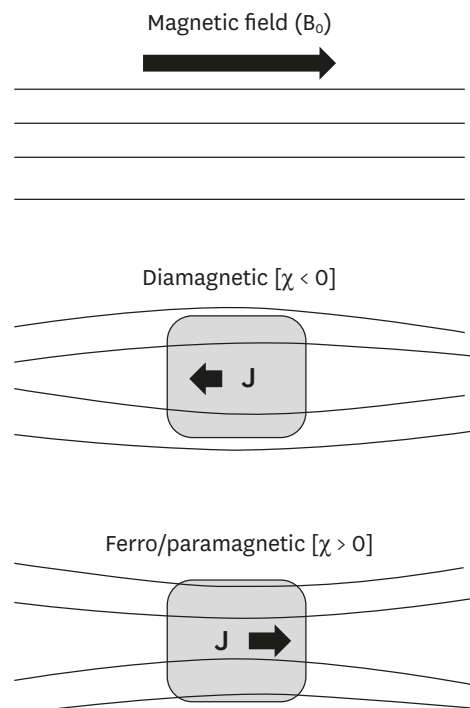
Figure 2. Classification of materials according to their interactions with magnetic fields. χ , magnetic susceptibility (synonym = magnetizability); J, Polarization or Internal magnetization.

During MRI, when no matter is present (*i.e.*, in a vacuum), the induced field (B) and applied field (H) are essentially equivalent. Whenever matter is present within a given region of space, the induced field (B) is generally not equal to the applied field (H) because various electromagnetic interactions (internal magnetization [Mi] or polarization [J]) occur that concentrate or disperse the magnetic lines of force. This magnetization is proportional to the applied field by a dimensionless constant known as magnetic susceptibility (χ), which is synonymous with magnetizability. It is a measure of the extent to which a substance becomes magnetized when it is placed in an external magnetic field. Another dimensionless factor is magnetic permeability, a physical constant. It is related to magnetic susceptibility by the expression: $\mu = 1 + \chi$.

With regard to magnetic effects, 3 classes of materials exist (**Table 2**; **Figure 2**). Nearly all biological tissues are weakly diamagnetic. Other than trace amounts of magnetite, there
