원위치 X-ray CT 촬영이 가능한 암석의 수리-역학 실험용 삼축셀 개발

Development of Triaxial Cells Operable with In Situ X-ray CT for Hydro-Mechanical Laboratory Testing of Rocks

장 리¹ Zhuang, Li
염 선² Yeom, Sun
신 휴 성³ Shin, Hyu-Soung

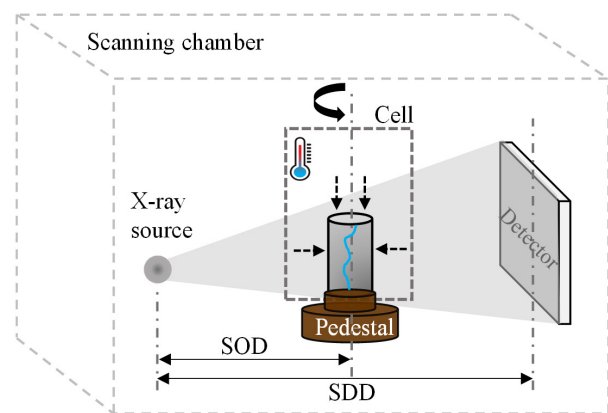
Fig. 1. Schematic representation of *in situ* industrial CT scanning. Cylinder represents sample (scanning object), the line segments in the water blue represents fluid flow, and the dashed arrows signify mechanical loading

The fundamental principles of X-ray CT have been frequently introduced. For a detailed introduction to industrial X-ray CT, we refer to ASTM (2011) and Hermanek et al. (2018). An *in-situ* industrial CT scanning is simply described in Fig. 1. The scanned object (e.g., a rock sample) and a cell are installed on the pedestal, and placed together in the X-ray scanning chamber. According to different research purposes, the cell can provide various functions, such as mechanical loading, thermal loading and fluid flow. Other components such as the control panel, pumping system and accessories of the testing system can be placed outside of the chamber. The *in situ* CT scanning system

allows one to obtain the 3D structure of the sample subject to loading, but under a quasi-static condition. Depending on the specifications of the scanning system, typical industrial CT scan takes up to half an hour or more. Therefore, it is almost impossible to catch catastrophic failure or to investigate real-time changes inside a sample. For in situ CT scanning design for the cell, one should consider the source to object distance (SOD) as well as the source to detector distance (SDD). As the name implies, the SOD is the distance from the focal spot of an X-ray tube and the center mass of the object, and the SDD is the distance from the focal spot to the detector, as shown in Fig. 1. Geometry magnification is determined by the SDD and SOD ratio. For a specific X-ray CT scanning system (e.g., the one used in this study), a decrease in the SOD realized by positioning the object close to the X-ray source allows for an increase in the geometry magnification, and, therefore, an increase in resolution. However, the SOD will be limited by the horizontal size of the cell. Moreover, as significant X-ray energy attenuation occurs upon the cell penetration, it is important to reduce the cell size and select a material with a relatively low atomic number and low density for obtaining high resolution CT scanning, under the precondition that the cell should have enough strength to ensure safety under a given confining pressure (e.g., 20 MPa), particularly for rock testing.

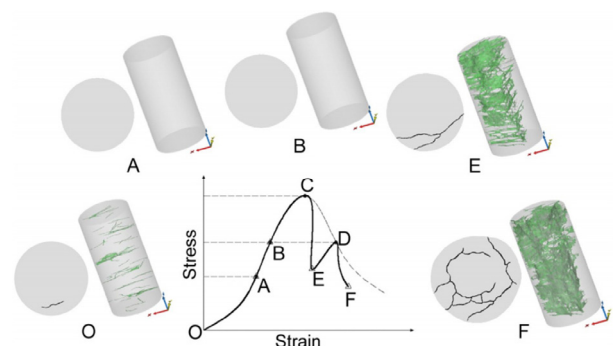
Fig. 2. 3D reconstruction of CT showing the progressive damage in the coal specimen subjected to axial compressive load under 15 MPa confining pressure. The green color represents fracture networks, and line drawings represent fractures in a cross section (after Ju et al., 2018)

MPa. Loading was frequently stopped to allow 3D CT reconstruction of the sample and the compressive load was maintained using the servo control function. Fig. 2 shows the evolution of fractures during the loading process. The pre-existing fractures inside the coal specimen close due to increasing load at the beginning of loading, therefore, fractures could not be extracted at the stages A and B. After the peak strength, a spatial fracture network was formed. In the above mentioned two studies using the in situ industrial CT, progressive damages inside the rock specimens are investigated. Dynamic propagation of fractures was impossible to be captured because acquisition time (3D reconstruction from CT scan) usually lasts for up to one hour or more, depending on sample size and scan conditions. The acquisition time will influence image quality and it can be optimized through selection of the exposure time for each projection, projection number as well as reconstruction algorithm (Lin et al., 2018). However, the improved acquisition time is still at a minute scale while dynamic fracture propagation is thought in the range of microseconds or even less.

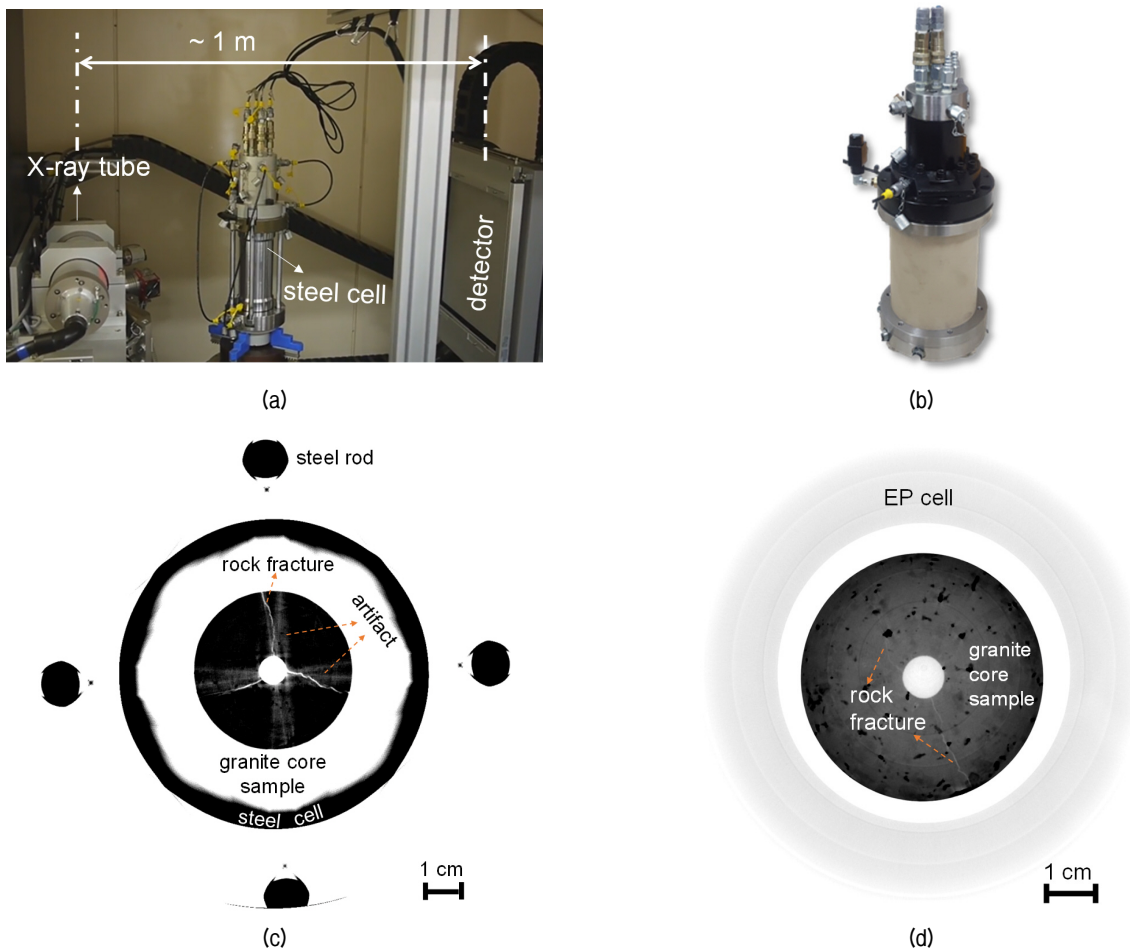
Fig. 3. Triaxial cell made from (a) steel and (b) engineering plastic designed for a hydraulic fracturing test coupled with in situ CT scanning; (c) and (d) show 2D cross-sectional images of a 50-mm-diameter Pocheon granite sample containing fractures corresponding to the steel and EP triaxial cells in (a) and (b), respectively (Modified from Zhuang et al., 2018a)

For the purpose of directly observing hydraulic fractures during fluid injection, triaxial test equipment was placed into the scanning chamber allowing CT scanning for the sample inside the triaxial cell. A hydraulic injection pump was arranged outside as it is relatively bulky. Fig. 3(a) shows a picture of the equipment being installed inside the X-ray chamber. The triaxial cell was made of stainless steel. For details about the equipment, we refer to Zhuang et al. (2019). Fig. 3(b) shows an alternative triaxial cell made from engineering plastic (EP). A rotation table was installed at the bottom of the pedestal to allow for rotation of the triaxial testing equipment together with the rock

Figure 3(c) shows a CT image of a 50 mm diameter Pocheon granite sample containing three preexisting fractures scanned inside the steel triaxial cell, using a voltage of 250 kVp, current of 2 mA and SOD of 448.9 mm. The image has a pixel pitch of 152 μm . Relatively large aperture (0.5 mm~) fractures can be distinguished; however, mineral recognition is impossible. For the same Pocheon granite, ex situ CT scanning with a resolution of 57 $\mu\text{m}/\text{pixel}$ has been reported for a 50 mm diameter sample with hydraulic fracture aperture ranging across ~8 pixels (0.46 mm) under the given test conditions (Zhuang et al., 2019). Metal artifacts due to the high density of steel components can seriously

degrade the image quality. Excessive X-ray attenuation due to the high atomic number and high density of stainless steel materials, can prohibit radiation from reaching the detector, resulting in artifacts such as metal artifacts and beam hardening artifacts (Boas and Fleischmann, 2012; Amirkhanov et al., 2011).

The four steel rods were removed and the steel cell was modified to use an EP cell, as shown in Fig. 3(b). The EP material has a much lower density of 1.31 g/cm^3 compared to steel. The EP cell has an external and internal diameter of 160 mm and 80 mm, respectively. Therefore the thickness of the cell is 40 mm, and it was tested to be safe under an inner pressure of 30 MPa and vertical pressure of 20 MPa lasting for more than one hour. Fig. 3(d) shows a cross-sectional image of a 50 mm diameter granite sample inside the EP cell scanned under 180 kVp, 0.18 mA and SOD of 260.8 mm. A smaller voltage and current compared to that corresponding to Fig. 3(c) was used because the low density EP cell will attenuate less X-rays than the steel cell shown in Fig. 3(a). The reconstructed 2D image has a resolution of $105 \text{ }\mu\text{m}$ per pixel pitch. Fractures (aperture of 0.3-0.5 mm) and minerals, such as mica and quartz clusters can be recognized.

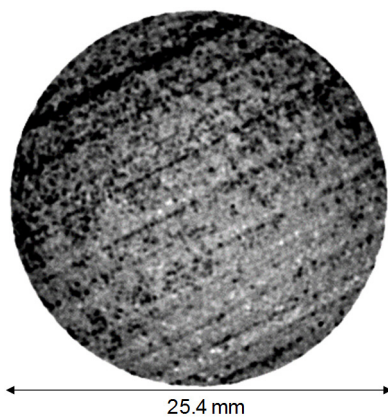
Fig. 4. Cross-sectional CT image of a transversely isotropic Berea sandstone sample installed inside the EP cell and subject to a vertical stress of 30 MPa. Scanning condition: SOD of 183.3 mm, voltage of 150 kVp, and current of 0.2 mA

An in situ unconfined compression test for a 1-inch (25.4 mm) diameter Berea sandstone sample installed in the EP cell was conducted. The Berea sandstone contains bedding planes and behaves transversely isotropic and its uniaxial compressive strength is reported to be approximately

40 MPa at a porosity of 10-14% (Kim et al., 2016). The axial load was increased in steps of 10 MPa. Fig. 4 shows a 2D CT image of the sample subject to a vertical pressure of 30 MPa and zero confining pressure. The image has a pixel pitch of $73 \text{ }\mu\text{m}$, and beddings in the sandstone can be recognized. Unfortunately, we failed to capture any visible cracks inside the sample before an unexpected catastrophic failure of the sample.

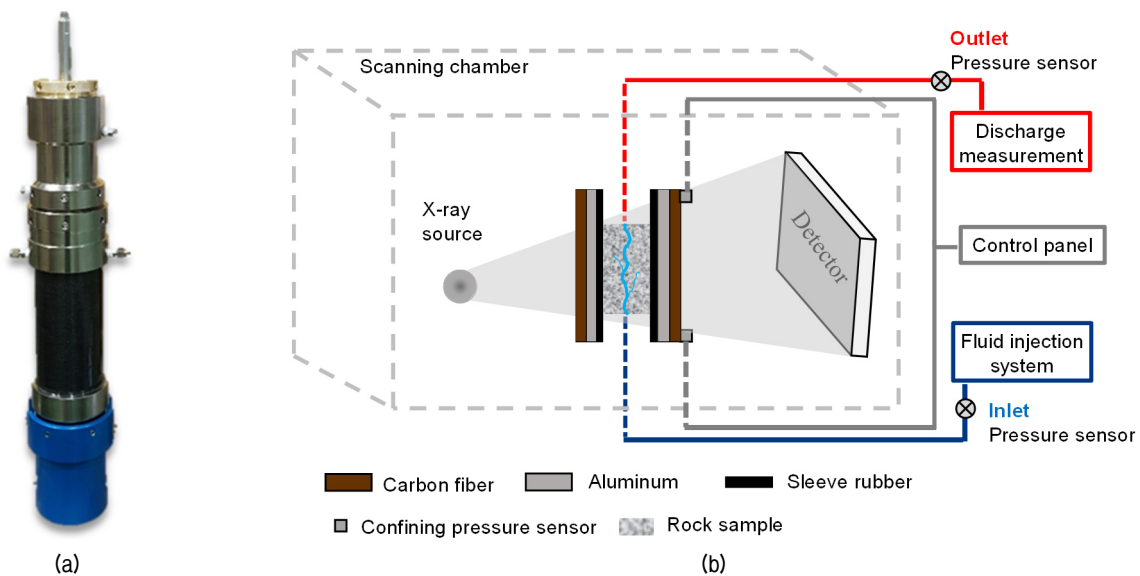
Fig. 5. Hydro-mechanical laboratory testing of rocks in an X-ray scanning chamber. (a) Triaxial cell, (b) schematic diagram of the testing system. The blue curves represent fluid flow in the sample

For the purpose of evaluating correlation between internal structures and hydraulic performance of rock samples (rock fractures in particular), we installed permeability measurement equipment in the scanning chamber allowing for in situ CT imaging of a sample during fluid injection (Fig. 5). A fluid (water or gas) injection device, discharge part and pressure control panel were arranged outside of the scanning chamber. The triaxial cell was made using carbon fiber and aluminum, which can work under temperature of 150°C and a confining pressure of 20 MPa. A sleeve

made from urethane rubber was placed between the sample and cell for sealing. Moreover, the sleeve is detachable and its material can be replaced for specific purpose testing, e.g., high temperature silicon rubber for testing of fractured granite samples under geothermal conditions. The inner and outer diameters for the cell were 38 mm and 92 mm, respectively, allowing a maximum core sample diameter of 38 mm for testing.

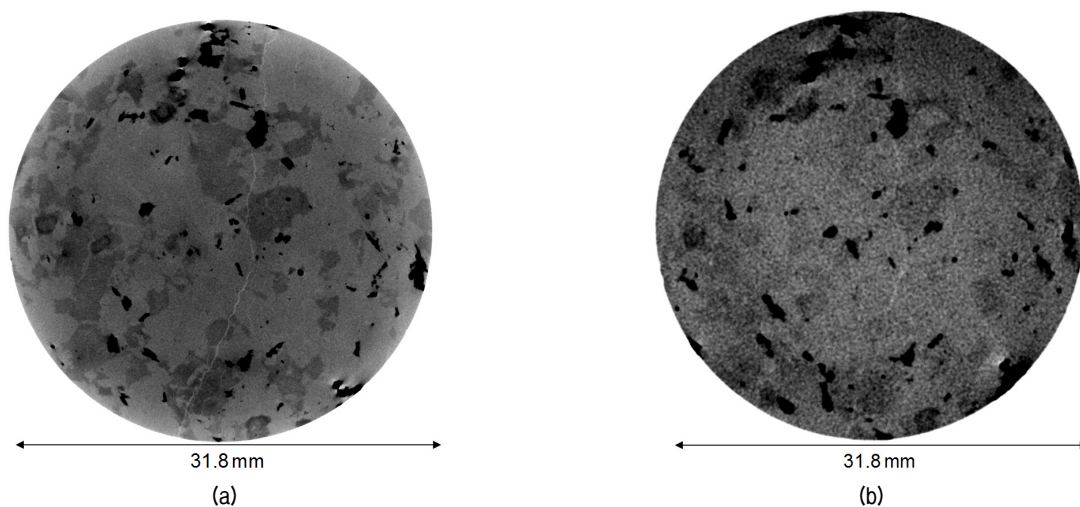
Fig. 6. Comparison of cross-sectional CT images obtained for a Pocheon granite sample containing a single hydraulic fracture: (a) ex situ scanning with an SOD of 85.1 mm, voltage of 160 kVp and current of 0.16 mA, (b) in situ scanning inside the triaxial cell with an SOD of 152.9 mm, voltage of 160 kVp and current of 0.18 mA

2D cross-sectional CT images obtained at a similar location for the same Pocheon granite core sample (1.25 inch diameter) containing a single hydraulic fracture scanned

under ex situ and in situ condition using the triaxial cell are compared in Fig. 6(a) and (b), respectively. The sample was cored from a block sample fractured by water using true triaxial hydraulic fracturing test equipment (Zhuang et al., 2020b). The two images have a pixel pitch of 34 μm and 61 μm , respectively. The aperture of the hydraulic fracture was estimated to be 3-4 pixels (102-136 μm) based on Fig. 6(a). Though the image shown in Fig. 6(b) shows a lower resolution compared to that in Fig. 6(a), the hydraulic fracture and mineral grains, such as mica and quartz, are clearly recognizable. In the near future, we plan to test the permeability of fractured granite samples and aperture changes for different confining pressures of up to 20 MPa. Comparison between the hydraulic aperture

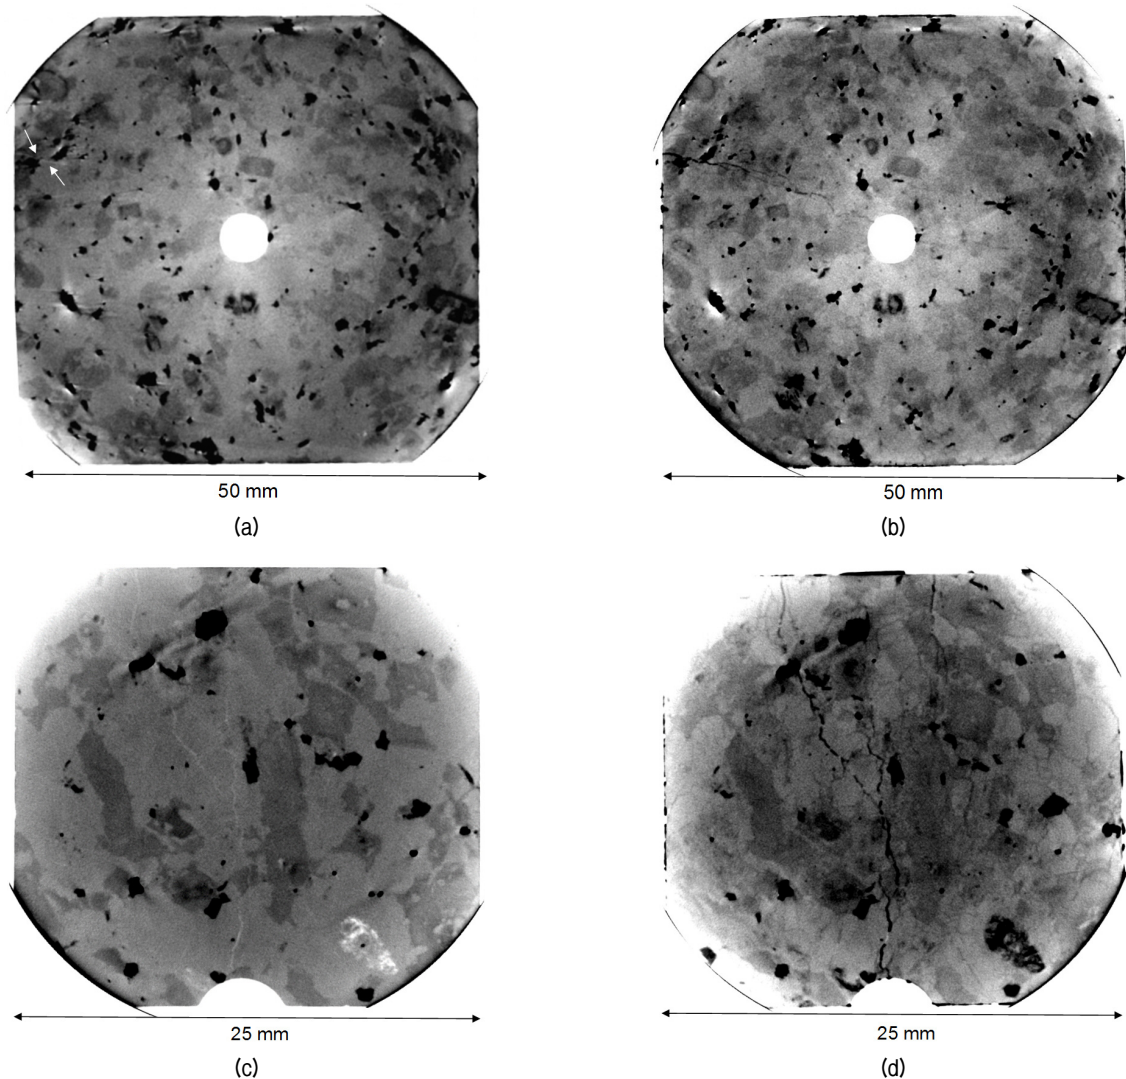
Fig. 7. Comparison of CT images obtained for fractured granite specimens via water injection: (a) and (c) before, (b) and (d) after saturation with 50% concentration KI solution. The original hydraulic fracture in (a) that is almost invisible to the unaided eye is marked by arrows

Fig. 7 shows a comparison of CT images obtained for two different sizes of Pocheon granite samples containing hydraulic fractures prior to and after saturation by a 50% concentration KI solution. The granite samples were fractured by tap water under true triaxial stress conditions (Zhuang et al., 2018b). After the hydraulic fracturing test samples were removed from the test equipment for ex situ CT scanning. Then, the samples were immersed in KI solution stored in a vacuum chamber. Hydraulic fractures that were previously hardly recognized in Fig. 7(a) were found to be very clear to the unaided eye after the saturation with KI solution, as shown in Fig. 7(b). Fig. 7(c) shows hydraulic fracture networks (at least three fractures) found to be visible when the sample size was reduced to 25 mm. Image contrasts of the fractures, particularly relatively thin fractures and their surrounding minerals, were found to be further enhanced by KI solution, as shown in Fig. 7(d). Thus, this can help one to quantitatively evaluate fracture properties.
